# DESTRUCTIVE WAVE OVERTOPPING TESTS ON GRASS COVERED LANDWARD SLOPES OF DIKES AND TRANSITIONS TO BERMS

Gosse Jan Steendam<sup>1</sup>, Jentsje W. van der Meer<sup>2</sup>, Bianca Hardeman<sup>3</sup>, André van Hoven<sup>4</sup>

*Keywords:* dikes; levees; prototype tests; overtopping; wave overtopping simulator; grass erosion

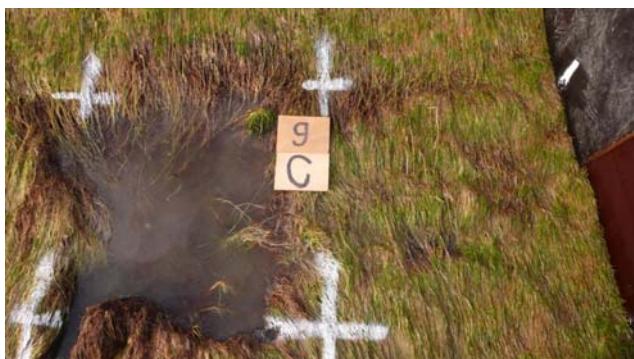
**Results of test series 1.** In the first session of two hours with 10 l/s per m initial damage occurred at a small irregularity at the toe of the dike. A small part of the grass cover was torn off creating a hole of about 0.75 m<sup>2</sup> with a depth of 0.1 m (Figure 9).

Figure 9. Initial damage at toe of section 1 ( $0.75 \text{ m}^2$ ; depth 0.1 m)

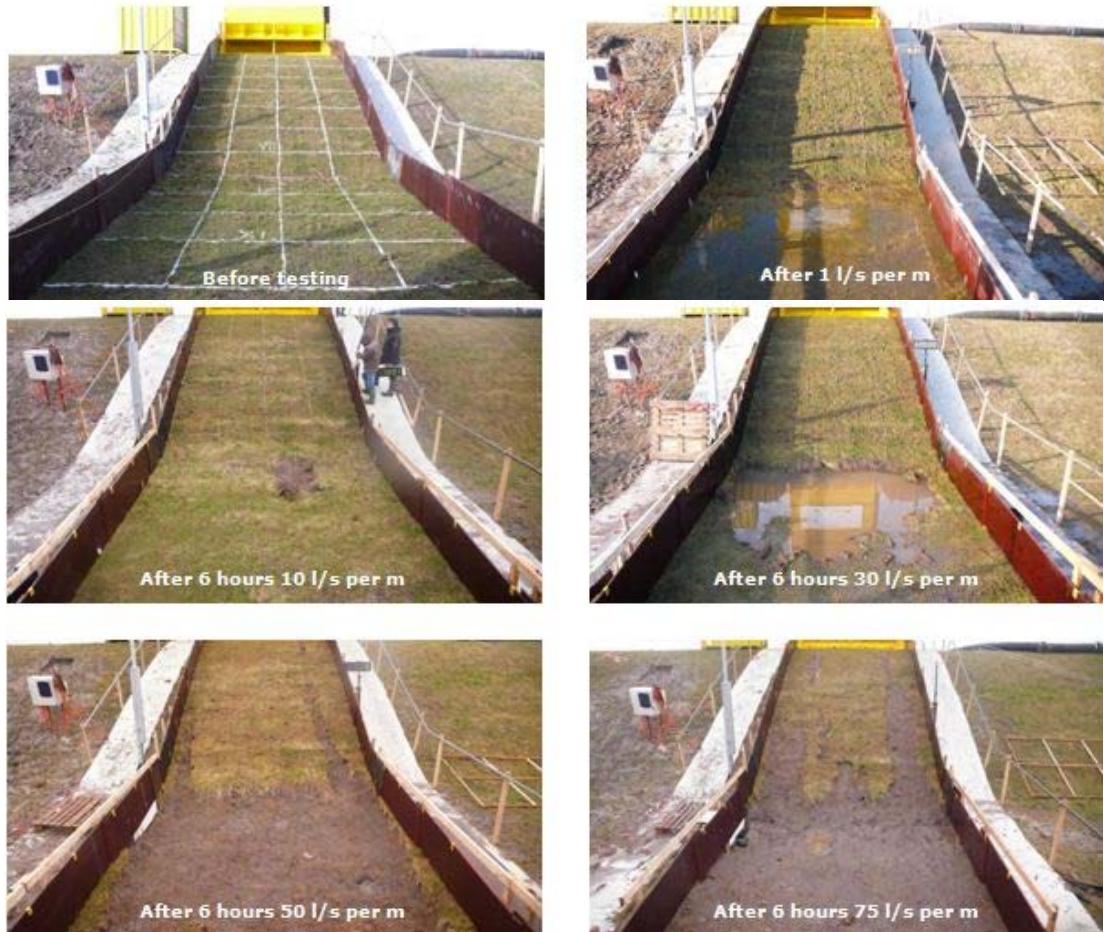
During 30 l/s per m the damage at the toe developed gradually to over  $10 \text{ m}^2$  and at 50 l/s per m the complete grass cover at the toe had disappeared. However the depth of the damage did not change much.

During the last test (75 l/s per m) the damages developed further in length and width but did not lead to failure of the dike. Figure 10 gives an overall view of the development of the damages over the test series in test section A1.

It was concluded that the grass cover failed easily, but the remaining top layer of rooted clay was remarkably erosion

Figure 10. Development of damages in test section 1

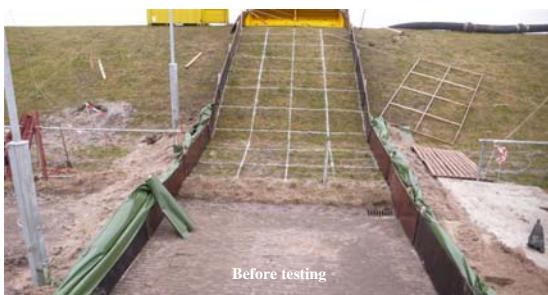
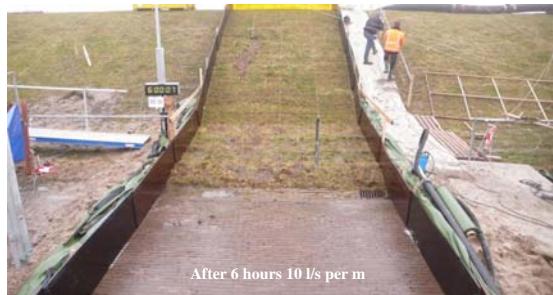
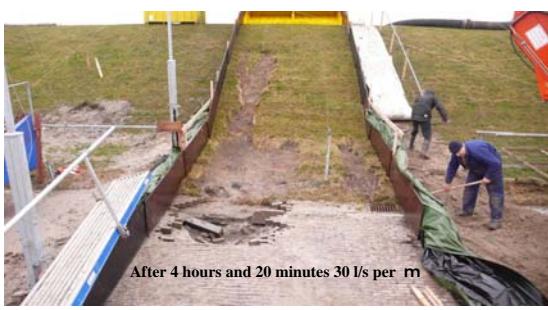
At 4 hours after the start of the test with 30 l/s per m, with a high overtopping wave some bricks were displaced (Figure 12). The rate increased rapidly. In 1 hour a total of 54 bricks were washed out. At the same time the erosion hole just in front of the curb expanded and deepened. At each following wave water was pressed underneath the concrete band causing upward forces on the bricks of the parking lot. Together with the uplift forces during over wash of the overtopping waves a first brick of the parking lot came out. This damage expanded fast. After 4 hours and 20 minutes the test was stopped because of the large damages (figure 13).

Figure 13. Damage development test section A2

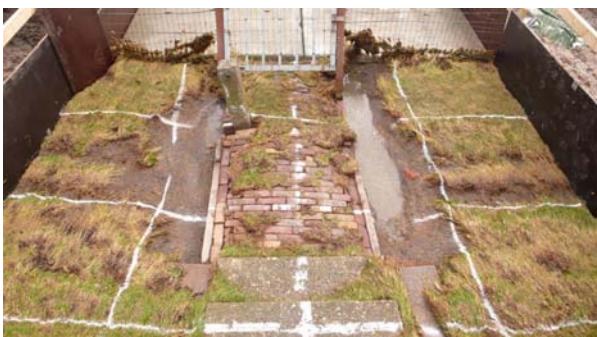
Figure 14. Result after 6 hours of 10 l/s per m.

In the 10 l/s per m test erosion started at the low end of the tiles on both sides of the staircase (Figure 14).

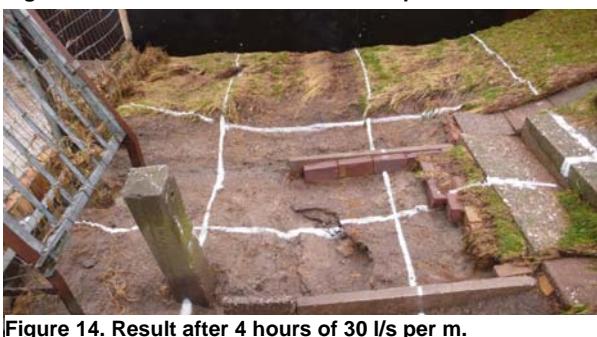
Figure 14. Result after 4 hours of 30 l/s per m.

In the 30 l/s per m test more damage occurred at the path. After 4 hours most of the path had disintegrated (Figure 14). The erosion holes at the toe deepened and a initial damage on the slope developed to the toe.

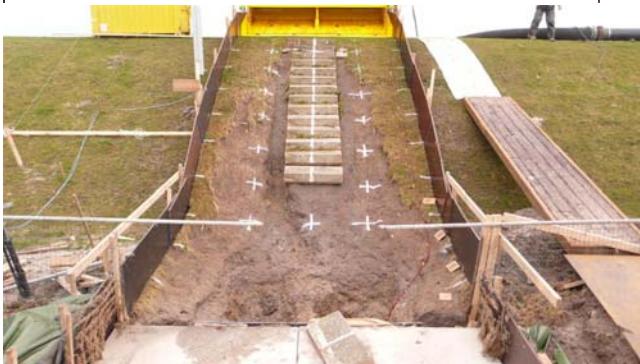
Figure 15. End result test section A3 after 2 hours 75 l/s per m

At 75 l/s per m the lower 4 steps of the staircase came down. The test was stopped because of this. Very deep holes (over 1 m) had developed beneath the staircase (Figure 15). As there was a 1.5 m thick layer of clay present, the core of the dike was not reached yet and therefore the dike did not fail yet.

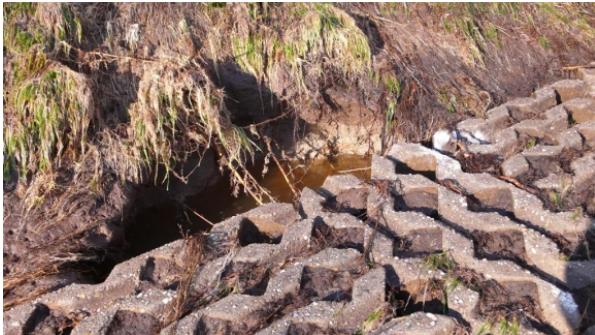
**Results of test series V1.** During the 1 l/s per m test initial damage developed at the vertical ridge just above the maintenance road. These damages evolved slowly at 10 l/s per m (Figure 17) and at 30 l/s per m these damages developed to two substantial holes undermining the road. (Figure 18).

Figure 18. One of the holes undermining the maintenance road

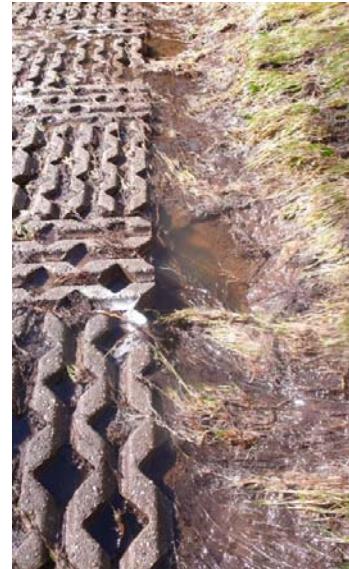
Just above the maintenance road deep track was present, showing a vertical ridge against the concrete bricks.

Figure 17. First damage at upper edge of maintenance road

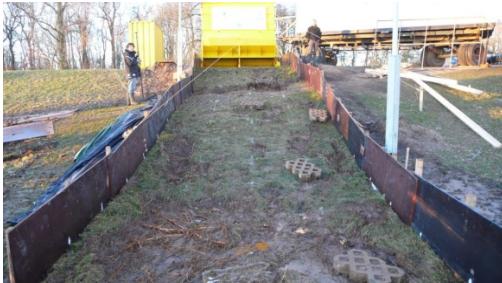
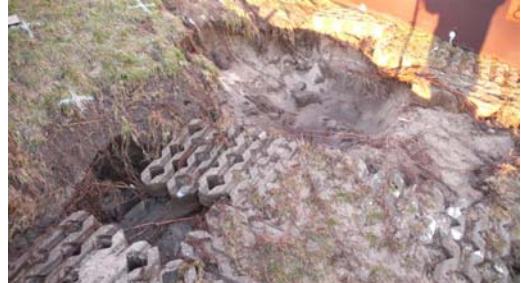
At the start of the 50 l/s per m test, with a large wave, bricks came out. The end result is shown in Figure 18. At this time also large surfaces (several square meters) of the grass cover at the toe and the berm were eroded as well.

Figure 18. End result test V1

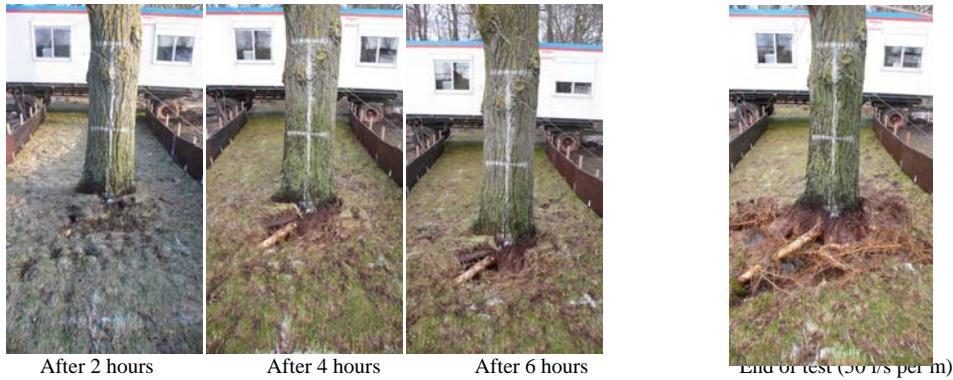
**Results of test series V2.** At the 5 l/s per m test the grass cover around the tree disintegrated showing a lot of near surface roots from the tree. The damage developed fast at the 10 l/s per m test (Figure 21).

**Figure 21. Damage development section V2 at 10 l/s per m and end result after 5½ hours 50 l/s per m**

In the 30 l/s per m test the surface of the slope did not change much. The damage at the tree increased. In the next test (50 l/s per m) the damage at the tree expanded to over 4 m<sup>2</sup> and sand was washed out. The test was stopped after 5½ hours; the dike at the tree was considered to have failed (Figure 21 on the right).

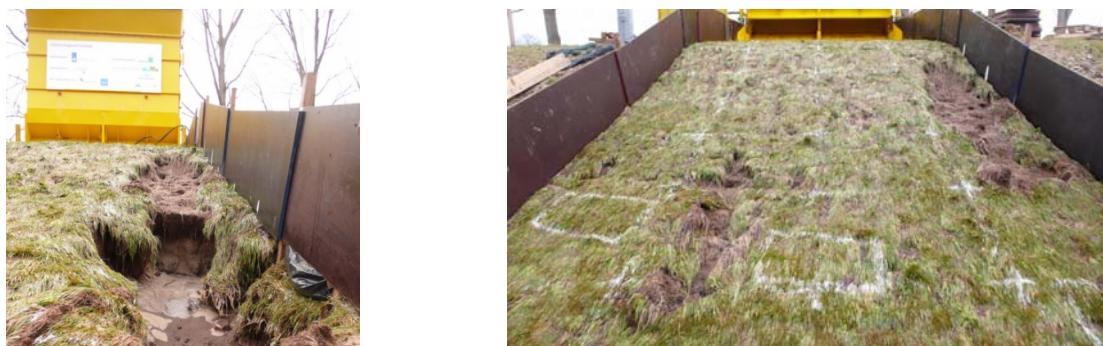
**Results of test series V3.** The behaviour of the slope was similar to the previous test at section V2. At 30 l/s per m things started to happen. The small holes on the surface eroded at large waves. All of the damages started where signs of activities of moles were found. In Figure 22 the damages after 30 l/s per m are shown.

**Figure 22. Damage section V3 after test session 30 l/s per m**

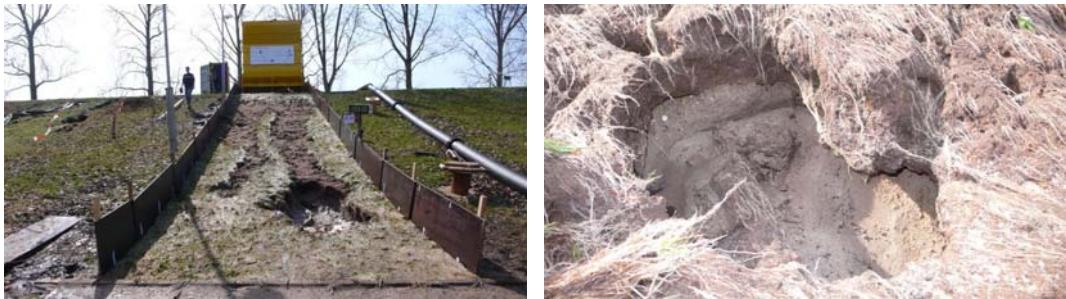
**Results of test series V4.** From the start of the test series it was observed that the larger overtopping wave volumes had an immediate impact on initiation and development of damage at the slope. This damage development appeared to be the same as with test series V2 (on the slope) and V3, but much faster. Already at 5 l/s per m several initial damages on the slope developed to gullies. To the end of this test some of the gullies merged but did not change much in depth. At 10 l/s per m, locally the depth increased to 35 cm revealing the sand of the core. All of these local deep marks were mole tunnel induced holes. The 30 l/s per m test was stopped after one hour (Figure 24). The core material was washed out, leading to head cut erosion. Also higher on the slope a hole was found which would have led to dike failure if the test had not been stopped.

Figure 24. End result section V4 after 1 hour 30 l/s per m
