DESTRUCTIVE WAVE OVERTOPPING TESTS ON FLEMISH DIKES

Gosse Jan Steendam¹, Patrik Peeters², Jentsje van der Meer³, Koen van Doorslaer⁴ and Koen Trouw⁵

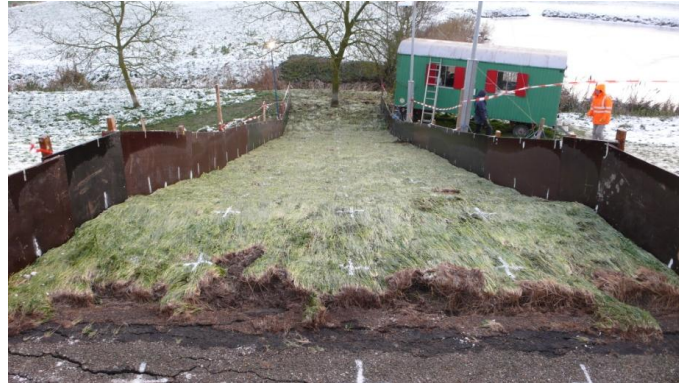
At the first section after completing all test conditions, no damage was found. Only superficial erosion of the grass cover had taken place. No damage was found near the tree at the berm. Minor damage occurred at the transition from the asphalt road to the grass covered slope. Next, pre defined superficial damages were applied to the slope. At 6 locations along the slope ranging from 0,15x0,15m to 0,35x0,35 m, the sward and turf part of the vegetation was removed. The rooted part of the topsoil was left in place. After completing again the total test conditions, damage only had grown little.

Figure 3. Final result test section 1, looking down the slope; minor damage at transition asphalt road to grass covered slope 1:4.

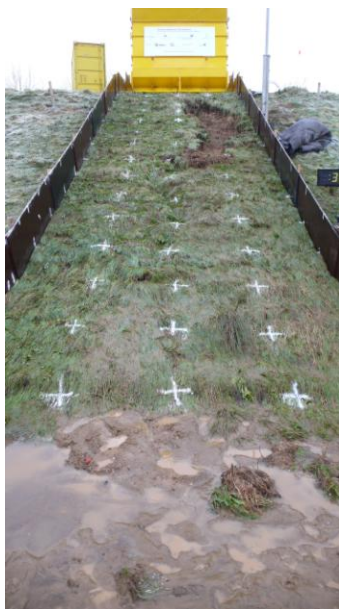
At the second test section (slope 1:2.5; high fine sand content) the initially irregular slope damaged quickly and failed after 36 minutes of 30 l/s per m (see figure 4).

Figure 4. End result of section 2.

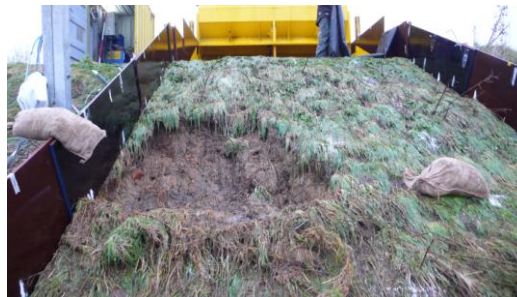
Also the third test section failed at a mean discharge of 30 l/s per m. This time the failure happened after 21 minutes (see figure 5). After provisionally repairing the damage with sand bags and covering it up with a fixed geotextile, the test was continued for an extra 10 minutes. In addition, to assess the stability of the sand bags alone, the geotextile was removed and 10 minutes of testing were done on uncovered sand bags.

Figure 5. End result of section 3.

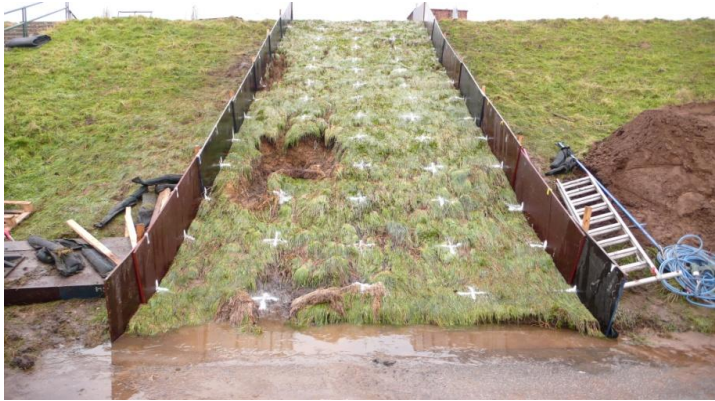
The fourth section was performed with high hydraulic conditions ($H_s = 3$ m). From experience on sections 2 and 3 and the assumption that large overtopping waves which exceed a certain critical volume or velocity cause damage, it was expected that this section would fail at 10 l/s per m. But after 2 hours of 10 l/s

per m the expectations were not met. It then was decided to go on testing with the same conditions. After one more hour the slope indeed failed (see figure 6).

Figure 6. Failure of section 4.

At section 4 the slope failed after 3 hours of 10 l/s per m but with a larger hydraulic load ($H_s = 3$ m). Looking at table 3 and the damage criteria again it can be concluded that the critical velocity of the tested slope is below 3.1 m/s ($V < 0,25 \text{ m}^3/\text{m}$).
