DESTRUCTIVE WAVE OVERTOPPING AND WAVE RUN-UP TESTS ON GRASS COVERED SLOPES OF REAL DIKES

Gosse Jan Steendam¹, Yvo Provoost² and Jentsje van der Meer³

In March 2011 new wave overtopping tests have been performed in the Netherlands. In contrast to previous tests the grass cover of this dike was not maintained well, which had significant effect on erosion stability. Additionally, for the first time a pilot test has been made on wave run-up from an asphalt berm onto the grass covered upper slope of the dike. The tested dike sections had a sand core covered by a layer of clay and a grass cover. The objective was to test the erosion stability of seaward and landward slopes for wave overtopping as well as wave run-up. For the wave overtopping also the influence on erodibility of the grass cover caused by obstacles or other elements, which may be present at dikes (stairs, fences), was investigated.

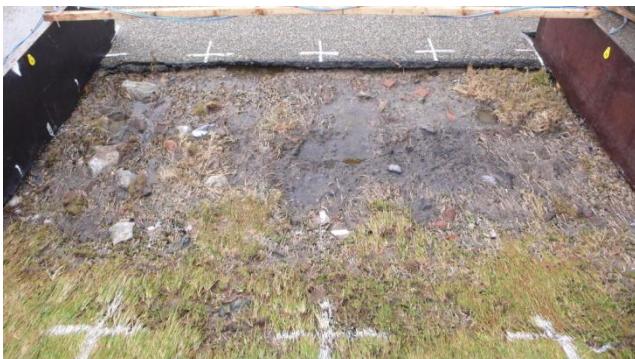
Figure 6. Final result of overtopping test section 1; various damaged locations (photo taken from the slope down)

Already from the start of the test it was seen that a lot of debris was present at the rehabilitated part of the slope and the berm. See also results of the wave run-up test further down this paper. It is believed that only large waves contribute to erosion damage. In this test and also in earlier tests it is seen that the wave fronts initiate erosion. The flow of water then provides a means of transport for the soil or other parts which are loosened by the impact of the wave front. This is one of the mechanisms which initiates damage and leads to progress of damage. In Van der Meer et al. 2010 the method of cumulative hydraulic overload was presented. The results of this test are quantified with this method and an indication of the critical velocity for this part of the slope was found to be around 4 or 5 m/s.

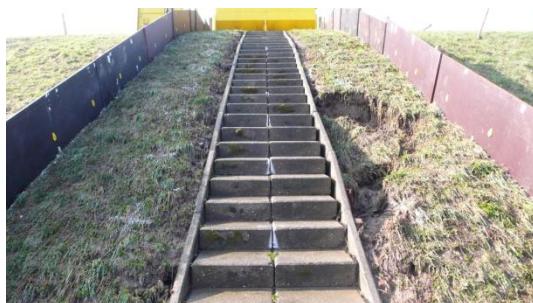
Already from the start with a mean overtopping discharge of 1 l/s per m strong erosion started alongside the stairs. At the end of this test already a hole of 0.5 m had formed next to the stairs. Also at the toe, the transition from the stairs to the asphalt berm, the grass cover had eroded. As this was not

the objective of this test this part was reinforced and covered. In this test it was also noticed that water rushed through holes of moles leading to wider openings and water flowing out at the toe. This increased with the increase of mean discharge to 5 l/s per m. Slowly the stairs and the grass cover were undermined. After 2 hours the grass cover failed as it collapsed in the erosion hole (Figure 8). With each overtopping wave the damage increased and after 4 hours the stairs collapsed as it then was undermined heavily (Figure 9).

Figure 8 Failure of slope section 2

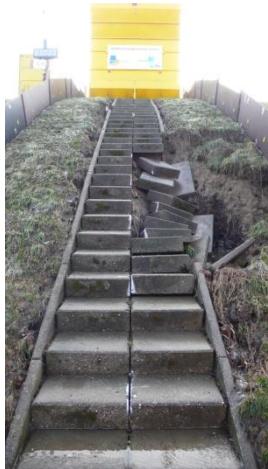
Figure 9. Failure of stairs, section 2

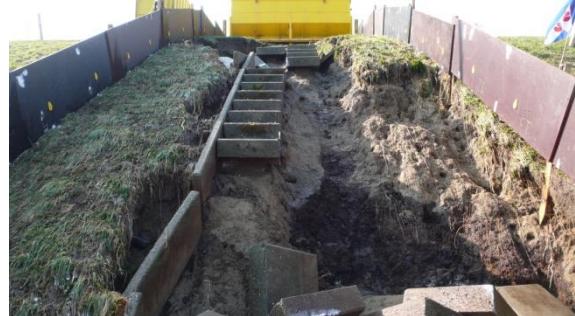
After the collapse the test went on. Figure 10 shows the end result. With each overtopping wave the damage grew and the stairs were undermined more leading to collapse of more steps. Also at the slope the damage increased steadily.

Figure 10. Destruction of stairs

It is of no use to assess the critical velocity of this slope with the stairs as it would be found that this was very low or even zero. Every overtopping wave leads to initiation and increase of damage. Therefore it is absolutely intolerable to allow this dike section to overtop in extreme conditions.

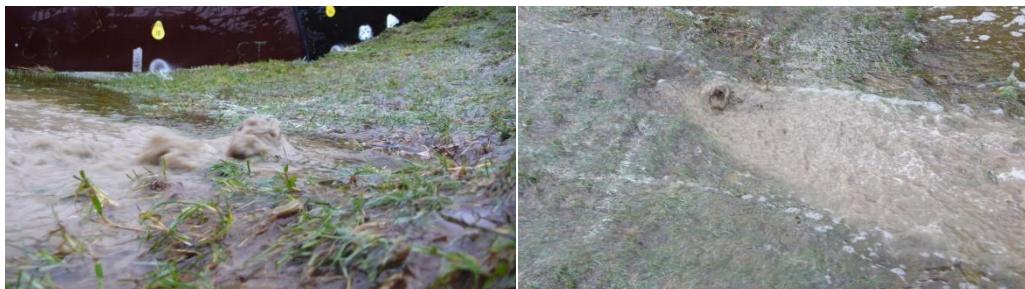
In the test program also a slope with a fence perpendicular to the crest was incorporated. The slope was very irregular and showed dents and small damages. A couple of mole tunnels were present. In one occasion the mole heap consisted of sand material. At the bottom of the fence a heap was present with a height of 0.2 m in average. On this heap rugged vegetation which withered away was present. With 5 l/s per m overtopping waves rushed through a tunnel of a mole. With the water coming out of the hole also sand came out, leading to a sand containing well some 5 m below the point of entrance.

Figure 11. Sand containing well through tunnel of mole

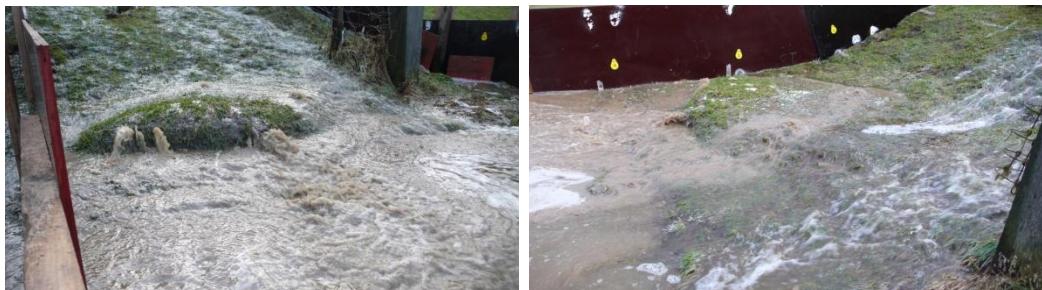
After an hour testing a subsidence on the slope became visible. The water and sand rushing out became larger and larger. At a certain point the section where the outflow was, lifted. This phenomenon has been seen before at earlier tests (Steendam, 2008) and was called the “bulge out” mechanism (Figure 12). After each wave the bulge went down as the water flushed out.

Figure 12. "Bulge out" mechanism before and after the water has flown out

Apparently the grass sod with its root system is strong enough to hold together as water rushes in the hole under the bulge. With each overtopping wave some of the roots at the edges break. The sod becomes weaker and weaker until with a large wave the forces get too large and the sod comes loose at one end and breaks off a little later. The test still was performed with a mean overtopping discharge of only 5 l/s per m.

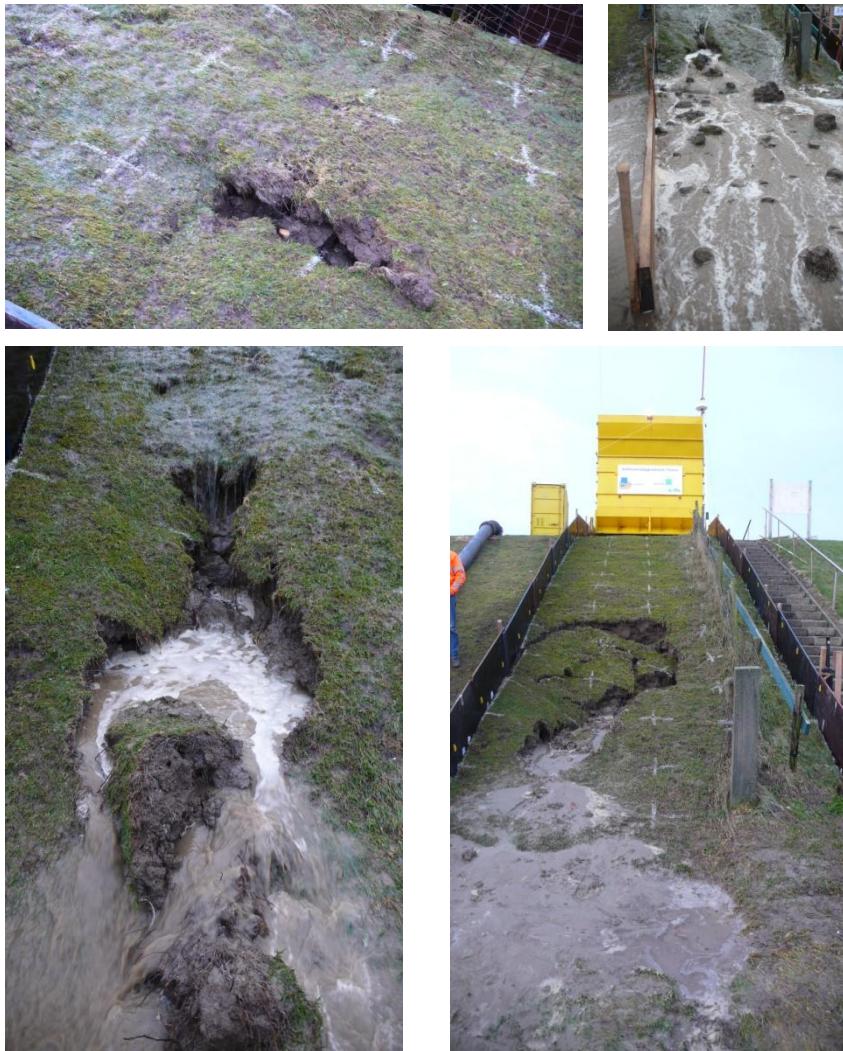
Figure 13. Consequent steps leading from “bulge out” mechanism to failure of slope section 3

The grass cover at this slope was investigated before testing. It was found to be very weak as it was very uneven, showed large open areas, had a cover containing a lot of mosses and showed damage by moles and damage by some mechanical force (tracks of hydraulic crane). This was consistent of what was found in the test. It is obvious that the critical velocity of this slope is very low. Every overtopping wave will contribute to damage on the slope. Therefore no overtopping at all must be allowed at this dike under design conditions.

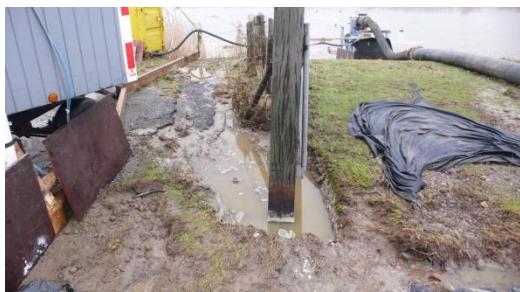
At the lower end of the slope across the maintenance road a pole of 0.2 m wide was present. At 10 l/s per m scour occurred around this pole. At 30 l/s per m this scour hole seemed to have reached an equilibrium depth of 0.6 m. No further increase of depth was found at 50 l/s per m.

Figure 14. Scour around pole 0.2 m, section 3

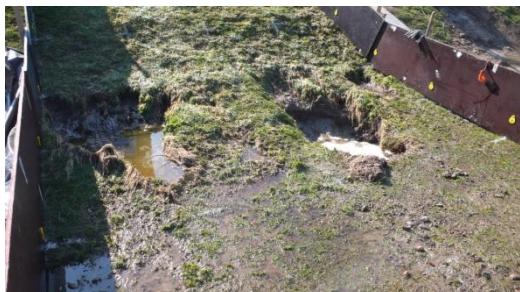
Figure 15. Damage at toe up to core of the dike, section 4

After 6 hours of 5 l/s per m only minor erosion of entrances of mole tunnels was found. Also some more, but still minor damage at the toe was seen. This latter damage grew to serious damage or even failure when testing went on with 10 l/s per m. After 4 hours and 45 minutes the test was terminated as the damage at the toe reached the sand of the core of the dike .

The toe of the dike was not the main objective of the test. Therefore again the damage was covered up and testing went on on the slope.

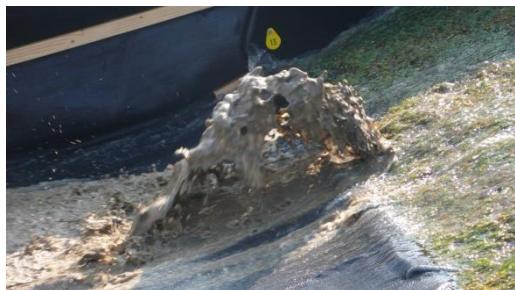
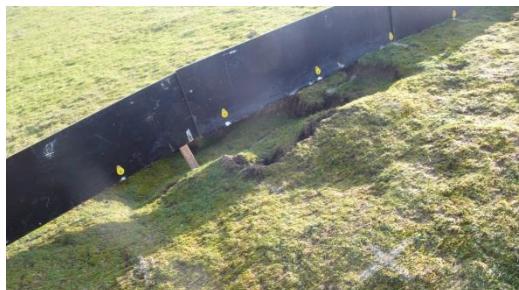
Figure 16 .Left: Water and sand flushing out tunnel of mole. Right subsidence of slope

At 30 l/s per m it was found that there again was a tunnel of a mole through which water with sand was transported to the toe of the dike. This lead to a lot of sand near the toe and a subsidence higher on the slope. As a result of the large quantity of sand flushed out from the slope a large hole occurred. At a certain moment the grass cover broke. To prevent extensive damage to happen the test was terminated. The mechanism that lead to failure was exact the same as found in section 3, but now at a little larger mean overtopping discharge.

Evaluation of the test section with the cumulative hydraulic overload method leads to an indication of critical velocity for this slope around 4 m/s. As shown the toe of the dike failed in an earlier stage. With the cumulative hydraulic overload method with the amplification factor it is found that $\alpha_M = 1.21$. This means that if the actual front velocity in a certain overtopping wave is over 3.3 m/s this wave contributes to initiation and progression of damage. As almost every overtopping wave at sea conditions will have a velocity over 3 m/s it is again proven that it is absolutely not safe to allow this dike to be overtopped at design conditions.

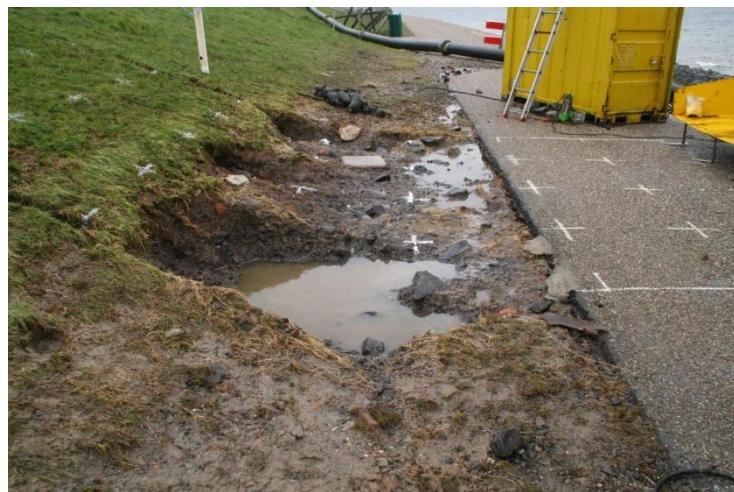
- Only small surface erosion was noticed for tests with a water level of 4.5 m and 4.0 m below the outflow opening ($z_{2\%}$ just below or on level of outflow).
- A first small erosion hole at the transition from berm to upper slope, about 7 cm deep, was noticed after 2 hours with $x = 3.2$ m ($z_{2\%} 0.8$ m above outflow opening). After the full test there were three small erosion holes each about 7 cm deep. This damage is close to the criterion of "several open spots".
- Damage increased during the next tests. The test was stopped after 4 hours with $x = 1.6$ m ($z_{2\%} 2.4$ m above outflow opening). A cliff had been formed at three holes at the transition from berm to upper slope with a height of about 0.5 m. The upper slope had not yet failed, see Figure 21, but the test had to be terminated as problems with the side boards (large hydraulic loads) led to unwanted effects.

Figure 21. Final damage after the pilot run-up test.

- The best predictable measure is "failure" with $\Sigma(u^2 - u_c^2) = 3500 \text{ m}^2/\text{s}^2$. Using $u_c = 6 \text{ m/s}$ gives a total cumulative overload for the whole test of $\Sigma(u^2 - u_c^2) = 1249 \text{ m}^2/\text{s}^2$. This is well below the value for failure, which was also the description of the final status of the slope after testing.
