## **Erosion strength of inner slopes of dikes against wave overtopping**

**Preliminary conclusions after two years of testing  
with the Wave Overtopping Simulator**

**Version: 1.1**

**Date: August 2008**

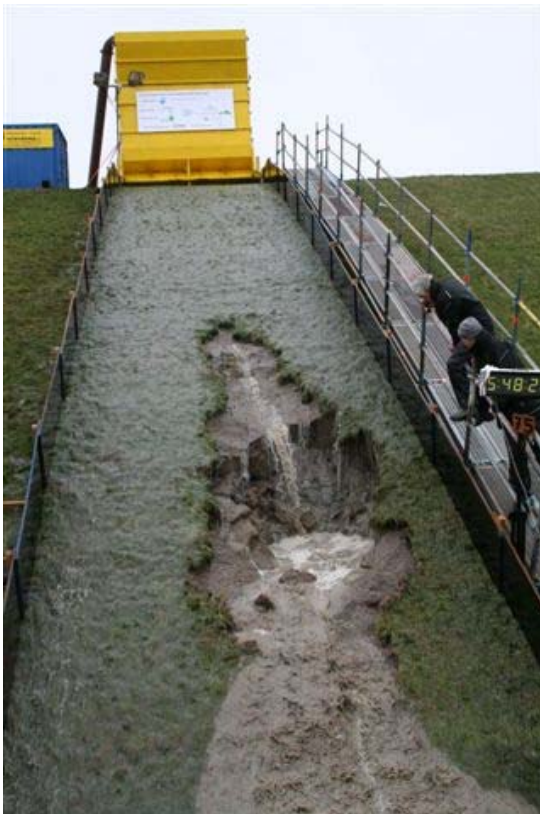
Figure 1.5. Damage to a dike section during a test with 75 l/s per m wave overtopping.

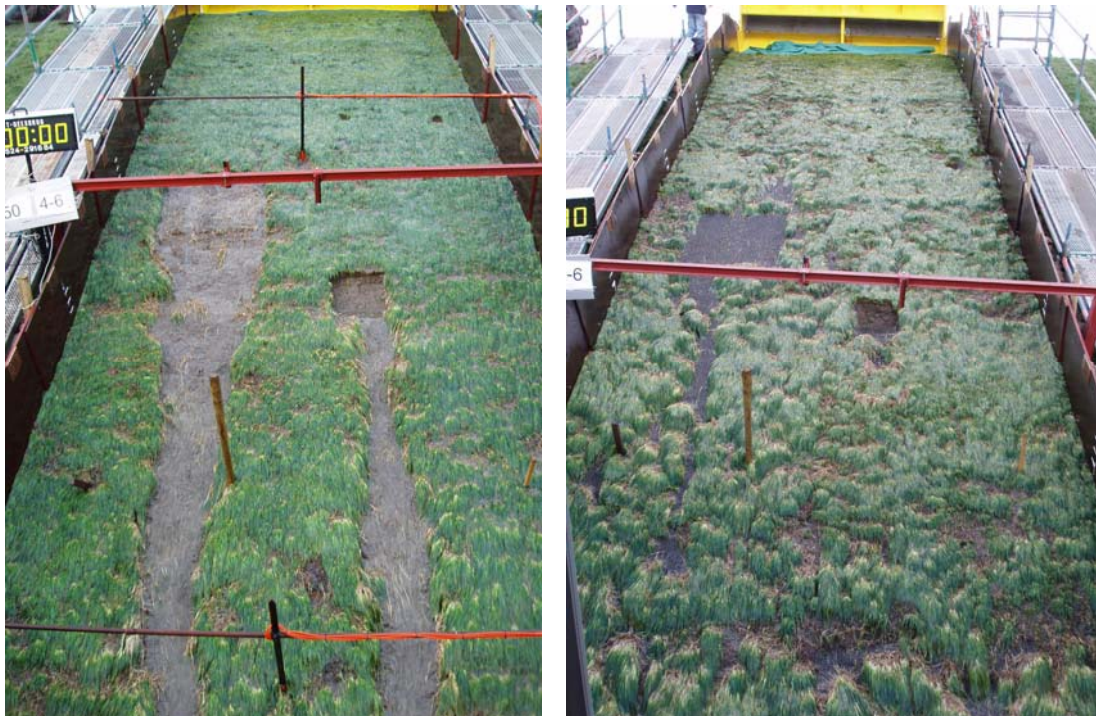
10. Damage was initiated in the grass cover on this erosion resistant clay (Delfzijl), by digging holes of 15 x 15 cm, 15 cm deep. A discharge of 50 l/s per m did not increase this initiated damage. At initiated holes of 40 x 40 cm (15 cm deep) and 1 x 1 m (5 cm deep) gulleys were created with the same discharge of 50 l/s per m. These gulleys extended from the down side of the holes to the toe of the dike, see Figure 1 of Chapter 3.

11. The reinforced grass cover at Delfzijl (SGR – Smart Grass Reinforcement) did not show the creation of gulleys after creating initial damage as described under observation 10, see Figure 1 of Chapter 3. This system appeared to be stronger than a normal grass cover.

Figure 1. Final result Delfzijl, Groningen. Left: the test section of the present dike after initiation of damage (1x1x0.05 m; 0.4x0.4x0.15 m; in the upper part two holes 0.15x0.15x0.15 m; three holes in the slope) and after 6 hours with 50 l/s per m. Gully development for the two largest holes, none for the smaller. Right: the reinforced section with geotextile (SGR = Smart Grass Reinforcement), where no gulleys were developed.

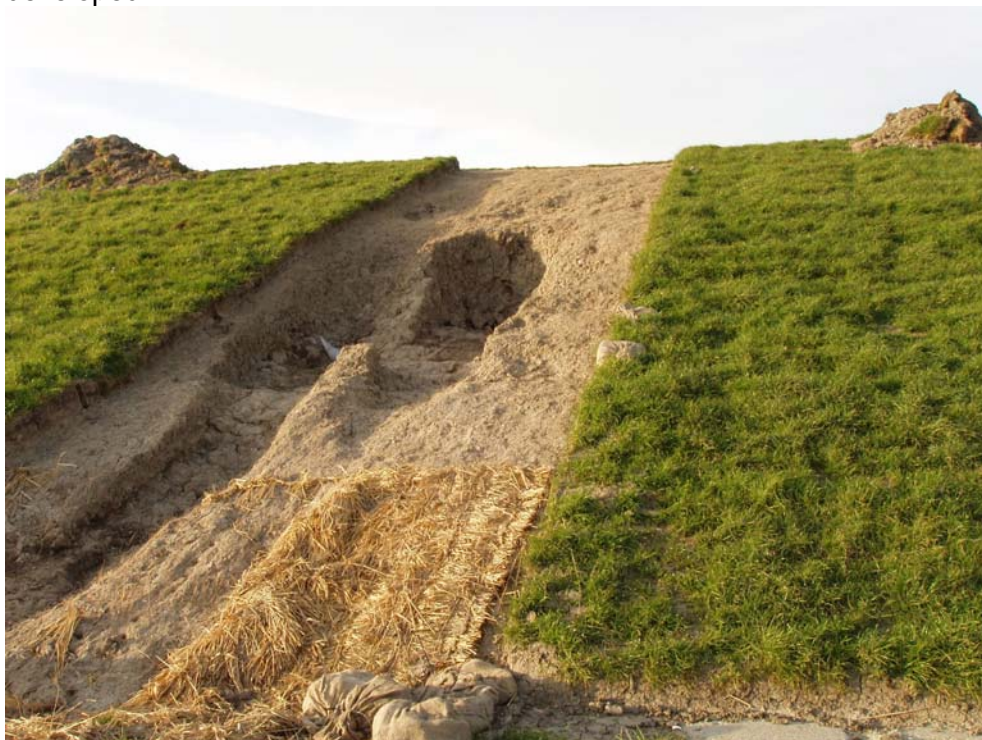
7. A hole in the clay with a vertical slope gives the mechanism of head cut erosion. the vertical slope erodes by lumps of clay falling down and the vertical slope moves upwards on the inner slope of the dike. This mechanism was observed in 4 test sections (the right hole in Figure 2 of Chapter 3 gives an example).

9. Good erosion resistant bare clay, as at the dike at Delfzijl, can resist 6 hours with 1 l/s per m overtopping, followed by 6 hours with 5 l/s per m and subsequently 6 hours with 10 l/s per m. During each large overtopping wave erosion was noticed over the inner slope of bare clay. The erosion consisted of small particles of clay. The final damage at this bare clay inner slope, therefore, was influenced by the other two conditions (the final result is shown in Figure 2 of Chapter 3). Results are valid for a homogeneous clay dike. If a clay layer covers a sand core, the critical moment will be when the erosion will reach this sand core.

Figur 2. Final result Delfzijl, Groningen. Bare clay (0.2 m grass cover was removed). Mean discharges of 1; 5; en 10 l/s per m, each during 6 hours. Ongoing erosion during each condition, which resulted in head cut erosion (horizontal part with vertical slope; vertical slop erodes by lumps of clay and the hole increases upwards).

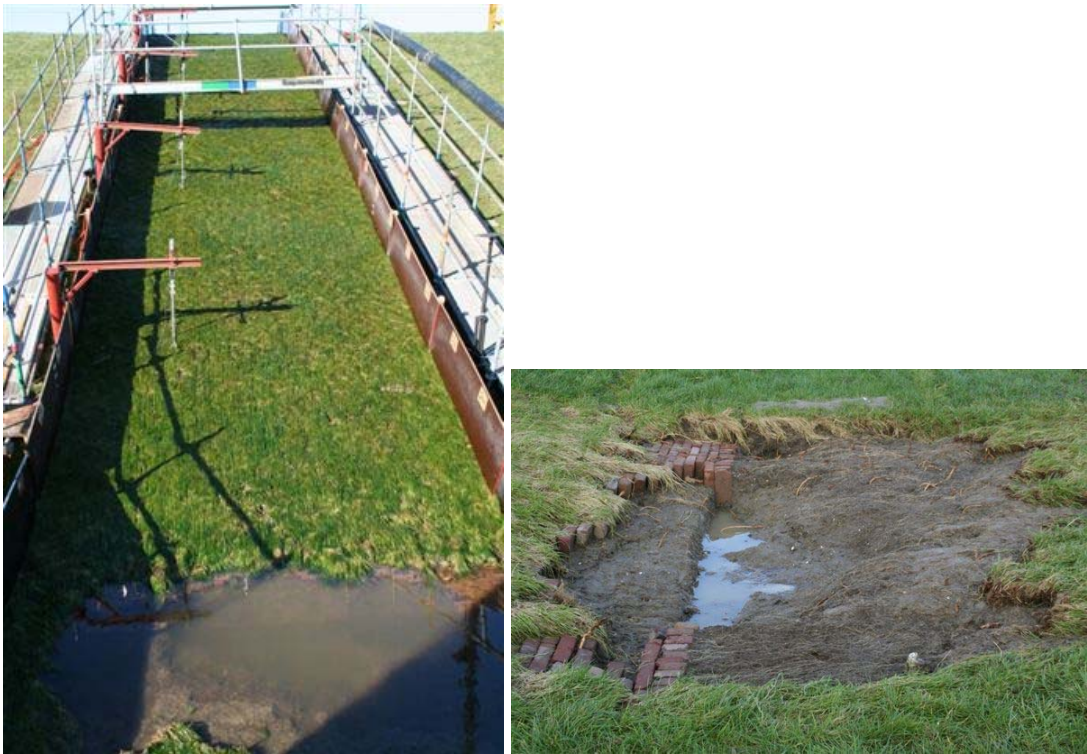
Figure 3. Final result Boonweg, Friesland, first section. Clay layer of 0.6 m on sand core. Normal maintenance (whole summer season grazing with sheep and 70 kg/hectare nitrogen). No damage to inner slope after 75 l/s per m; After 4 hours with 50 l/s per m damage to horizontal part (toe), where a hidden path with brick stone appeared to be present. This damage increased during 75 l/s per m (photo right).

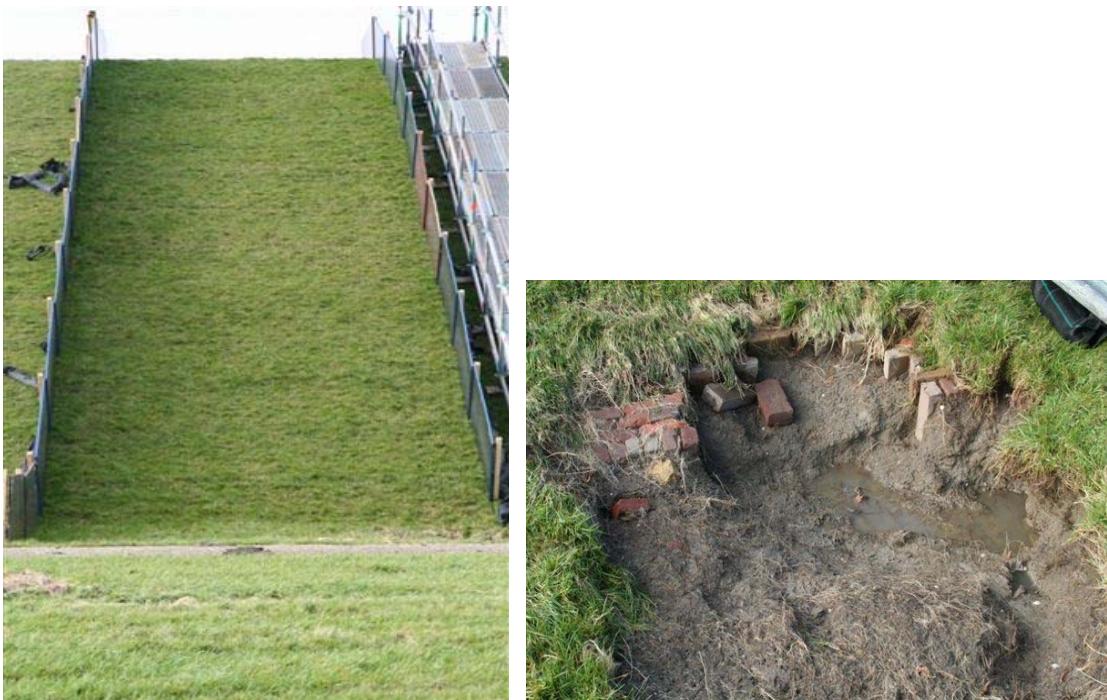
Figure 4. Final result Boonweg, Friesland, second section. Maintenance: two times grazing with sheep, two times mowing of hay and no nitrogen for 17 years. No damage after 75 l/s per m. In last hour of 75 l/s per m damage to the toe (hidden path of brick stone, see photo right).

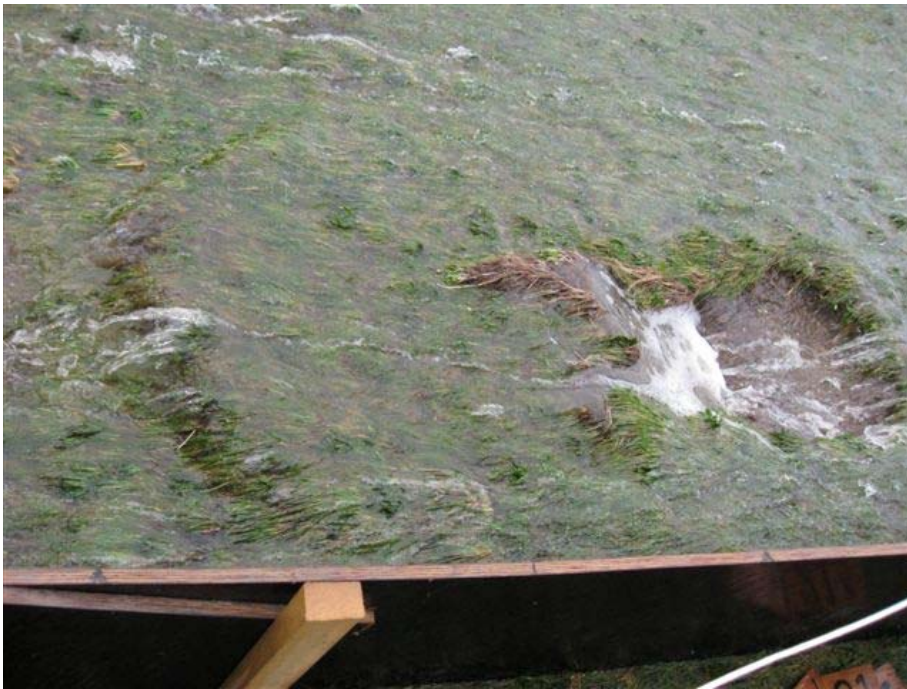
13. At two test sections, both (almost) without grazing with sheep and a strong grass sod, the “bulge out” mechanism was observed for 75 l/s per m overtopping. This mechanism was unknown, see Figures 5, 7 and 9 of Chapter 3.

Figure 5. Initial damage Boonweg, Friesland; section 3. Two times mowing of hay, no nitrogen en in 17 years no grazing with sheep. Damage in the second hour with 75 l/s per m. At that moment the grass sod felt “spungy”. It might be that loose clay in the upper few centimetres of the sod was eroded. The force on the upper part of the grass could then become so large that the roots of the sod broke (this is still speculation, more analysis is required). The grass with clay layer “bulged out” and was filled with water. A large overtopping wave destroyed the bulge and a part of the grass cover with clay layer disappeared.

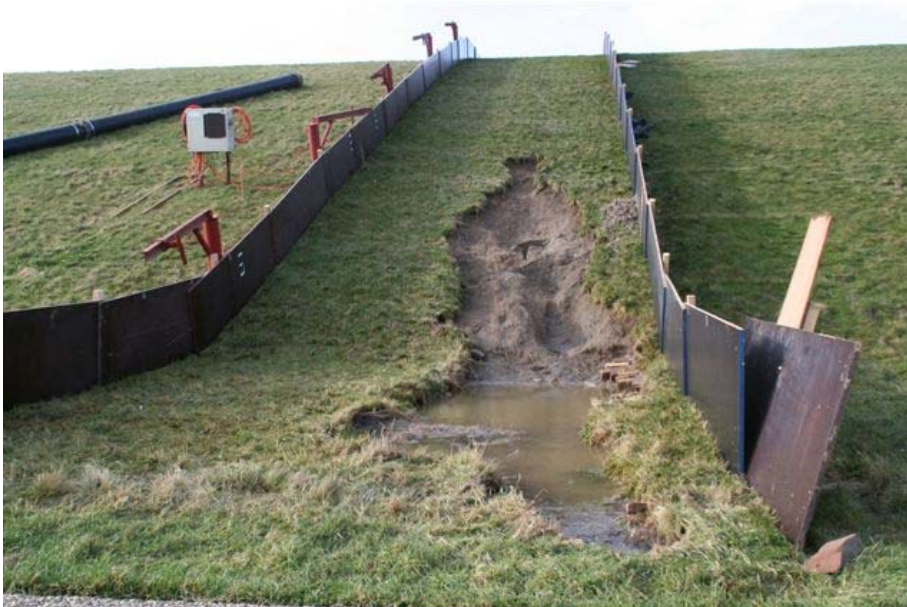
Figure 6. Final result Boonweg, Friesland, section 3 (see also figure 5). The “bulge out” mechanism appeared again in the last hour of the 75 l/s per m and finally, the two damages coincided to form one large damage area where the grass cover was not present anymore. The damage extended to the toe where the hidden path with brick stone eroded too. The damage did not (yet) extent through the clay layer and did not reach the sand core. Final result after 75 l/s per m.

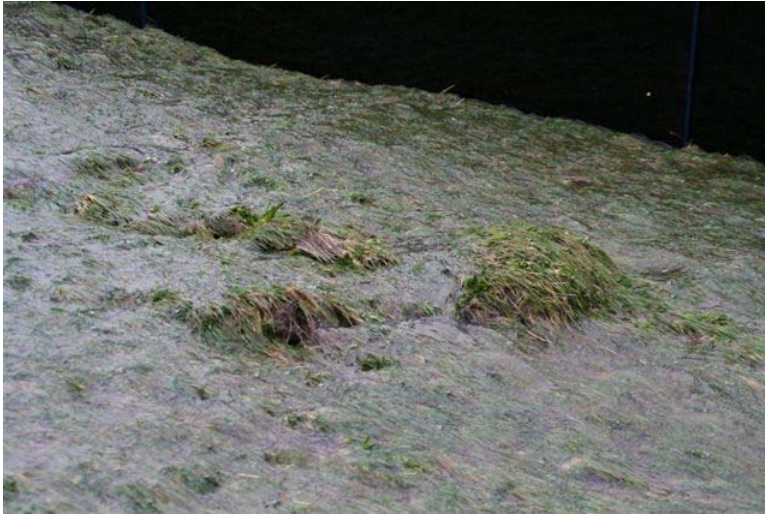
Figure 7. Initial damage Boonweg, Friesland, section 4. One time grazing with sheep, one time mowing of hay, no nitrogen for 17 years. Development of “bulge out” mechanism in last hour with 75 l/s per m. In this occasion it took about 5 minutes before a large overtopping wave destroyed the bulge. Water flows from left to right on the picture.

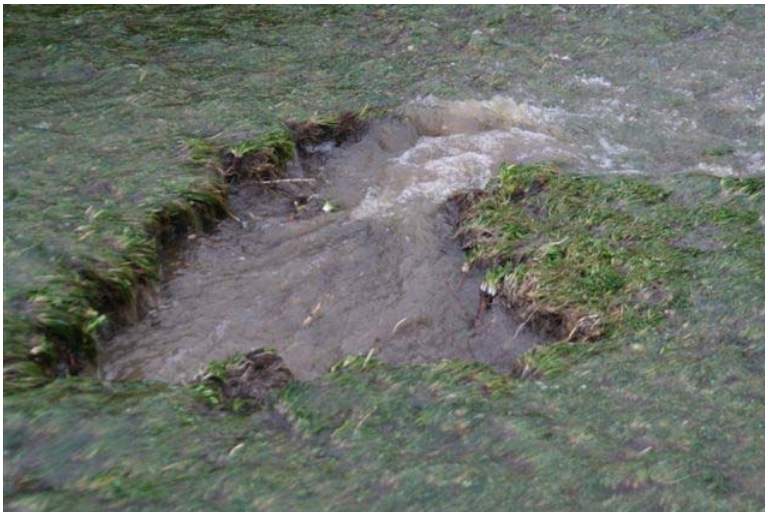
Figure 8. Boonweg, Friesland, section 4. Directly after the bulge in figure 7 was destroyed. Picture taken from above.

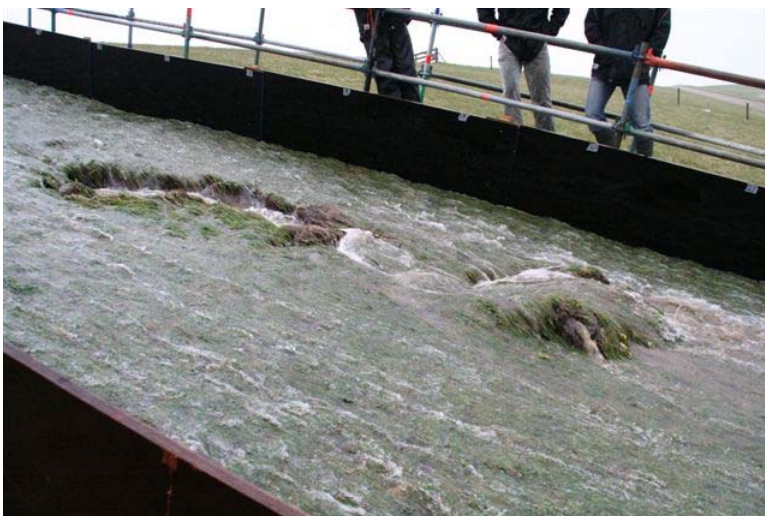
Figure 9. Boonweg, Friesland; section 4. After the first hole in figure 8, a second bulge was formed, directly below the first one. This one was “leaking” water.

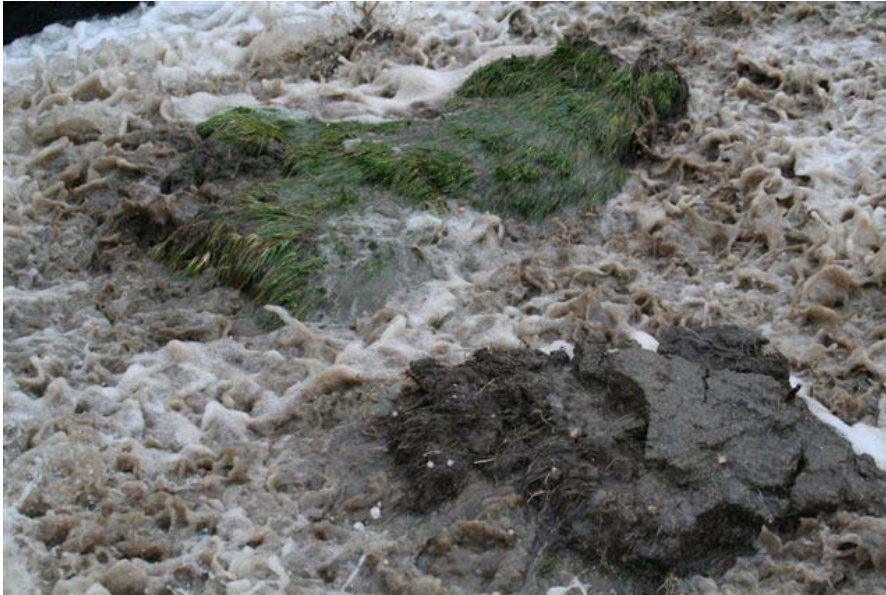
Figure 10. Boonweg, Friesland; section 4. Destruction of the second bulge by a large overtopping wave, a few minutes after the bulge appeared. The plaque of grass sod still has a small layer of clay. This might be a proof that the roots were broken beneath this clay layer (further analysis required), where less roots are present. The presence of this clay layer may be the reason why the bulge seems to be water tight, as the grass cover itself is of course not water tight at all. In the picture water flows from right to left.

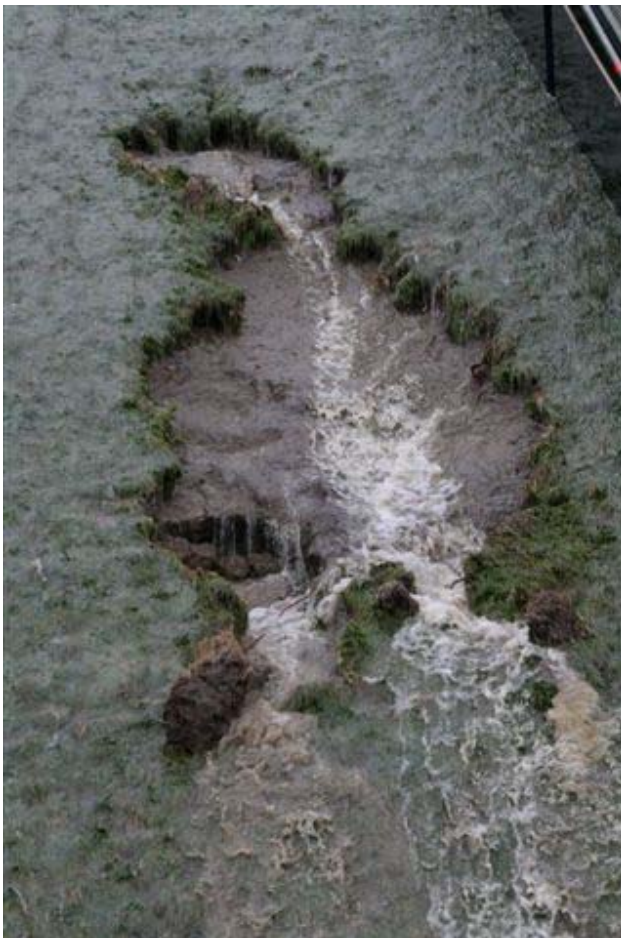
Figure 11. Boonweg, Friesland; section 4. Situation about 5 minutes after the second bulge (Figures 9 and 10) was destroyed. Left in the middle, a hole in the clay layer becomes present with a vertical slope. Here the hole will increase and the sand core will be reached.

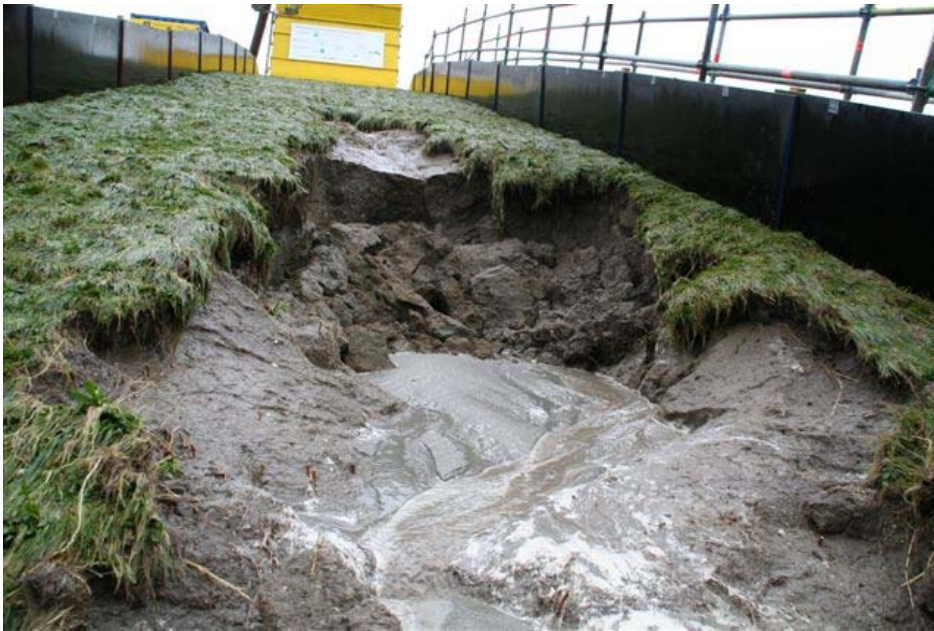
Figure 12. Final result Boonweg, Friesland; section 4. After 5 hours and 51 minutes with 75 l/s per m. The sand core has been eroded to at least 1 m depth and the right side wall is about to collapse. Final result after about 45 minutes after creation of the first bulge out (as in figure 7).

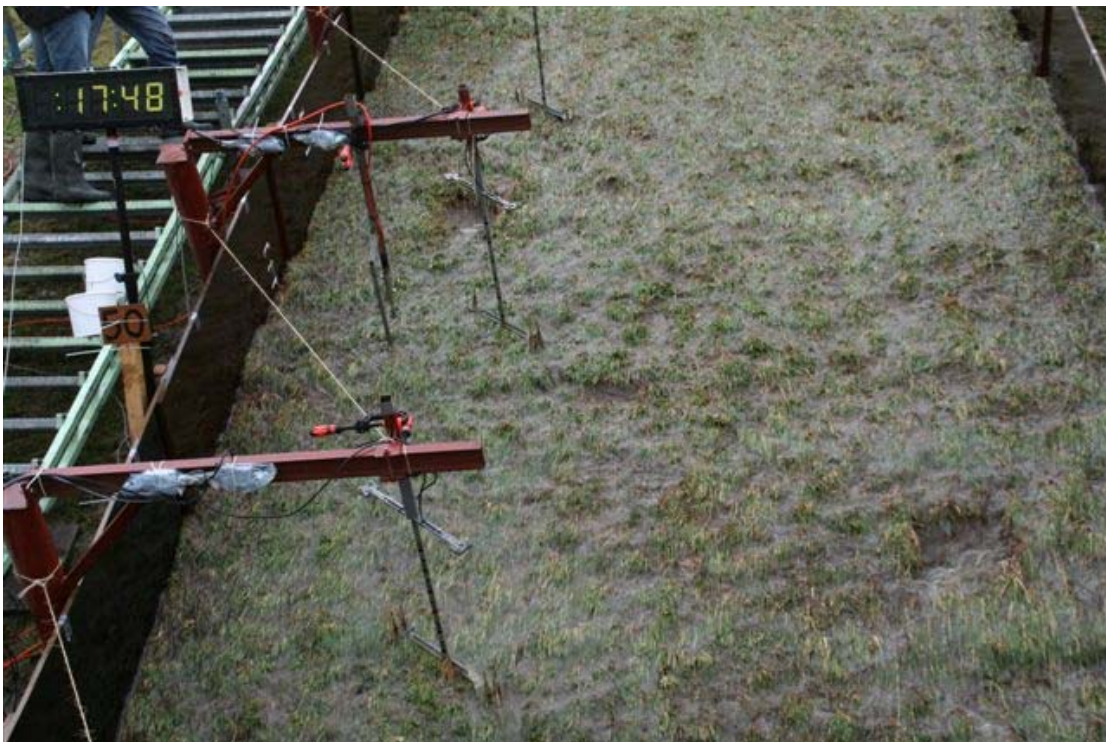
1. None of the test sections gave significant damage at the inner slope at 30 l/s per m during 6 hours of simulation.
2. One test section gave significant damage on the inner slope at 50 l/s per m (St Philipsland). The inner slope was 1:2.5 with a sandy clay on a sand core. The grass cover was fairly open.

Figure 13. Initial damage at St Philipsland, Zeeland, at the start of the 50 l/s per m test. A steep 1:2,5 inner slope with a poor grass cover and some damages by moles. The two small holes (one left above, between two front velocity gauges and one right down on the picture) were created by the same large overtopping wave at the start of the test. The hole left above did not increase during further testing, whilst the hole on the right increased to “failure”.

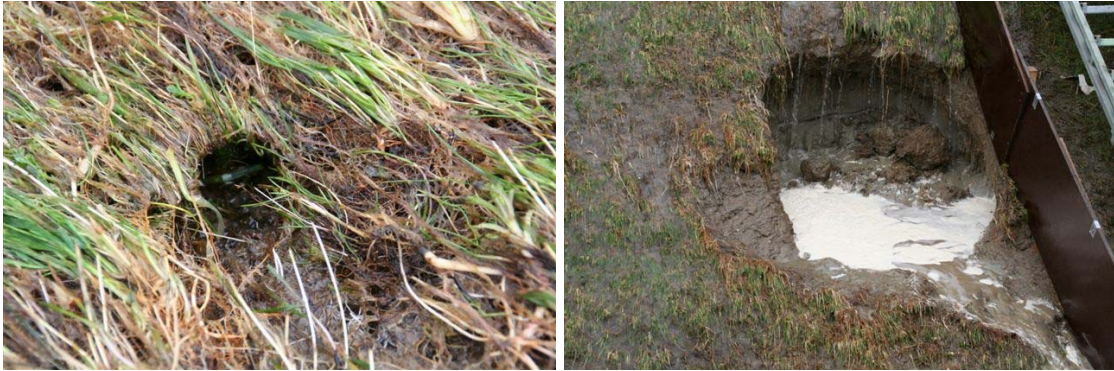
Figure 14. (Left). Final result St Philipsland, Zeeland, after 50 l/s per m. The entrance of the mole track was visible from the start of testing, but never increased to significant or further damage.

Figure 15. (Right). Result half way testing at St Philipsland, Zeeland, with 50 l/s per m. The hole got a vertical slope and the sand core has been reached. It appeared that the clay layer had a layer thickness of only 0.38 m.

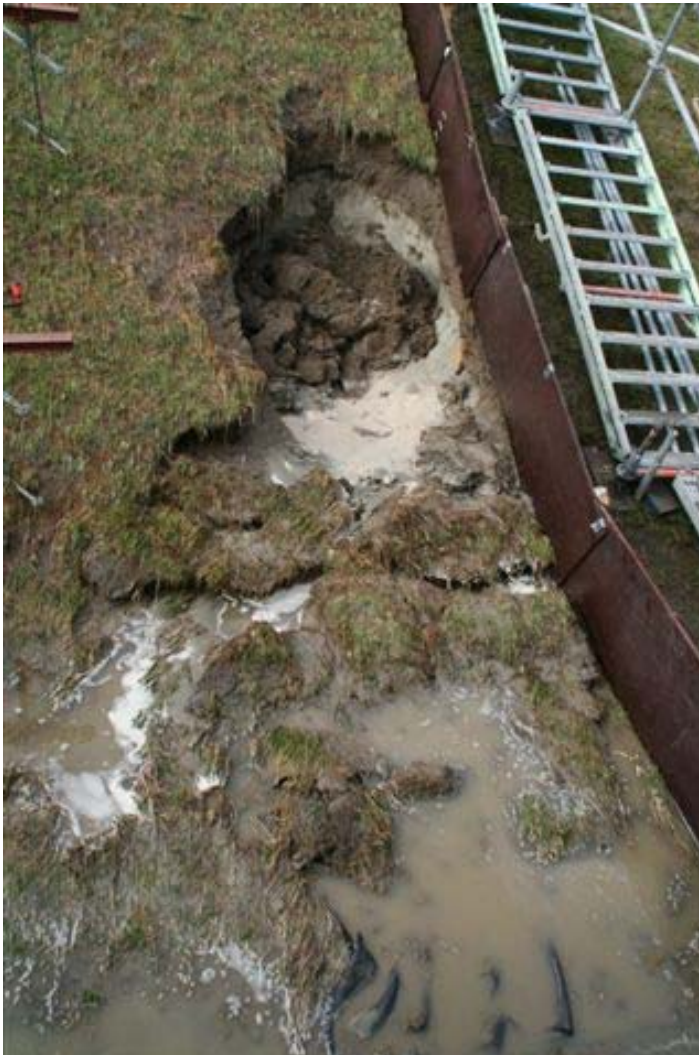
Figure 16. Final result St Philipsland, Zeeland, after the 50 l/s per m test. Also damage at the horizontal part (the toe) was created, which is visible at the lower part of the picture. This hole became so large and deep that a large overtopping wave pushed the remaining layer below the hole in the inner slope into this hole at the toe. The transition from clay layer to sand core is clearly visible at the hole in the inner slope and a deep hole in the sand core was the final result.

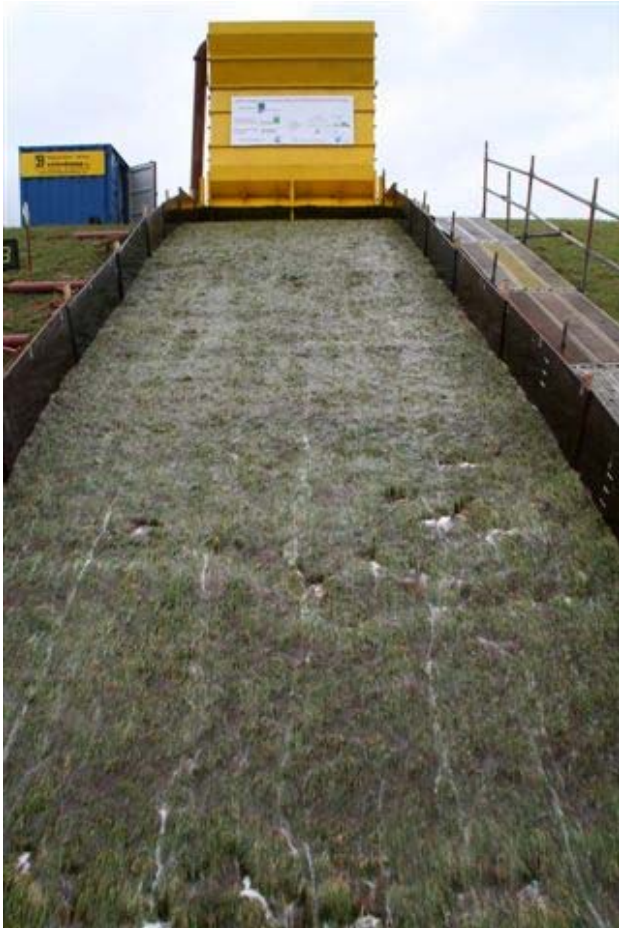
Figure 17. Kattendijke, Zeeland, section 1. At the start of the test with 10 l/s per m. Poor grass coverage. In the whole test section about 80 mole-holes were present. The mole-heaps disappeared with the first overtopping waves, and the holes/entrances became clearly visible. Also the tracks at the surface are clearly visible. At the start of the 10 l/s per m testing, it was expected that the test section would not survive this 10 l/s per m situation. The actual result was that the test section withstood 75 l/s per m with only small enlargements of some entrances, but no initiation of damage at all.

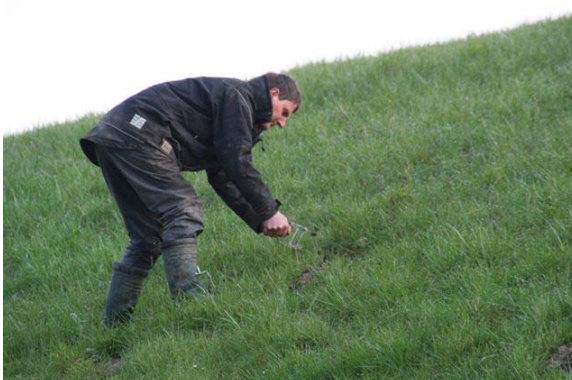
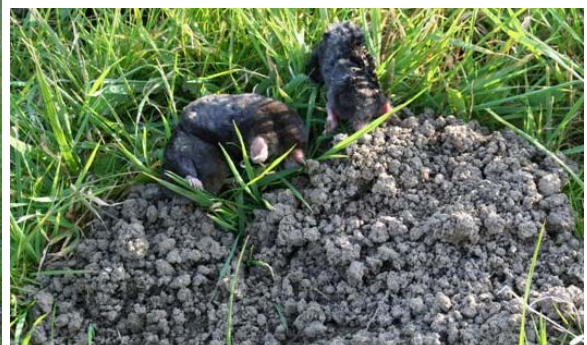
Figure 18. Kattendijke, Zeeland. Putting a mole trap (left) with the final result right.

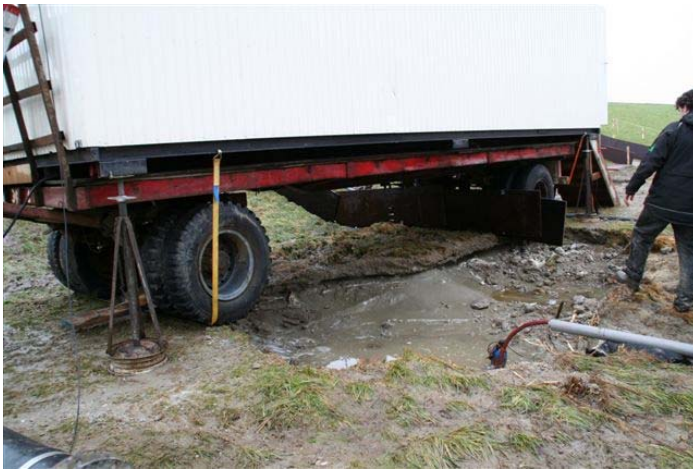
Figure 19. Kattendijke, Zeeland, section 1. Damage to the rear side of the maintenance road, which started at 30 l/s per m. The inner slope of the test section is at the other side of the measuring cabin. This cabin had to be removed after 1 hour with 75 l/s per m in order not to fall in the hole. The picture has been taken just before the cabin was removed.

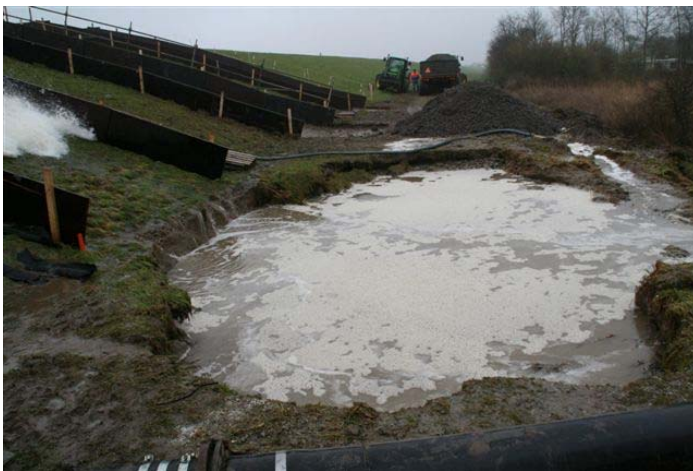
Figure 20. Kattendijke, Zeeland, section 1. Enlargement of the hole in Figure 19, including removal of the whole maintenance road. Half way the 75 l/s per m test. The hole became at the end 15 m wide and about 1 m deep.

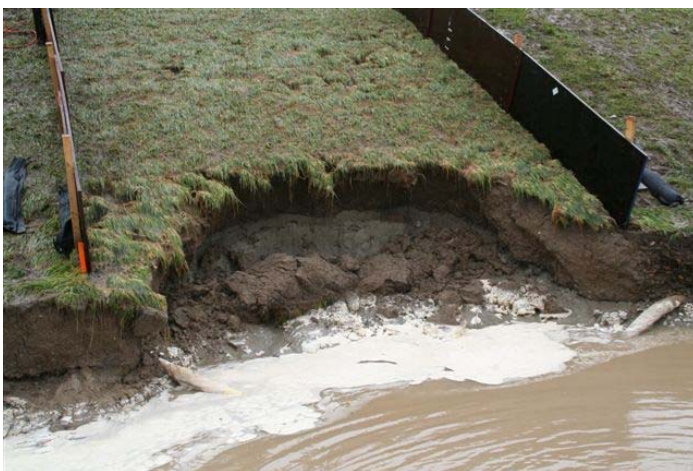
Figure 21. Final result Kattendijke, Zeeland, section 1. The test with 75 l/s per m was stopped after 5 hours and 40 minutes. The hole in the maintenance road reached the start of the inner slope and increased upwards (head cut erosion). The sand core was clearly reached and the erosion at this stage was very fast. The inner slope itself did not show any significant damage.

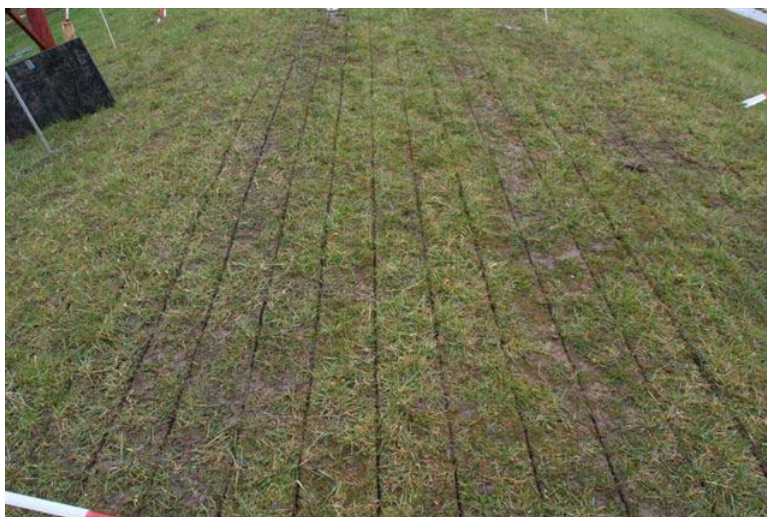
14. Damage initiated by a farmer’s manure injector (see Figure 22 of Chapter 3) gave no further increase of damage during wave overtopping.
15. Recently placed poles with a small diameter in general do not give initiation of damage. One pole (at Kattendijke) disappeared from the slope, mainly because it had been placed only at a depth of 30 cm and in or close to a number of tunnels by moles. Although damage was initiated, the damage did not increase (up to the maximum discharge of 50 l/s per m at this section). Poles with a larger diameter or other larger obstacles have not been investigated.

Figure 22. Kattendijke, Zeeland, section 2. Before the test. The cuts with the farmer's manure injector were present at the crest, the toe and the lowest part of the inner slope, not on the middle part of the inner slope.

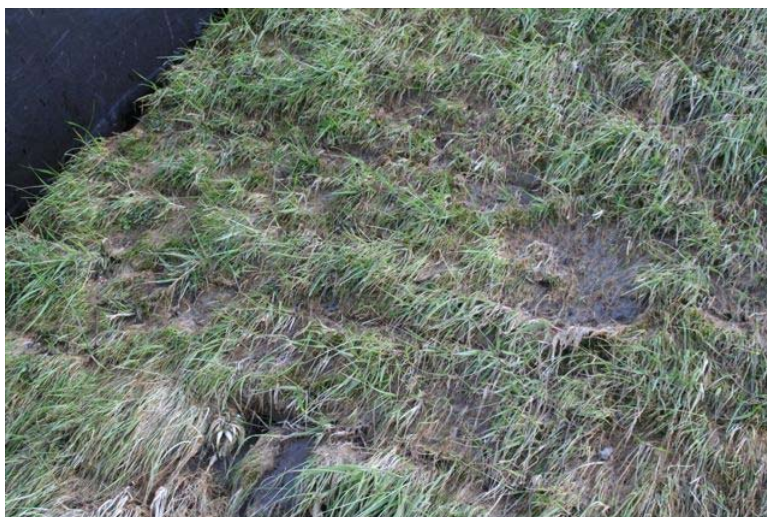
Figure 23. Final result Kattendijke, Zeeland; section 2. After 50 l/s per m. The damage by the manure injector did not initiate further damage. No damage to the inner slope.

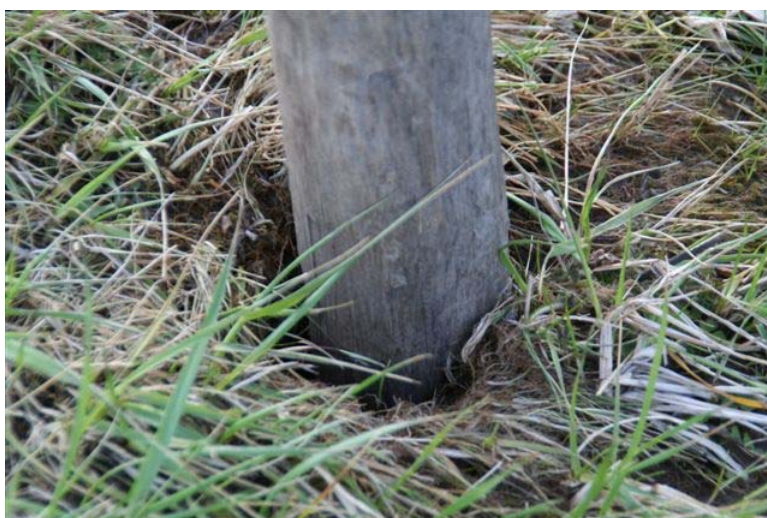
Figure 24. Final results Kattendijke, Zeeland; section 2. After 50 l/s per m. Two poles were placed, one on the crest and one in the middle of the slope. Very light erosion occurred around the pole on the crest, but no ongoing erosion.

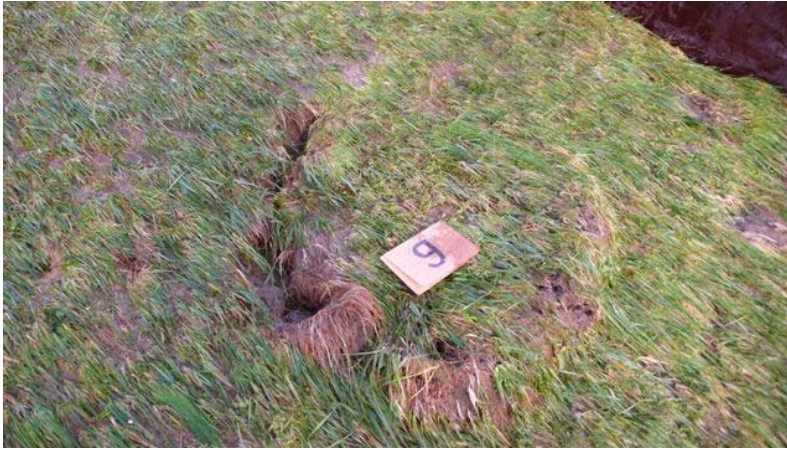
Figure 25. Kattendijke, Zeeland; section 2. After 2 hours with 50 l/s per m. The pole in the middle of the slope was swept away. This pole was standing vertically (not perpendicular to the slope) and 30 cm deep. A plaque of clay and grass was pushed upwards and a little down the slope when the pole was swept away.

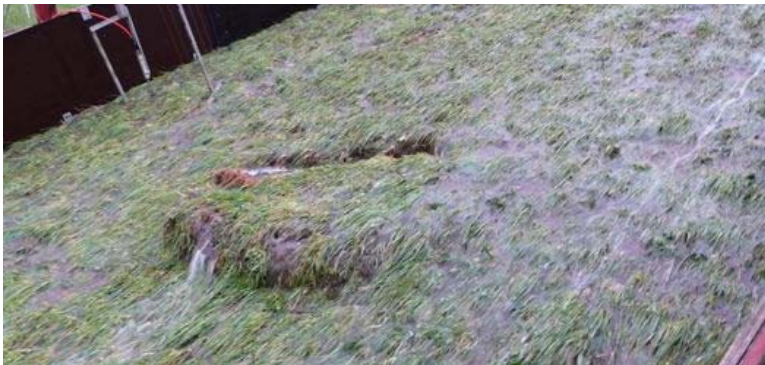
Figure 26. Kattendijke, Zeeland; section 2. Continuation of the 50 l/s per m test after initial damage by the pole that was swept away (Figure 25). It was expected that the plaque would be removed by a large overtopping wave.

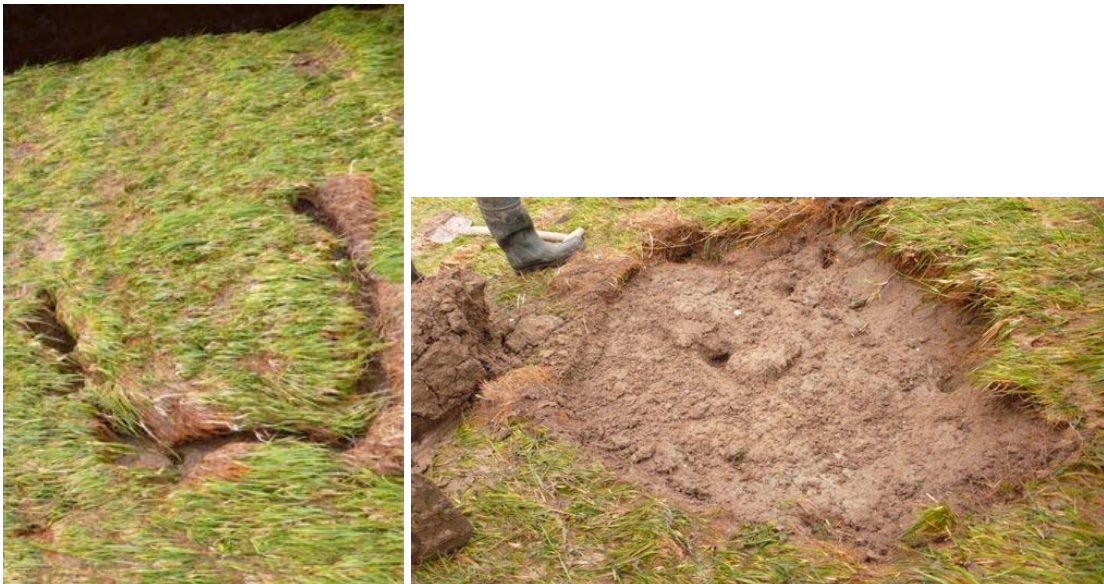
Figure 27. Final result Kattendijke, Zeeland; section 2. After 50 l/s per m. During further testing the clay underneath the plaque eroded, but the plaque itself was still fastened enough not to be swept away. Finally, the plaque subsided after this erosion underneath it and it became in line again with the slope (left). Right: after digging out the plaque after the test (hole not created by testing!). It appeared that the pole had been placed in a mole track, some of them were more than 50 cm deep.

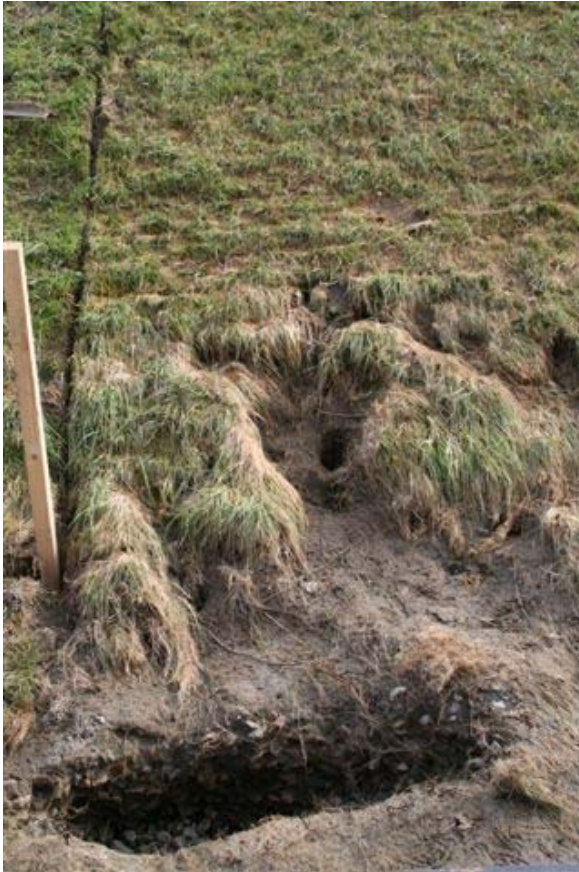
Figure 28. Final result Kattendijke, Zeeland; section 2. After 50 l/s per m. Damage to the toe of the inner slope (the filter structure existing of gravel) started already at 30 l/s per m. It was expected that this damage would increase drastically for 75 l/s per m, as was the case for section 1. It was decided not to create such a significant damage again. It was expected that further testing would not show significant damage at the inner slope and the main objective (effect of a manure injector) had already been reached.

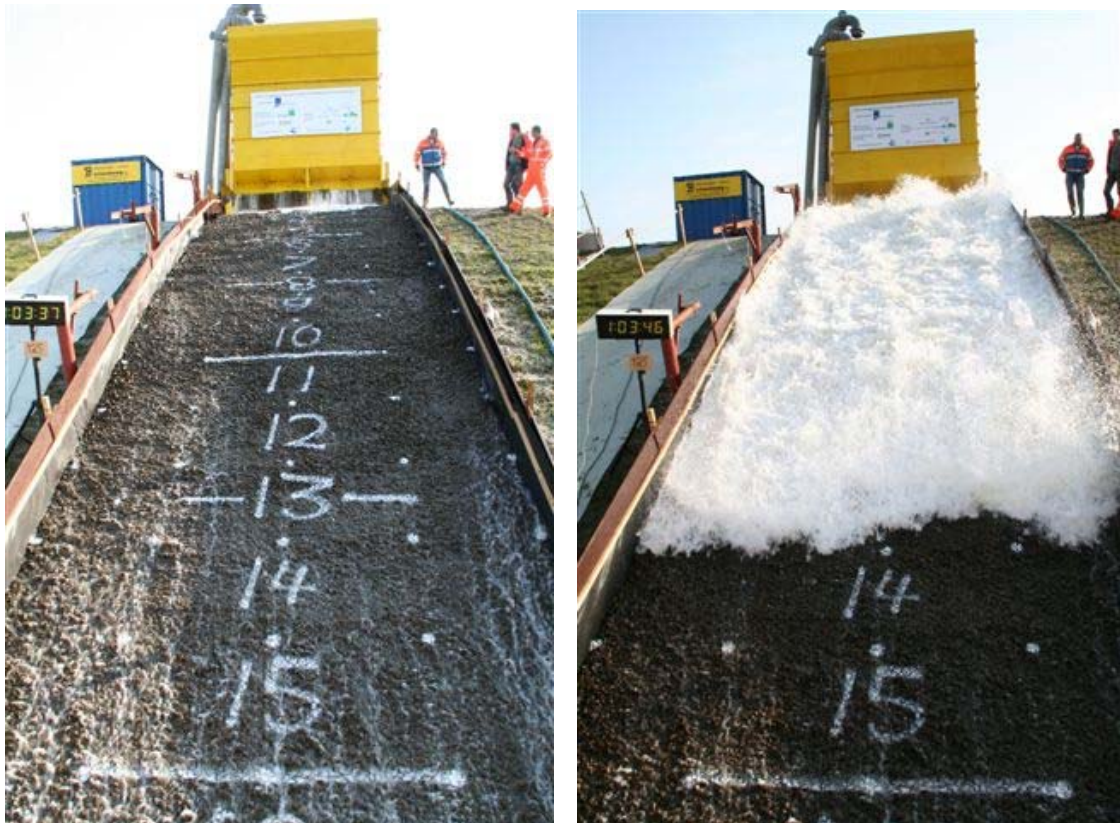
Figure 30. Kattendijke, Zeeland. Final test on elastocoast. With two extra pumps a mean discharge of 125 l/s per m was realized. It must be noted that overtopping volumes larger than 5,5 m<sup>3</sup> per m could not be simulated (maximum content of the simulator). With 125 l/s per m about 10 overtopping waves in 2 hours will occur which are larger and 4 of them will be larger than 7 m<sup>3</sup> per m. Both the elastocoast as well as the open asphalt concrete did not show any damage.

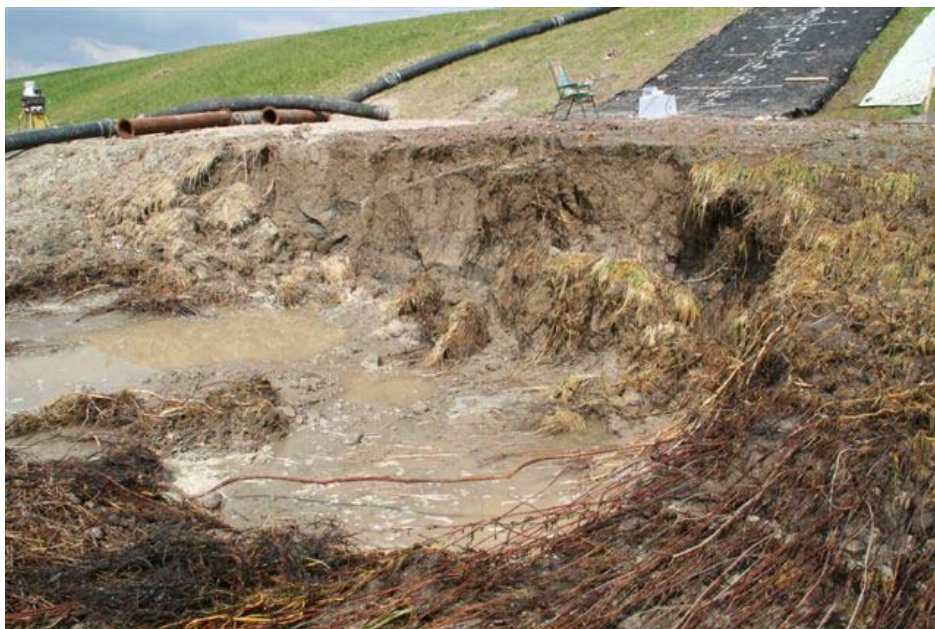
Figure 31. Final result Kattendijke, Zeeland; section with open asphalt concrete, after 125 l/s per m. A large erosion hole was created beyond the maintenance road, about 1.5 m deep. The maintenance road itself was protected by plates and could not be eroded.

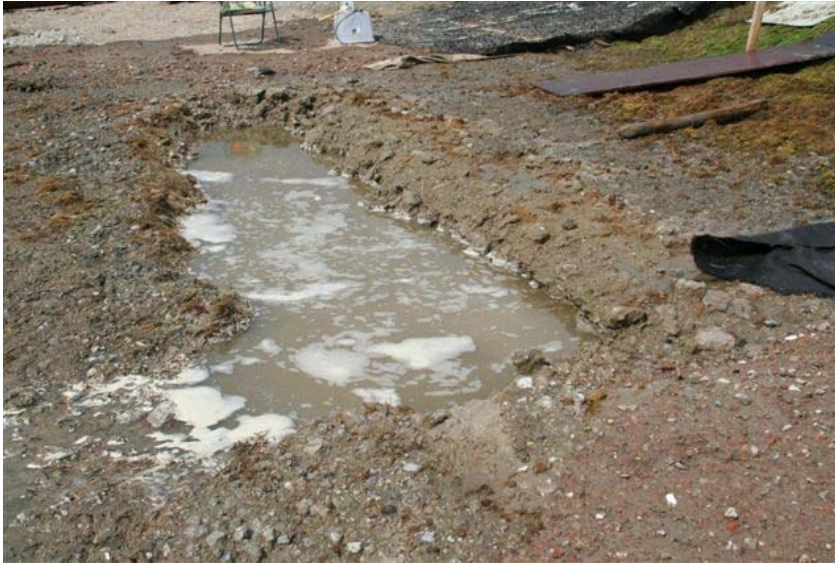
Figure 32. Kattendijke, Zeeland. Demonstration after all the tests were finished. On 16 April 17 water managers from Florida visited the site. On a new location a test section was set-up and during 20 minutes a demonstration was given with 75 l/s per m. In this short time a hole was created in the maintenance road with a depth of about 0.5 m.
