# Influence of management and maintenance on erosive impact of wave overtopping on grass covered slopes of dikes; Tests

ABSTRACT: In March 2008 wave overtopping tests were performed at a dike along the Waddensea in the Netherlands. At this location 4 different test sites were available. Over a period of over 15 years each of these sites has been managed and maintained in a different manner. This has resulted in 4 different grass covers. These differences could have an effect on the resistance against erosion by overtopping waves. Therefore were performed with the Wave Overtopping Simulator. The research is part of the Dutch SBW program. This paper describes the setup and the results of the tests.

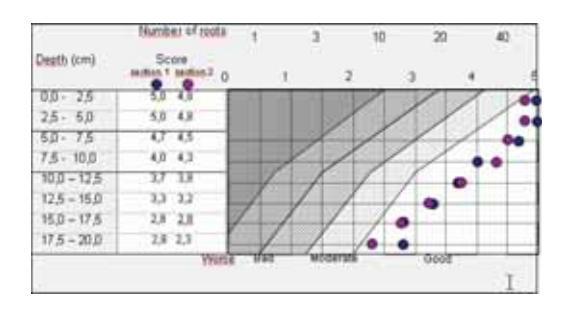
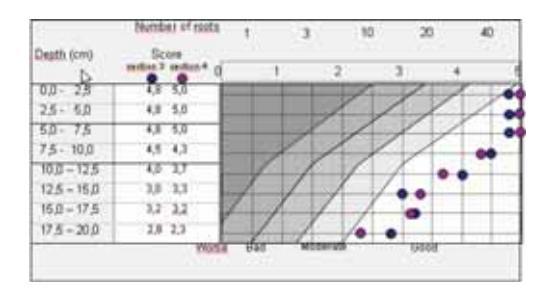
In Figure 3 and 4 examples are shown of the root structure in November 2007. Figure 3 shows by black dots the root structure section 1. The gray dots in figure 3 show test section 2. In figure 4 the lightest dots represent section 3 and the darker dots section 4.

The figures show that at the surface a high number of roots are required to get a condition score "good". At the deeper sections less roots are needed to get to this score. This is consistent with the general way for ground covering vegetations; roots decrease with depth.

Figures 3 and 4 also show that the condition of the grass cover in February 2008 of the test locations was good at every test site.

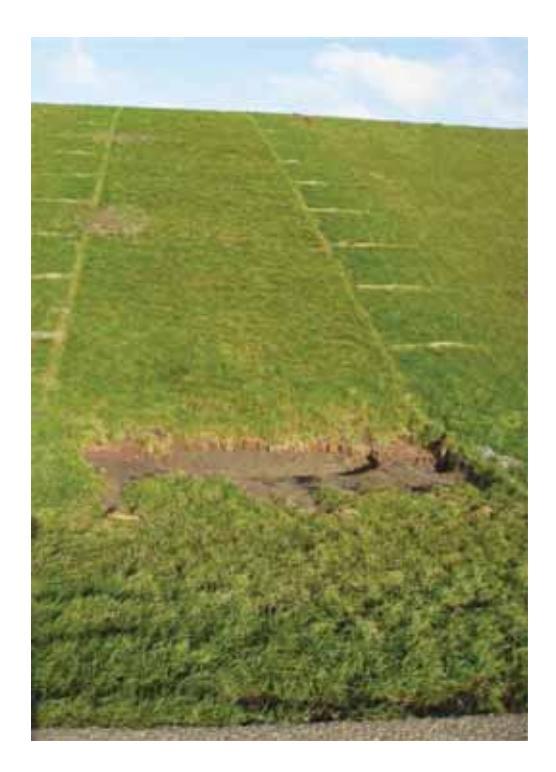
During the 30 l/s per m test and following tests damage occurred at the horizontal toe just in front of the slope. This is where the water with high veloc-

Figure 13. Damage test section 1 after 75 l/s per m.

ity has to make a transition from the 1:3 slope to horizontal. This leads to forces on the horizontal part resulting in initial damage. The damage which occurred first showed a few clumbs of grass coming out of the lawn. The holes became slowly wider and deeper after each wave. The damage expanded on the horizontal part and did not travel up the slope. At a rate of 50 l/s per m it appeared that underneath the last part of the slope and the first part of the horizontal part at a depth of 0.1 m stones were pitched. These were remains of an old discharge gutter which was filled during the last dike improvement. Once the stones were reached the hole widened faster than before. At the rate of 75 l/s per m even the stones disappeared from the hole. The stones could be found back at the far end of the horizontal area, close to the canal.

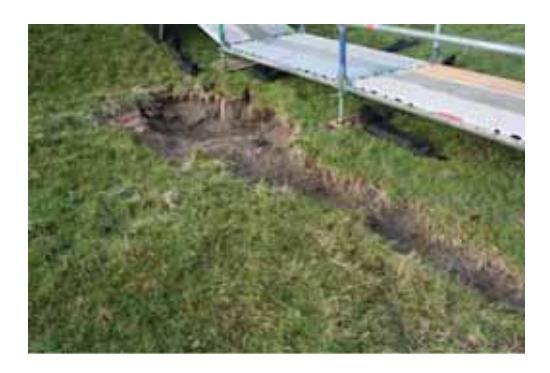
Figure 14. Result section 2 after 75 l/s per m.

seen neither on the slope nor at the toe. Only some minor traces of erosion at the toe were visible. At 75 l/s per m damage occurred. After 2 hours of testing with this overtopping rate the pitched stones 0.15 m below the toe of the dike became visible again. After 6 hours a part of the stones came out en were transported to the far end near the canal. The damage did not proceed downward.

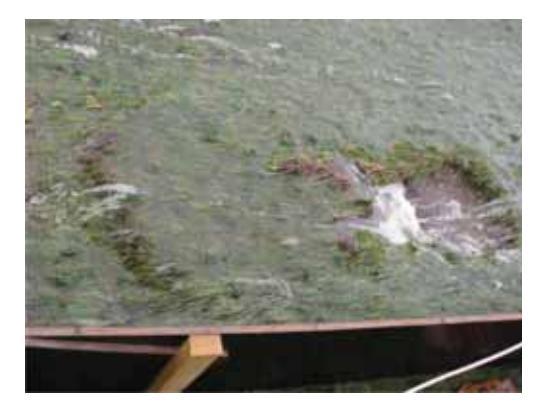
Figure 15. Local lifting of the grass cover.

After the regular testing with 75 l/s per m some visual flow depth measurements were performed. At the 4th wave for these measurements again lifting of the grass cover occurred about 4 m higher on the slope than the first lifting. It was decided to continue regular testing. After 30 minutes the first and the second damage merged. The testing was stopped then.

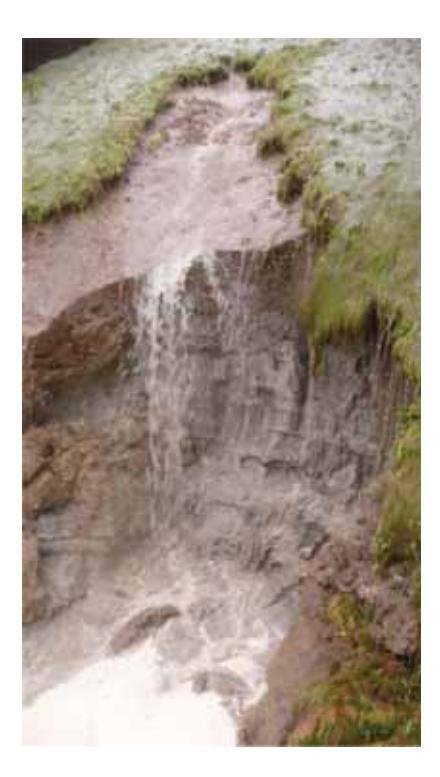
Figure 16. Head cut erosion section 4.

At the second damage the surface deepened to a vertical front, see figure 16.

This hole expanded. The deepening was an ongoing event. After 5 hours and 50 minutes, 45 minutes after the first damage, the test was stopped because the sand core of the dike was reached and was eroding rapidly. The experienced upward head cut erosion went on long after the test was stopped.
