Stability assessment of single layers of orderly placed and of pitched natural rock

J.W. van der Meer¹, S. Nurmohamed², L.A. Philipse³, G.J. Steendam¹ and J. Wouters¹

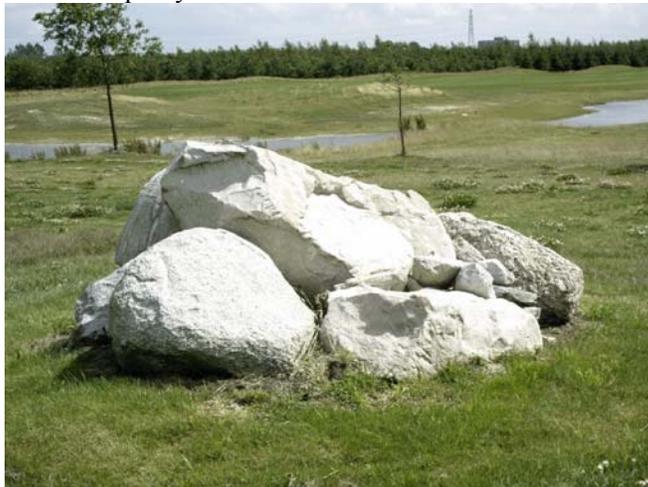
Figure 1. Ice age boulders in the Netherlands found during construction of a golf course

The rock, which was used for the first applications on dikes some 150 years ago, for a part was gathered from the north part of the country as the remains of the last ice age. In the Netherlands there is no other rock available from natural sources. This rock is partly more rounded than natural rock from a quarry. Sometimes these boulders are still found during construction works. Figure 1 gives an example of “fresh” ice age boulders, which were found during the construction of a golf course. Some of the rocks are nicely rounded, others do not show any wear due to the travel from Norway to the Netherlands and look like fresh quarry rock.

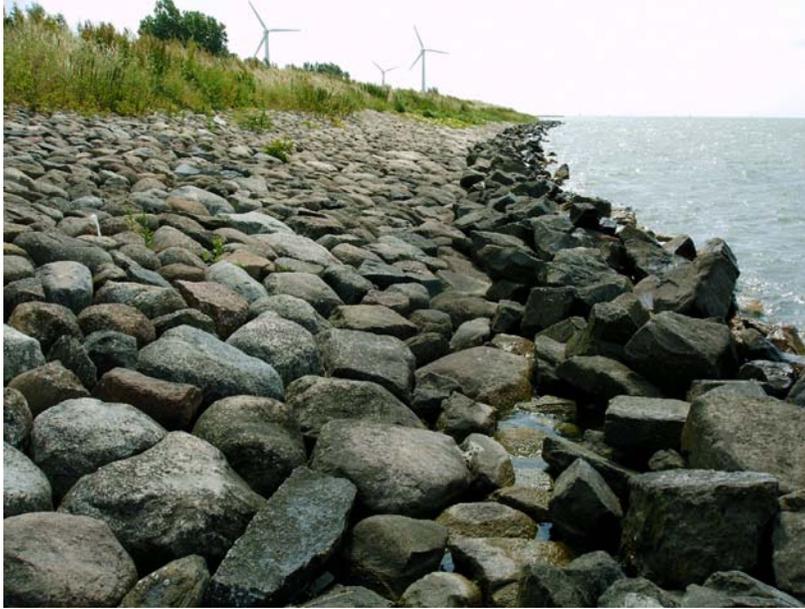
Figure 2. Pitched rock slope along large lake with a randomly dumped rock berm in front

Figures 2 and 3 give an overall impression of these pitched natural rock slopes and Figure 4 gives a part of the slope more in detail. The slope in Figure 2 is situated along a large lake with a more or less constant water level. Around the water line a berm is present of loosely dumped quarried rock. The difference between randomly dumped and pitched rock is very clear. Figure 3 gives a slope along the Waddensea, where tide and storm surge play a role.

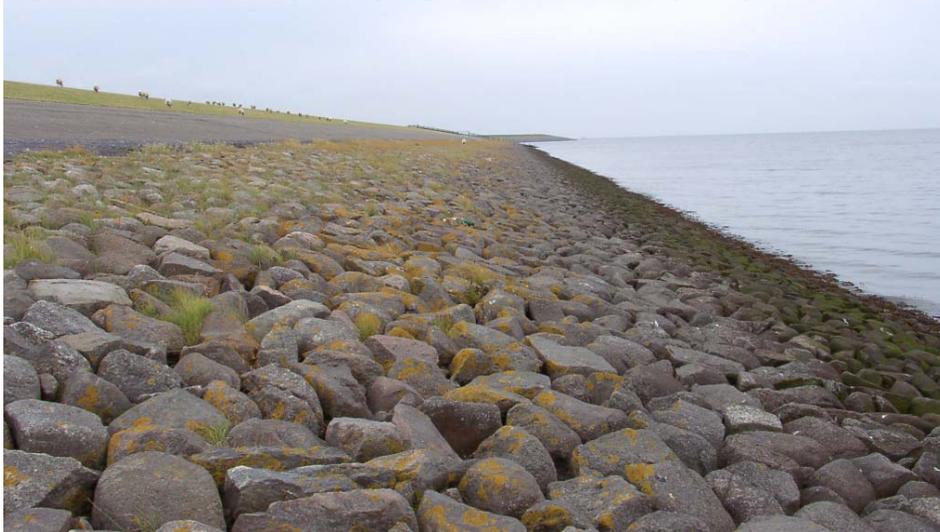
Figure 3. Pitched rock slope along the Waddensea

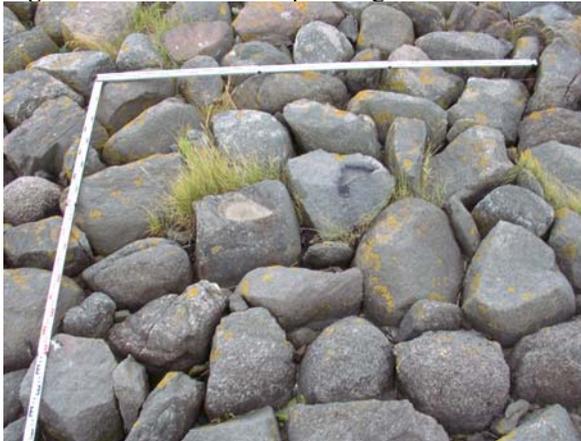
Figure 4. Detail of slope in Figure 3

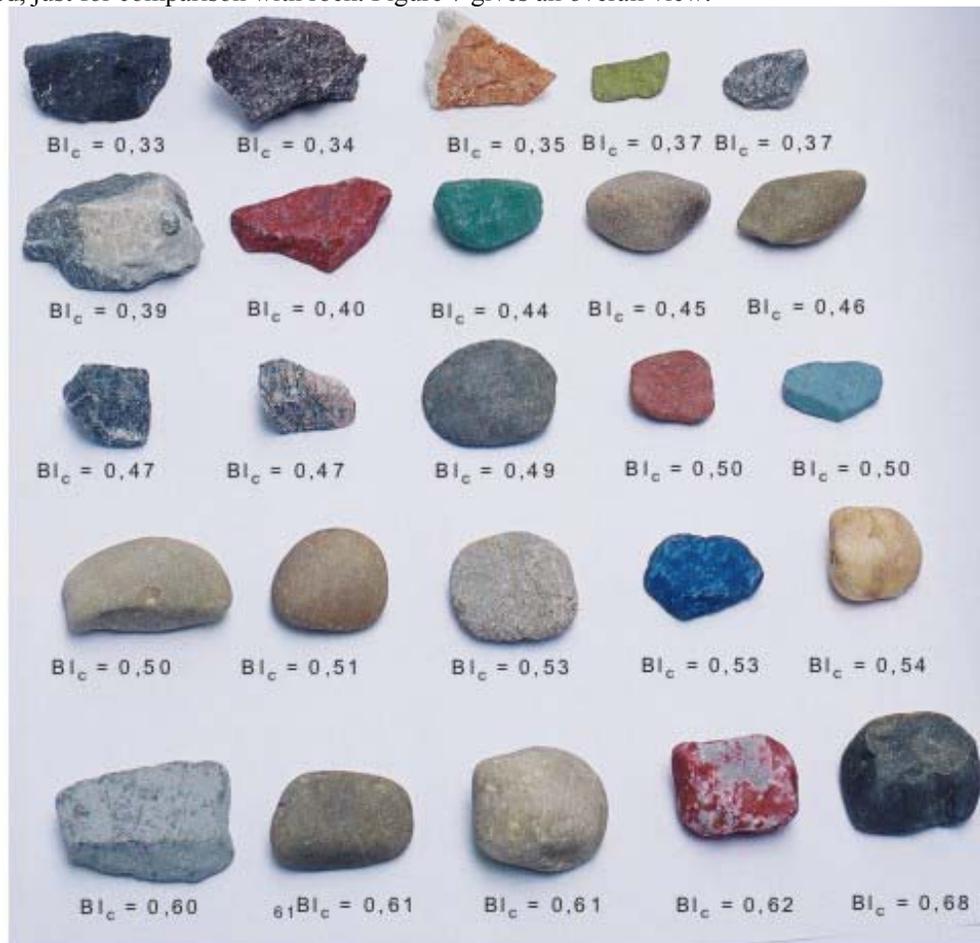
Figure 5. Different rock shapes ranked according to their blockiness coefficient BL_c

Photographs in Figure 5 and 6 were used to assess the actual blockiness coefficient in reality on a protection, for each rock measured in a batch. It should be noted that $BL_c = 1$ is according to a cube and a value of 0.52 describes a sphere. It appears that nice blocky shapes have the highest coefficients around $BL_c = 0.6-0.7$. Irregular shaped rock with triangular shapes have lowest values with $BL_c = 0.3-0.4$. More rounded shapes come close to a ball or sphere with values around $BL_c = 0.5$. The method was validated with natural rock in a stockpile. This method can be applied to normal rock protections if the rock size is not known.

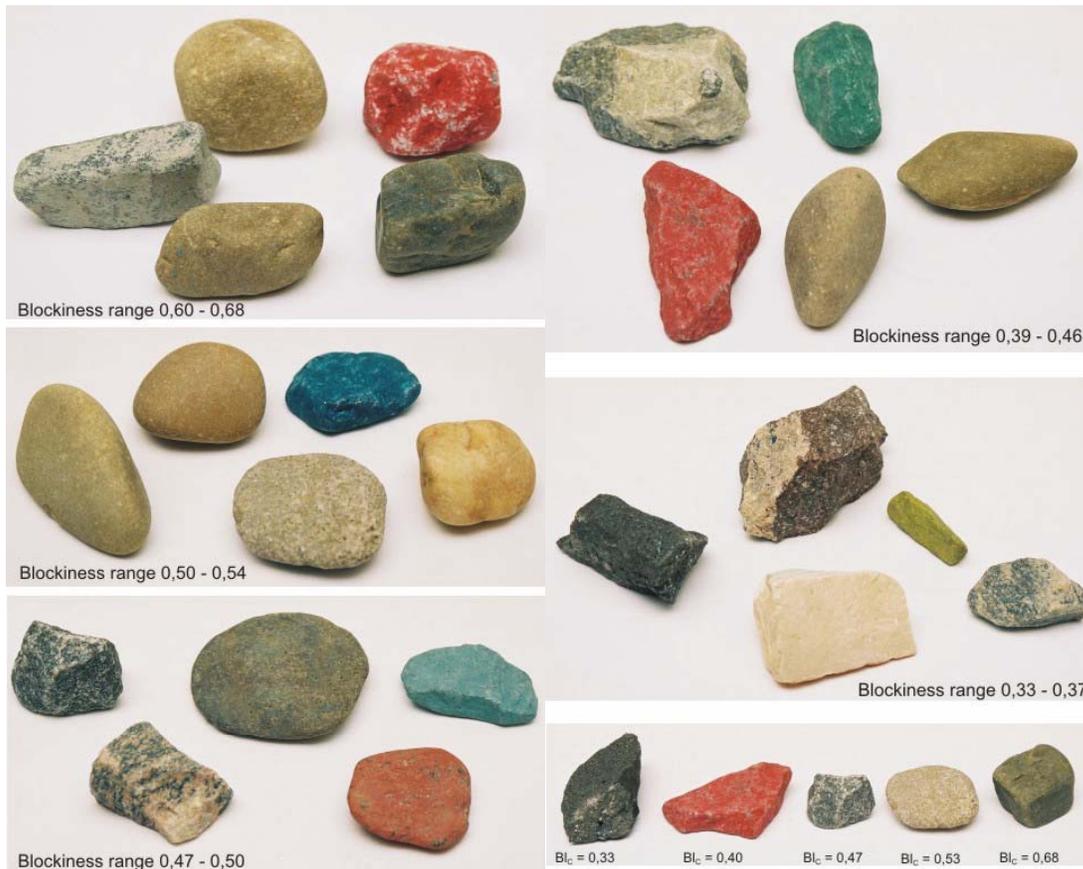
Figure 6. Groups of rocks in various ranges of the blockiness coefficient

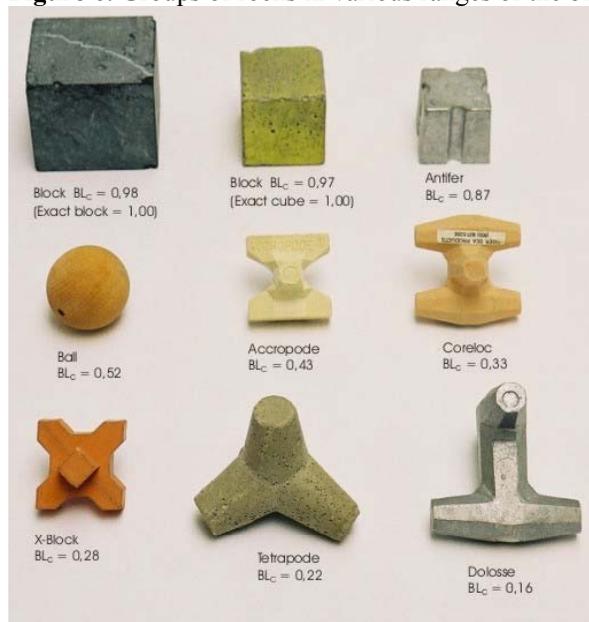
Figure 7. Blockiness coefficients for armour units

This idea was developed further and the final method can also be used for other rock structures or breakwaters to get a good measure of the actual grading of the rock on a built structure. First of all small rock samples with different shapes were gathered. All these small rocks were ranked according to their measured BL_c -value and photographs of this ranking were made. Figure 5 shows a picture of all 25 rocks in a ranking. Figure 6 shows groups of rock in a certain blockiness range. Other armour units for coastal protection were taken and also the blockiness coefficients of these units were measured, just for comparison with rock. Figure 7 gives an overall view.

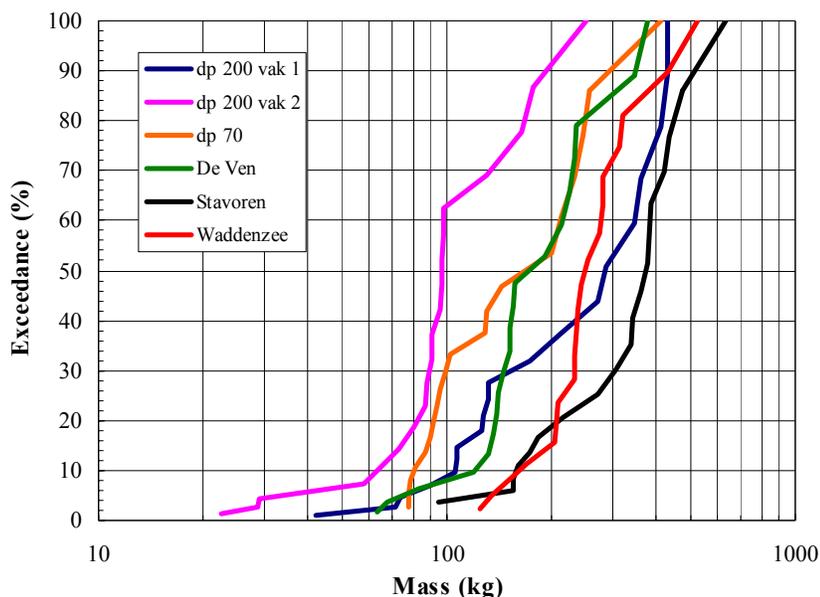
Figure 8. Grading curves for various pitched rock slopes, based on a non-destructive method to establish the weight of a rock

Various locations with pitched natural rock were analyzed in detail. Every time the three dimensions of 10 rocks were measured. The weight of each rock was established based on the guessed blockiness coefficient of each rock. The ten rocks together give a (rough) grading curve as shown in Figure 8. In this figure the grading curves of all locations are given. Table 1 gives a summary of the findings, such as the average mass M_{50} , the nominal diameter D_{n50} , the grading D_{n85}/D_{n15} the layer thickness and the average blockiness coefficient. The average mass was not established by reading the value on the 50% line, but by estimating a *straight line* through the grading curve, matching the trend of the grading between the 15% and 85% lines. Therefore, values in Table 1 differ from direct readings from the graph.

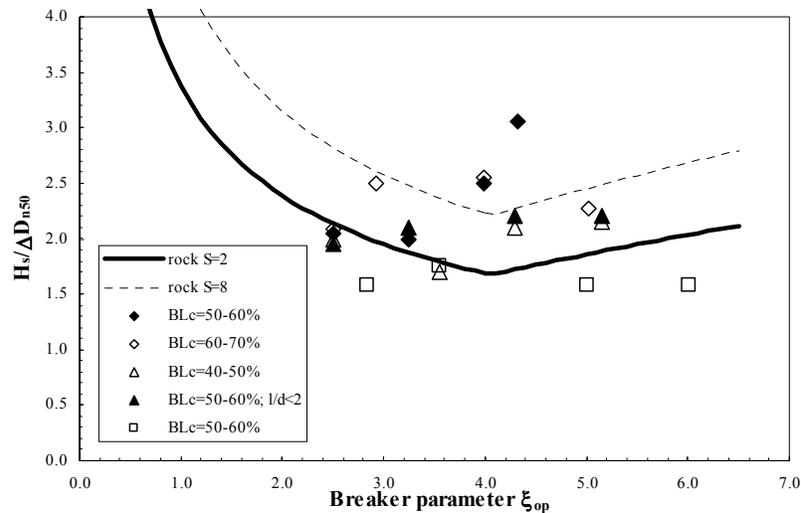
Figure 9. Single layer of rock on permeable underlayer (Stewart et al., 2003)

Stewart et al. (2003) performed an extensive research on packing densities, rock shape and the influence on stability and wave overtopping. A part of the research was focused on a single layer of rock. The placing of rock was described as a “dense pack” where every rock was placed individually by crane. Tests were performed with different blockiness coefficients of the rock. Tests were performed with a permeable underlayer ($P = 0.5$, see Van der Meer (1988)) and with an impermeable underlayer ($P = 0.1$). Results are shown in Figures 9 and 10.

The slope of the structure was 1:2. The tests with $BL_c = 50-60\%$ and a permeable underlayer were repeated. These repetition tests showed lower stability. The results show “first damage”. This could be one rock displaced or a few. Tests were stopped as soon as the first damage was observed. In the figures the formulae for classical rock layers (Van der Meer, 1988) are given for comparison. In Figure 9 most results are equal or higher than the curve for $S = 2$ (start of damage), except for the repeated test series, which gives lower results. Results for the impermeable underlayer are always better than the curve.

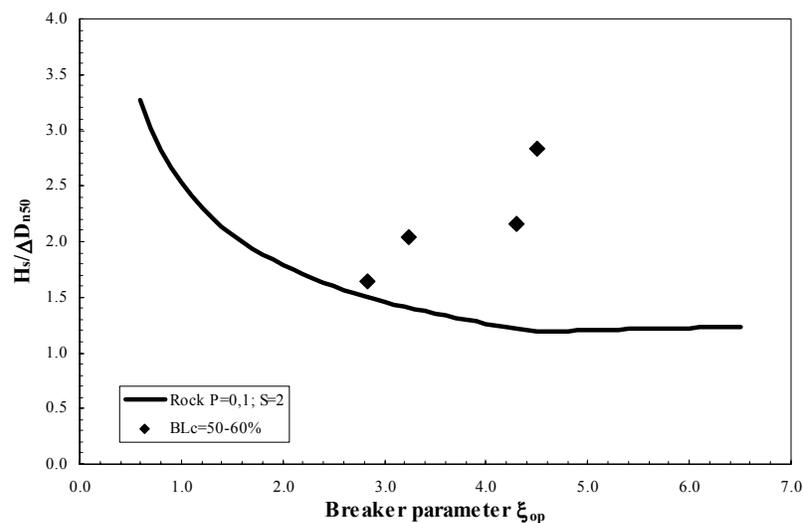
Figure 10. Single layer of rock on impermeable underlayer (Stewart et al., 2003)

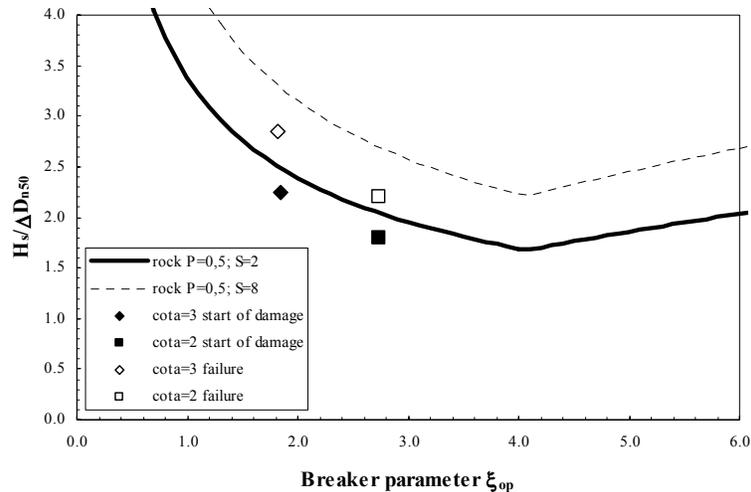
Figure 11. Single layer of rock on permeable underlayer (Van den Bosch., 2001)

Van den Bosch (2001) studied different placing patterns for a single layer of rock. Results here are shown for the method were, if possible, rock was placed (but not pitched) with the longest axis perpendicular to the slope. Slopes of 1:2 and 1:3 were tested. Testing concerned only one wave steepness. Results are given in Figure 11, both for start of damage and “failure”. Results are compared with a permeable underlayer. The results are just lower than the stability curves for classical rock layers, but the trend for plunging waves (lower stability for larger breaker parameter) is confirmed.

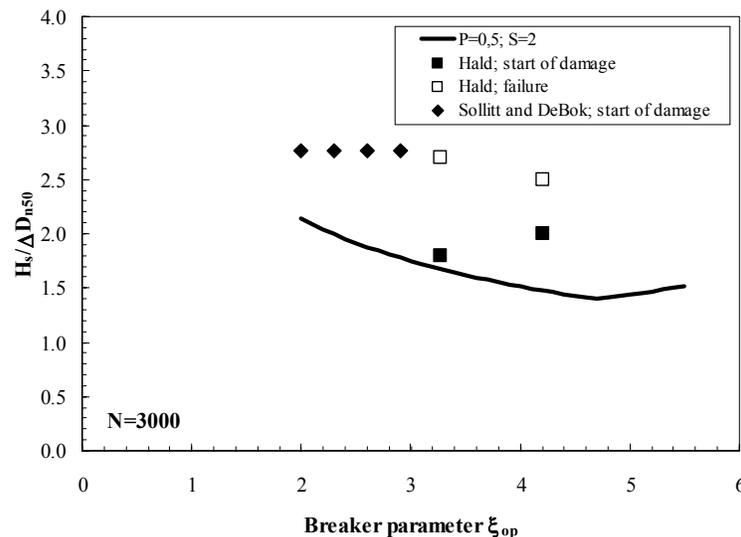
Figure 12. Single layer of rock on permeable underlayer (Hald, 1998 and Sollitt and DeBok, 1976)

In Norway many breakwaters have been constructed with a single layer of large rock. These rocks were placed individually by a crane. Hald (1998) called this “orderly placed” and he performed tests for these steep slopes. Results are shown in Figure 12, both for start of damage and failure. Start of damage is situated above the classical curve.

Sollitt and DeBok (1976) performed large-scale tests in the flume of Oregon, USA. Tests were performed on approximately rectangular parallelepiped shaped rock and the longest axis was placed perpendicular to the slope. The slope was 1:2 and the underlayer was permeable. Tests were performed with regular waves. A K_D -factor of 29 was found for no “damage”. This gives $H/\Delta D_{n50}=3.87$. If it is assumed that a regular wave height has similar effect as the 2%-wave height in a random sea state, the stability factor can be calculated by dividing by 1.4 (being the ratio $H_{2\%}/H_s$ for relative deep water). This gives a stability factor of $H_s/\Delta D_{n50} = 2.76$. This value is also shown in Figure 12 for the range $\xi_{op} = 2 - 3$.

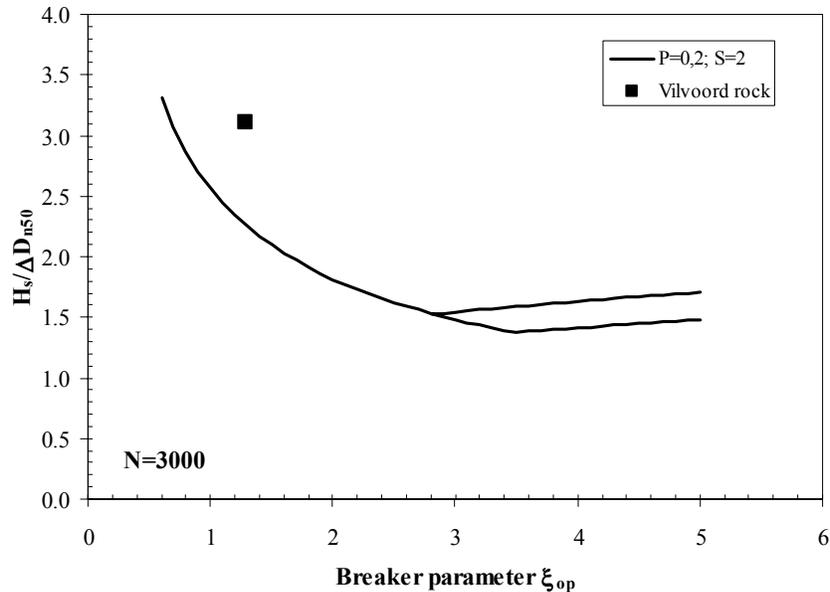
Figure 13. Single layer of rock on impermeable underlayer (Delft Hydraulics, 1985)

In 1985 stability tests were performed in the Delta flume on small pitched natural rock (Delft Hydraulics, 1985). The fairly rounded rock (called Vilvoord rock) was placed with the longest axis perpendicular to the slope. The underlayer was fairly impermeable. With rock weighing in average 15 kg a significant wave height of 0.75 was withstood, giving $H_s/\Delta D_{n50} = 3.11$. The slope was 1:3.5, giving a small breaker parameter of $\xi_{op} = 1.29$. Figure 13 gives this point with the corresponding curves for a classical structure. Stability is better for the tested structure.

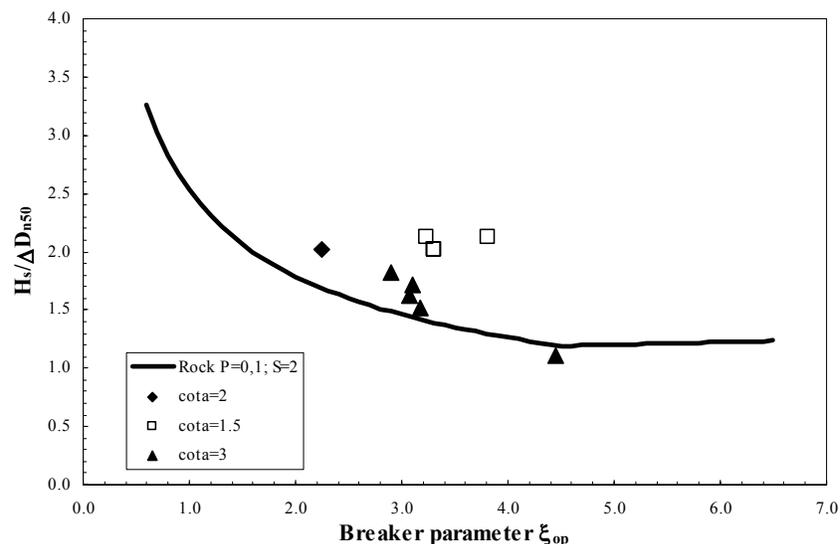
Figure 14. Single layer of rock on impermeable underlayer (Camfield, 1976 and Camfield and Reed, 1998 - unpublished)

Finally tests of Camfield (1996) will be described. He investigated orderly placed single layers of rock with regular waves. Direct stability results are not described in the paper. On request (personal communication Don Ward) two not-published reports were received with stability results. Tests with an impermeable layer were described in Camfield and Reed (1998 – unpublished). Slopes of 1:1.5, 1:2 and 1:3 were investigated. Damage was defined as clear movement or as displacement of rock. With a clear movement the rock remained in the armour layer. As regular waves were used, a similar translation was made to random waves as for Solitt and DeBok (1976). The stability number was divided by 1.4, keeping the same wave steepness. Figure 14 gives the results for start of damage. The data points are on or above the classical stability curve.

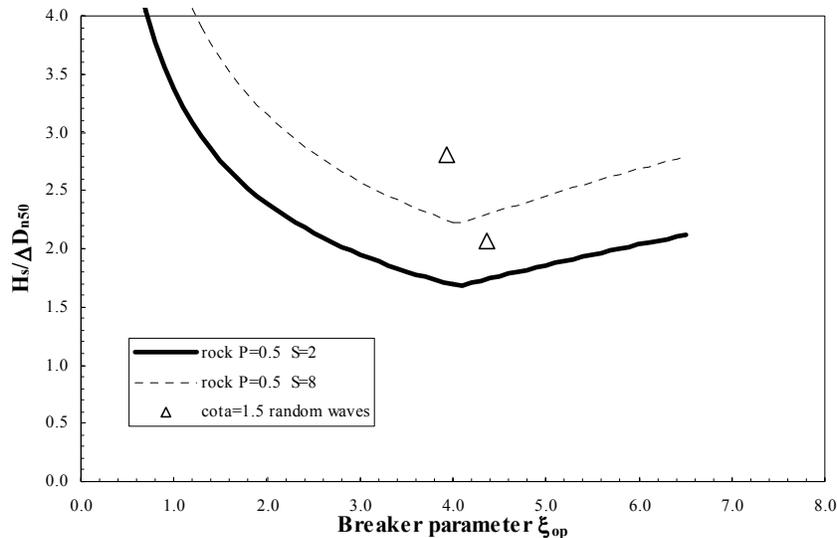
Figure 15. Single layer of rock on permeable underlayer (Camfield et al., 1999-unpublished)

In Camfield et al. (1999 – unpublished) tests were performed on a breakwater with a single layer of rock. The underlayer, therefore, can be considered as permeable. Again tests with regular waves were performed, but now a small 1:16 foreshore slope was present. Waves were only measured at deep water and sometimes had the same value as the water depth at the toe of the structure. As the wave height at the structure was not known, these tests were not further taken into account. Only two tests were performed with random waves. Although these results may also be less reliable, they are given in Figure 15. Both data points are located higher than the classical stability curves.

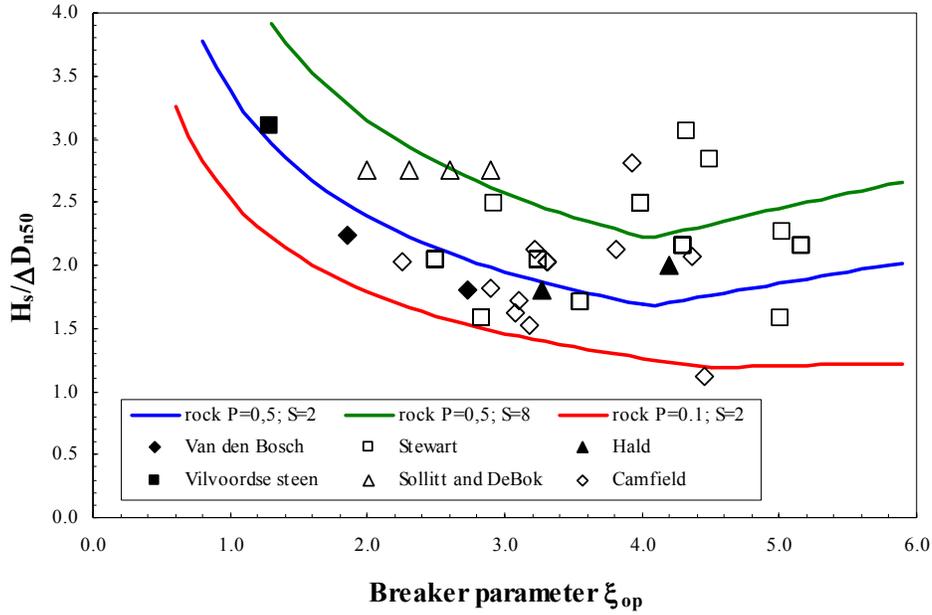
Figure 16. All results for a single layer of rock compared with stability of classical layers

All stability results together for a single layer of orderly placed rock are given in Figure 16. Each point gives “initial damage”. The definition is not very sharp, it could be one or a few rocks displaced, but also first movement without displacement. Some structures were a kind of revetment with an impermeable core, others were more like a breakwater with permeable underlayers and core. Here all results are given together.

Stability of a randomly placed double layer of rock can be described by Van der Meer, 1988. This can be considered as the real lower boundary for orderly placed rock. The formula is given in Figure 16 for S=2 and S=8 for P=0.5 (permeable underlayer) and for S=2 and P=0.1 (impermeable underlayer). Practically all model test results in Figure 16 are higher than the curve for an impermeable underlayer. Even many results are better than the curve for a permeable underlayer.

Curves for a classical rock protection of two layers of randomly placed rock do not match with the total result of the single layer results, although the trend for plunging and surging waves seem to be present. This means lower stability for increasing breaker parameter for plunging waves and increasing stability for increasing breaker parameter for surging waves.

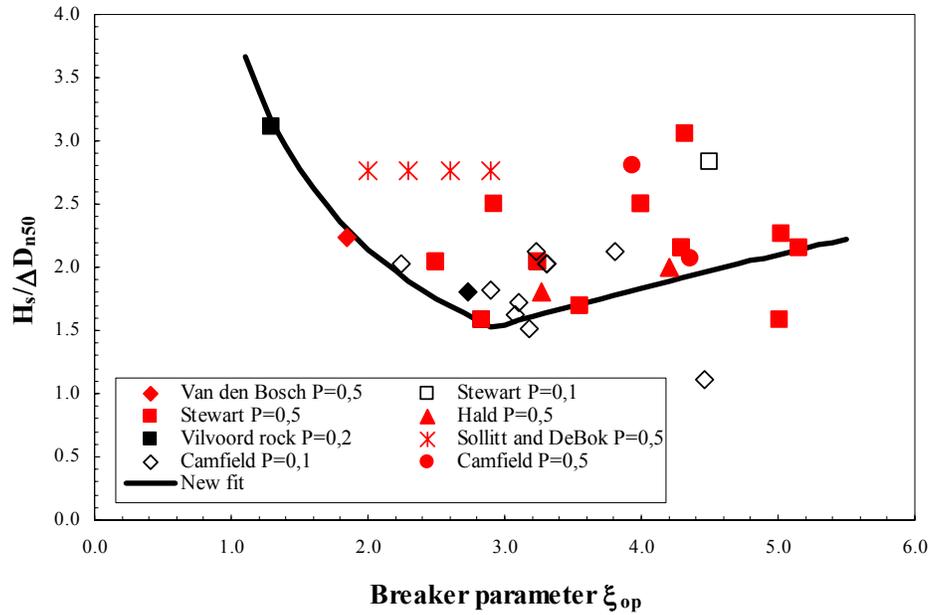
Figure 17. All results for a single layer of rock (red = permeable underlayer; black = impermeable underlayer) compared with a new fit as a lower boundary

The new fit in Figure 17 may be described by the following equations:

$$H_s/\Delta D_{n50} = 4 \xi_{op}^{-0.9} \quad \text{for plunging or breaking waves} \quad (3)$$

$$H_s/\Delta D_{n50} = 0,8 \xi_{op}^{0.6} \quad \text{for surging or non-breaking waves} \quad (4)$$

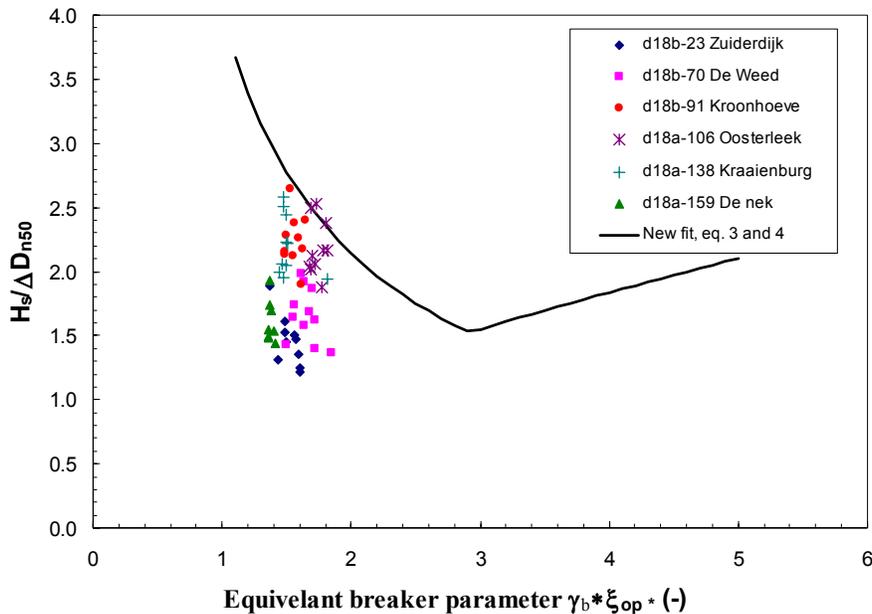
Figure 18. Hind casted results for first location, based on limited data

This figure is very promising as some points are even on the new curve, where all data points can be considered as “no damage”! The problem, however, was that data was limited and based on conservative estimations in a safety assessment. This means that sizes were possible taken on the lower side and effect of a foreshore was ignored. For a first safety assessment this is a right procedure, but not for the method of proven strength. For the method of proven strength it should be proven that a certain wave heights has indeed occurred on the structure and that the average size of the rock is not taken too small. This is all just opposite to a safety assessment.

Due to the fairly small foreshores the water depth at the toe of the structure reduced in many cases by 10-40%. Therefore, also the wave heights at the structure reduced in the same order. Finally, the rock berm in front of the slope (see Figure 2) was measured and in a few cases this berm was wider than from first data. A wider berm means a larger effect on the wave breaking, which gives a smaller equivalent breaker parameter (data points will shift to the left in Figure 18).

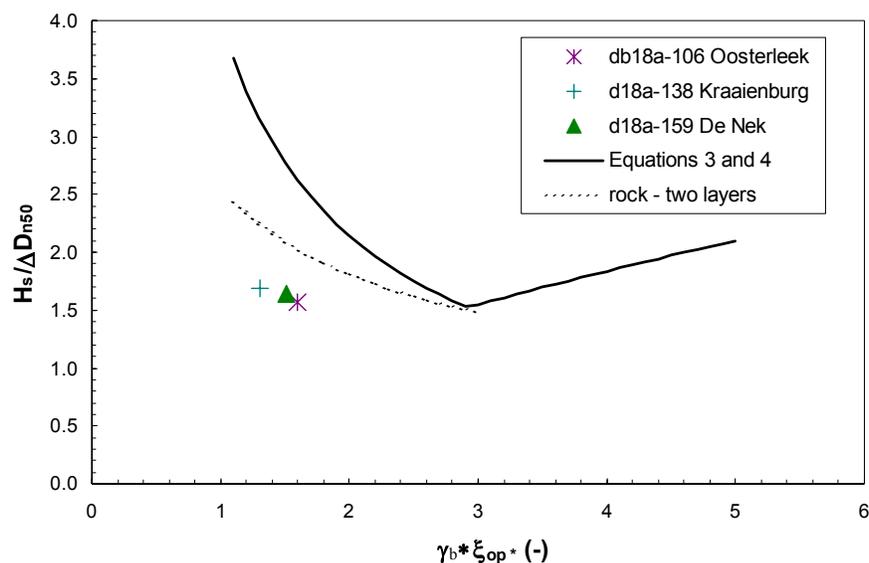
Figure 19. Hind casted results for first location, based on detailed investigation

After the detailed investigation on the actual situation the same graph as in Figure 18 was constructed, but now with the real data. Only the largest storm was taken, giving the highest points close to the curve of Equation 3. Figure 19 gives this final graph. Due to the larger rock than first assumed and the lower wave heights at the structure, the $H_s/\Delta D_{n50}$ -values reduced a lot. The data points are now even lower than the curve for start of damage for a classical two layers rock slope (Van der Meer, 1988).

The conclusion is that in this case the method of proven strength could not validate the assumption that equations 3 and 4 are a good estimation for start of damage of a single layer of pitched rock. The final conclusion on this exercise was that the approach of proven strength and the approach of a safety assessment are opposite to each other. For the method of proven strength one has to take into account all possible causes which may have led to lower wave conditions or a stronger structure than anticipated on limited data. One has really to prove that the structure has survived a given wave height.

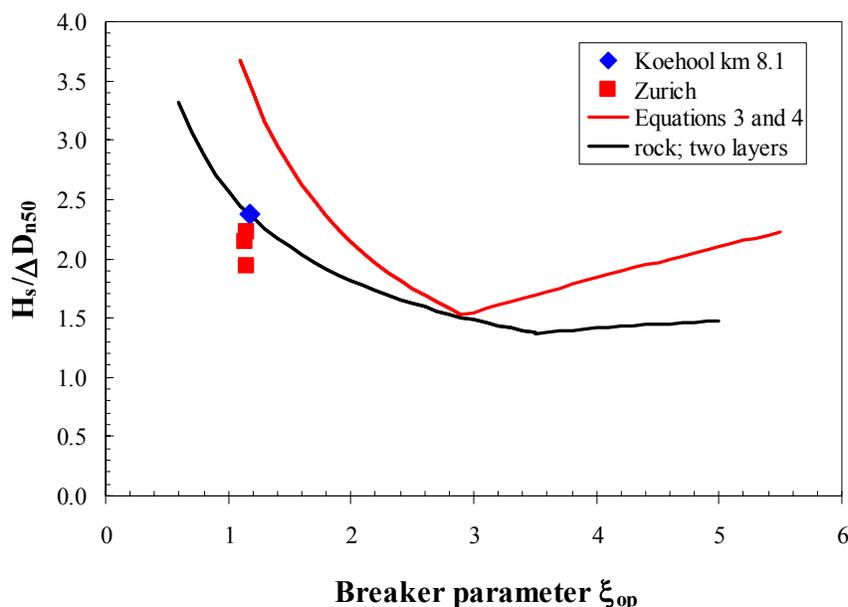
Figure 20. Hind casted results for second location (Zürich and Koehool)

Also here the actual rock size was determined with the method described in this paper. The results of the SWAN-calculations were used to establish the wave height at the toe of the structure (see Figure 3). Finally the stability graph was drawn, which is given in Figure 20.

Two locations along the Waddensea dike were chosen, one at Zürich (where the rock was moved) and one at Koehool, about 20 km north. Figure 20 gives the results for 3 water levels for Zürich, including the peak of the storm and the highest water level at Koehool. The data points are close to the stability curve for the classical two layers of rock, but still do not validate equations 3 or 4.
