FIELD TESTS ON SEA DEFENCES SUBJECT TO WAVE OVERTOPPING

Gert Jan Akkerman¹, Patrizia Bernardini², Jentsje van der Meer³, Henk Verheij⁴
and André van Hoven⁵

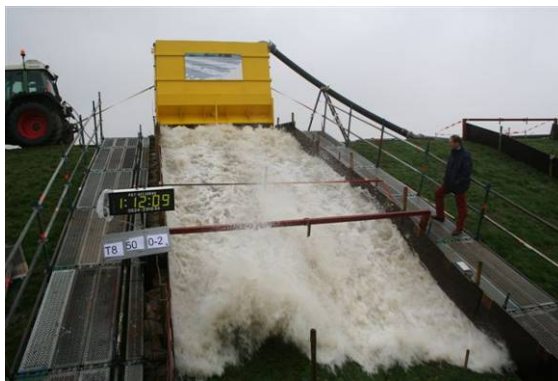
Figure 1. Wave overtopping simulator during the field tests on the sea dike, releasing a maximum wave volume of 3.5m³ per m width in a few seconds.

The overtopping discharges could be varied within a wide range: from 0.1 l/s per m to about 50 l/s per m, the latter overtopping discharge being far beyond present overtopping standards.

An impression of the simulator during maximum wave overtopping is given in Figure 1 below.

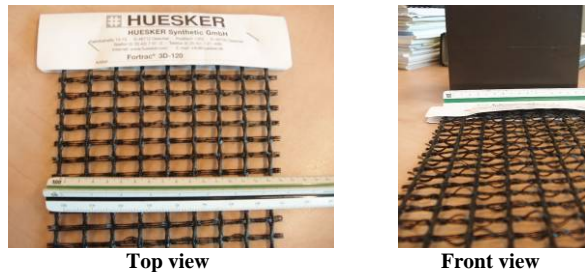
Figure 2: Selected Fortrac 3D-120 system for reinforcement of dike crest and inner slope

The grass reinforcement system was elaborated by the Royal Haskoning & Infram consortium after consideration of a wide variety of reinforcement systems (Van Gerven, 2005). This reinforcement system was the winning concept during a contest that was issued within the ComCoast program. This system consists of a 3-dimensional specifically selected geosynthetic placed underneath the grass surface. This reinforced grass system was denoted 'Smart Grass 'Reinforcement' (SGR). After placement this system enables optimum root penetration and intertwinement of the grass roots and, at the same time, provides sufficient shelter to the under laying substrate when uncovered. In addition, the strength and stiffness of the system is such that shear forces can be dissipated well by the geosynthetic. The selection of this system followed after an extensive functional analyses of the specifications for the SGR, with sometimes contradictory demands. The system selected, the Fortrac 3D-120 system by Huesker Synthetic, fulfilled these demands best. An impression of the geosynthetic is given in Figure 2, from which the 3-dimensional character can clearly be seen.

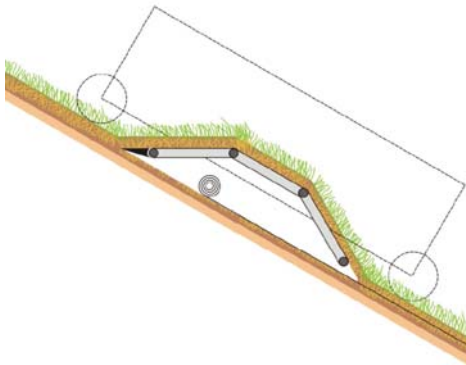
Figure 3: schematical sketch of placement of the geosynthetic in upward direction

The placement technique to install the geosynthetic in an adequate way underneath the grass cover is still subject to further detailing and engineering, as only the conceptual idea could be developed within the ComCoast program. This concept implies the deployment of a machine that cuts the grass at some distance below the surface and lifts the upper grass cover temporarily while placing a geosynthetic at the same time underneath this cover, as shown in Figure 3. In passing, the lifted grass cover is guided back to its original position, which is feasible due to the elasticity in the grass sod.

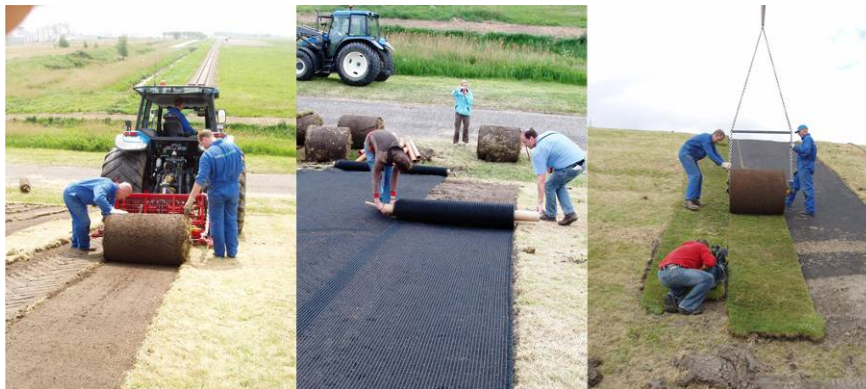
Figure 4: Illustration of obtaining the SGR: cutting of grass (left), placement of geosynthetic (middle) and unwinding of the big rolls (right)

For the field tests this methodology was not engineered further to the extent required for proper placement. Hence, another way of placement was adopted: cutting the grass with a small thickness (0.05 m) in 1 m wide strips and winding the grass cover to 'big rolls'. After installation of the geosynthetic, these rolls were replaced with a crane and the grass was unwound. This type of installation had a highly exploratory character, as it had not been done before. Hence, the installation was preceded by an extensive analysis of risk factors and mitigation measures for placement. In May 2006 the 4 m wide SGR test section was installed at the sea dike according to this methodology. An impression of this method, denoted as Big Roll method, is given in Figure 4.

The Big Roll method was not ideal, as the grass cover suffered considerably during the whole placement, which took 2 days. However, the grass recovered quite well after one growing season, after receiving after-treatment, such as

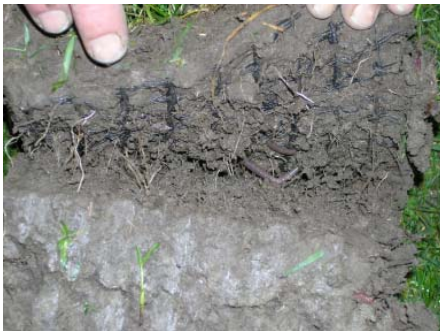
Figure 5: Root penetration of grass roots and intertwinement of geosynthetic

Prior to the tests early 2007, some samples with SGR were dug up and the grass roots showed a root penetration and intertwinement as anticipated, as can be seen in Figure 5. This encouraging result was obtained within one growing season.

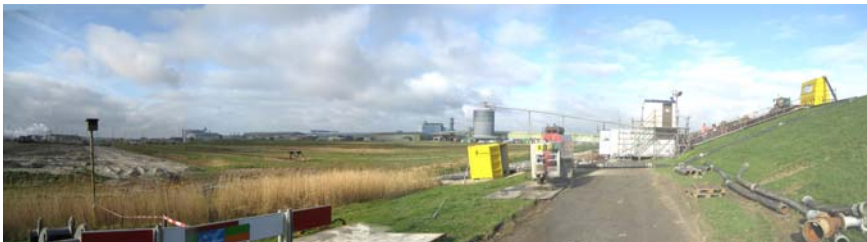
Figure 6: Wide angle view of test set-up at the inner slope of the Groningen sea dike

An impression of the test set-up is shown in Figures 6 and 7.

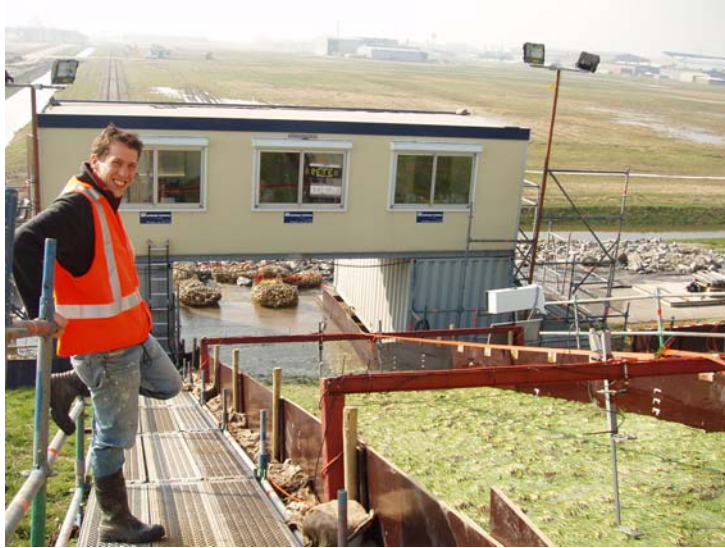
Figure 7: View of the test set-up, with guiding walls and measuring cabin

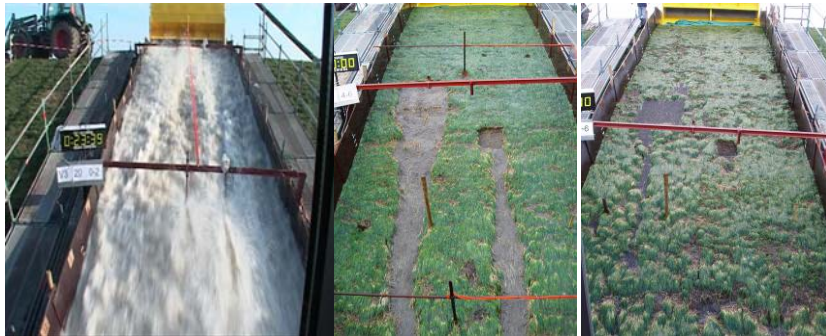
Figure 8: Damage pattern at the natural grass section (middle) and the SGR section (right), showing differences in damage progression after 50 l/s per m

Hence, it was decided to introduce some damage to the test sites and to repeat the 50 l/s per m test. Different types of damage had been applied to the inner slope (small holes, two major bare spots, placement of poles and pickets). After testing, a marked difference could be observed between the natural grass section and the SGR section. This is illustrated in Figure 8 which shows the damage patterns after completion of the 50 l/s per m test.

At the non-reinforced section, gullies had developed, which extended to the toe of the dike, whereas at the SGR section gully formation was virtually absent.

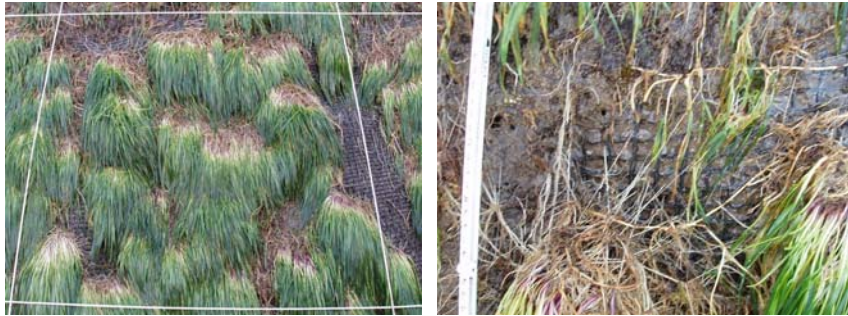
Figure 9: Anchoring of the grass sods to the geosynthetic, even at bared spots

This can be explained from the presence of the SGR, by which the grass layer is successfully reinforced with the geosynthetic. The strength improving action could be observed from the grass roots that 'anchored' very well to the geosynthetic, as is illustrated in Figure 9.

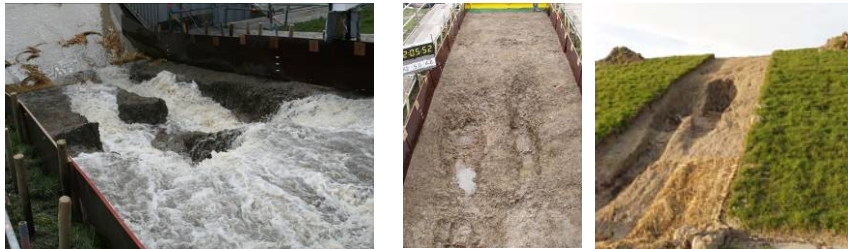
Figure10: Impression of the erosion at the bare clay section directly after testing (middle) and after removal of the test equipment (right).

Finally, the erosion resistance of the bare clay section was investigated. Here, the absence of grass was clearly noticeable, as damage already occurred at the 1 l/s per m test. After performing an intermediate test with 5 l/s per m, a final test of 10 l/s per m showed severe erosion of the inner slope. This erosion manifested itself with distinct scour holes and steep cliffs. This erosion progressed towards the crest of the dike. The deepest hole was about 1 m deep, as is shown in Figure 10. From literature, this cliff type of erosion was to be expected.

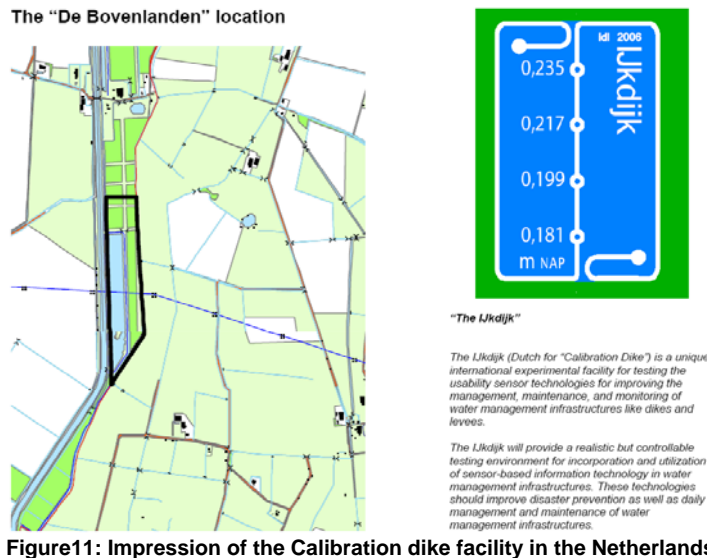
Figure11: Impression of the Calibration dike facility in the Netherlands

Some impression of the Calibration dike program are given in Figure 11, see also http://www.inspectiewaterkeringen.nl/documents/inspectiewaterkeringen/downloads/brochure%20ijkdijk_engels.pdf.
