LARGE SCALE TESTS OF BOULDER CLAY EROSION AT THE WIERINGERMEER DIKE (IJSELMEER)

A large scale model investigation (scale 1:1) of the erosion resistance of boulder clay in dikes under wave attack was carried out in the Delta Flume of Deltares|Delft Hydraulics. The investigation showed that boulder clay has considerable erosion resistance, indicating that the Wieringermeer dike can withstand extreme storm conditions, at least several hours, after the stone revetment has been damaged. However, depending on the location of the dike section, the local wave conditions for safety assessment and the thickness of the boulder clay layer, the remaining strength is not always large enough to meet the assessment conditions without the additional protection of a toe berm and/or a revetment. The investigation indicates that the erosion resistance of boulder clay could be taken into account in the safety assessment of dikes.

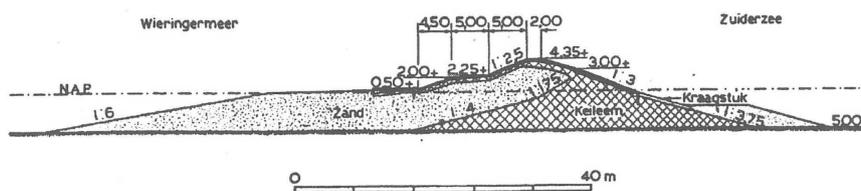
Figure 1. Cross section of the Wieringermeer dike (IJsselmeer).

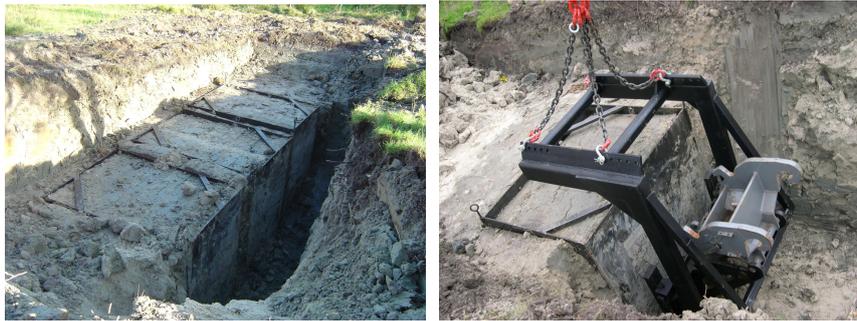
(a) Boulder clay blocks with supporting framework (b) Lifting of boulder clay blocks
Figure 2. Excavation process at the Wieringermeer dike.

which has no water defensive purpose anymore. The material was transported in blocks of 10 ton and installed in the Delta Flume, see Figures 2 and 3. The tests were conducted without revetment in order to test the erosive strength of the boulder clay material alone. After the tests the excavated section of the Wieringermeer was restored and vegetated.

Before excavation the top layer of the dike (disturbed gras/root layer of 1m thickness) was removed. 35 boulder clay blocks of 1.8m x 1.3m x 1.6m were carefully cut out of the old dike using rectangular, at the bottom sharpened metal frames (low friction between steel sheets and soil), which were slowly pushed (not vibrated) into the dike after each other, see Figure 2. In this manner the block was incased in sheets of metal. Then the ground around the sheets was excavated, a pointed plate pushed beneath the block and the block lifted by a pallet fork out of its position. Between blocks sufficient distance was kept to ensure that excavation work did not disturb the quality of the next blocks. The above described process guaranteed that the disturbance of the boulder clay material was kept to a minimum during excavation and transport. The maximum deformation of the blocks was about 3-5cm (<0.5% strain). Each blok weighed about 10 ton. After excavation the boulder clay blocks were kept wet and protected from desiccation by a plastic cover. The excavation of the boulder clay blocks and their installation in the testing facility were conducted simultaneously to ensure that the blocks did not have too long resting/settling periods before installation. The methodology of the excavation and installation process in the Delta Flume of Delft Hydraulics is described in more detail in Delft Hydraulics (2007).

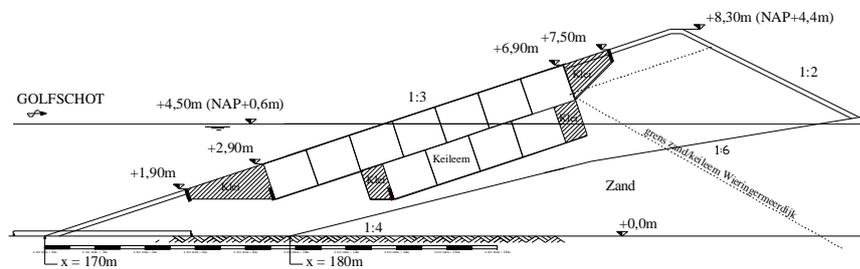
Figure 3. Model set-up in the Delta Flume of Delft Hydraulics.

The testing location was the 240m long Delta Flume of Delft Hydraulics. The flume is 5m wide and 7m deep. Water depths of 1 to 5.5m are possible. The maximum realizable significant wave height in the facility is $H_s \approx 1.7\text{m}$ (irregular). Wave periods of 1-12s can be realized depending on water depth. Wave energy spectra can be prescribed by using standard or non-standard spectral shapes or by a specific time-series of wave trains. The wave board is equipped with second order steering and an active reflection compensation (ARC) system. This means that the motion of the wave board compensates for the reflected waves preventing them to re-reflect towards the model.

- Length and width of the installed boulder clay layer in the Deltagoot: 12,6 m x 3,9 m.
- Maximum thickness of the boulder clay layer: 3 m (horizontal thickness: 7 m).
- Length, width and height of the individual boulder clay blocks: 1,8 m x 1,3 m x 1,6 m.
- Boulder clay density: 2090 kg/m^3
- Surface level in respect to water level: from -1,6 m to +2,4 m.
- The slope from the channel bottom up to a level of +1.9m and beyond +7.5m was made of concrete. Between +1.9m and +2.9m and from +6.9m to +7.5m compacted clay was installed. The core of the model was made of sand.
- Slope 1:3.
- Crest level: +8,3 m in respect to the bottom of the wave channel
- Horizontal floor: no influence of shoaling was modelled/expected.
- Water level during testing: 4.5m (NAP +0.6m)

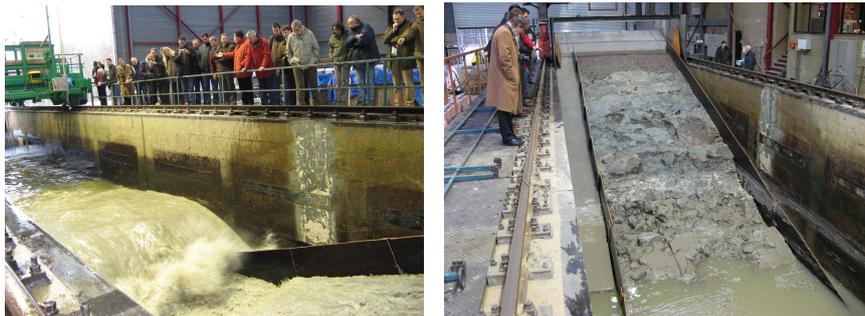
Figure 4. (a) Testing of Wieringermeer dike section in the Delta Flume. (b) Erosion profile after testing.

During testing it was observed that the erosion occurred mainly in horizontal direction, the erosion depth increased only gradually. The first 10 minutes of testing caused strong erosion. Individual waves were observed to quarry large chunks of boulder clay out of the slope (resulting in a horizontal erosion length of 1.1m with an erosion depth of 0.3m). Most of the erosion was found just beneath the waterline. After the first 10 minutes the erosion visibly slowed. The starting erosion revealed stones of 5-15cm diameter which were embedded in the boulder clay and a large quantity of roots was also revealed. These can have a destabilizing effect on the boulder clay and can reduce the erosion strength. The increase in wave height in test 3 ($H_{m0}=1.5\text{m}$) caused a renewed increase in erosion and renewed quarrying of boulder clay blocks out of the slope. The maximum cumulative (horizontal) erosion length found after testing was $E_x \approx 5,4\text{ m}$ ($\sim 0,3\text{ m}$ beneath the water level, see Figure 5) and the maximum cumulative erosion depth (measured vertically) was $\sim 1,9\text{ m}$.

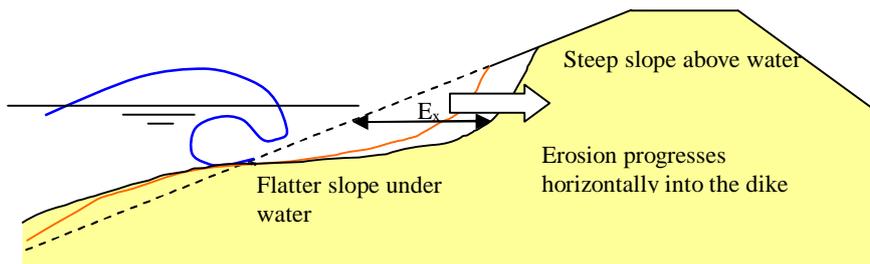
Figure 5. Schematic representation of erosion process in the horizontal direction.

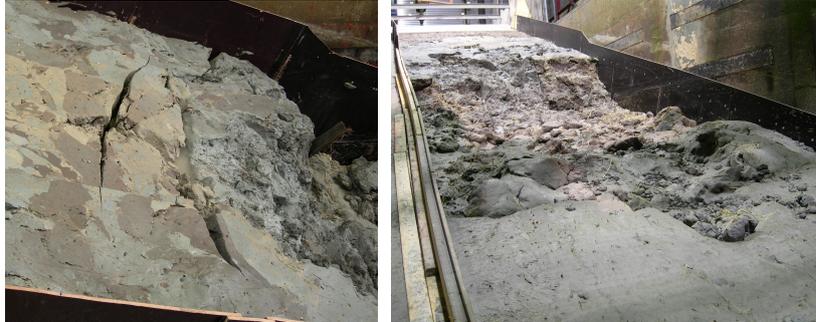
Figure 6. (a) Formation of large fissures in the boulder clay slope (b) Erosion profile development .

- The erosion process was increased by the formation of large fissures in the boulder clay slope which initiated the breaking off and removal of large boulder clay blocks.

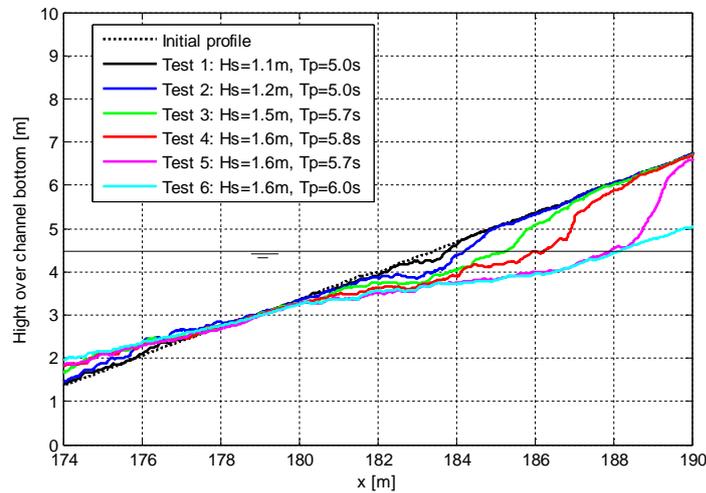
Figure 7. Averaged erosion profiles (vertically averaged over 3 rows, water level +4.50m).

In Table 4 the equivalent test durations are given for a constant wave height of $H_{m0}=1.6\text{m}$, together with the maximum measured horizontal erosion. The erosion profiles, averaged over the width of the channel, can be seen in Figure 7. Figure 7 clearly shows that the erosion profile has become flatter over time whereas the erosion front has become much steeper (cliff).

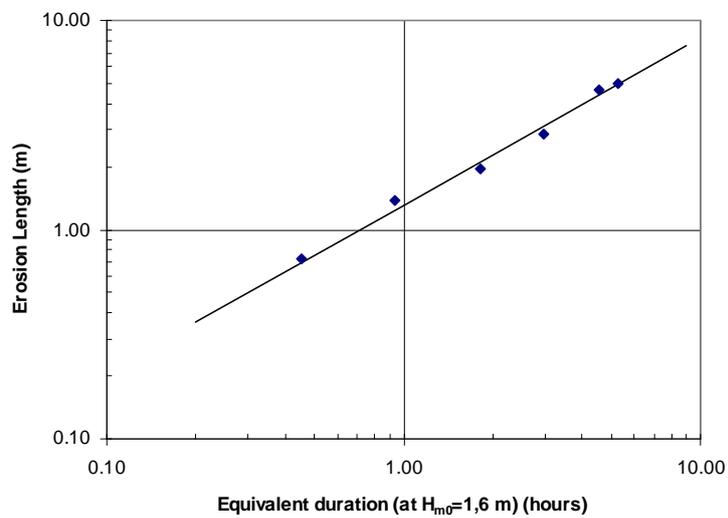
Figure 8. Measured erosion length as function of the cumulative time (recalculated for a constant wave height of $H_{m0}=1.6$ m)

The erosion profile was found to follow an exponential trend, see Figure 8.

Based on the observed exponential trend of the erosion the following formula was developed ($R^2=0.98$):

$$\frac{E_x}{H_{m0}} = \left(\frac{t}{k} \right)^{0.56} \quad (1)$$

As Figure 8 shows, does the formula provide a good correlation between formula and measurements. A comparison of the formulae from textured clay with the new formula for boulder clay is also given in Figure 9. The employed clay formula is (Delft Hydraulics, 2007):

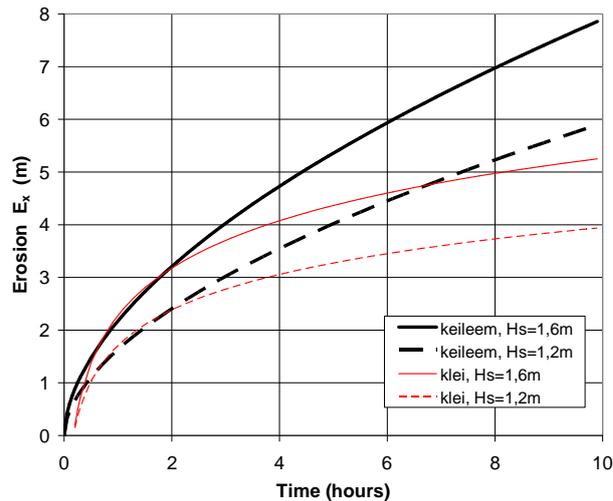
Figure 9. Comparison of measured boulder clay erosion with clay erosion formulae.

Figure 9 shows that in the beginning clay erodes somewhat faster than boulder clay, but with time the erosion velocity becomes much lower than that for boulder clay. Although this trend is generally deemed to be reliable, several factors should however be noted regarding the set-up of the boulder clay tests:

A number of softer boulder clay blocks (as typically found in dikes due to varying boulder clay quality) which were placed above the water level were observed to cause an increase in erosion over time. On the other hand it should be noted that a faster clay erosion in the beginning could be explained by the fact that the top layer is usually textured/fissured or desiccated, which was not
