# Guidance on erosion resistance of inner slopes of dikes from three years of testing with the Wave Overtopping Simulator

**Jentsje van der Meer**, Van der Meer Consulting B.V., P.O. Box 423, 8440 AK, Heerenveen, the Netherlands (NL); [jm@vandermeerconsulting.nl](mailto:jm@vandermeerconsulting.nl)

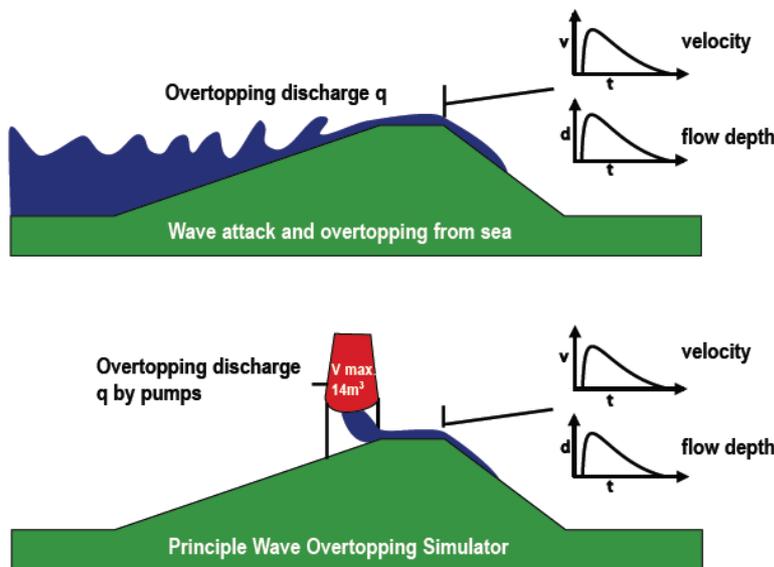
Figure 1. Principle of Wave Overtopping Simulator.

The Simulator consists of a high-level mobile box to store water. The maximum capacity is  $5.5 \text{ m}^3$  per m width ( $22 \text{ m}^3$  for a 4 m wide Simulator). This box is continuously filled with a predefined discharge and emptied at specific times through a butterfly valve and a guidance to the crest, in such a way that it simulates the overtopping tongue of a wave at the crest and inner slope of a dike. The discharge of water is released in such a way that for each overtopping volume of water the flow velocity and thickness of the water tongue at the crest corresponds with the characteristics that can be expected. See Figure 1 for the principle of the Wave Overtopping Simulator. Various overtopping volumes are released randomly in time, see Figure 2.

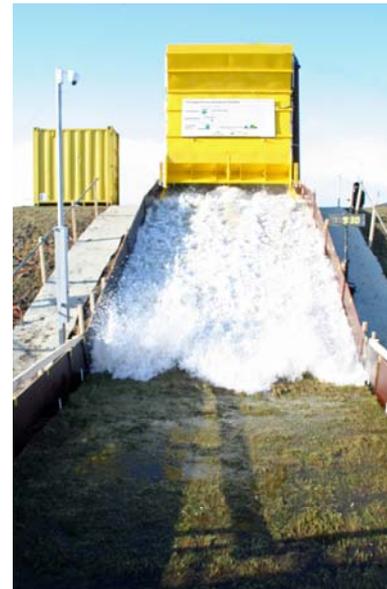
Figure 2. Release of a wave.

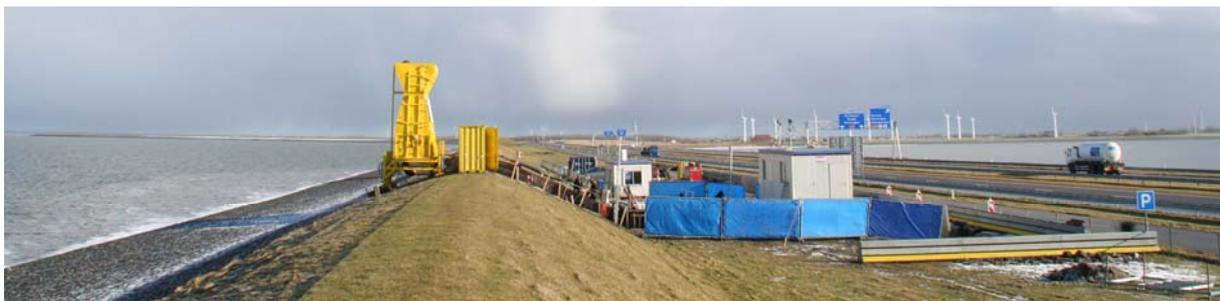
Figure 3. Set-up of Wave Overtopping Simulator close to a highway (February 2009)

Field tests on real dikes have been carried out in 2007, 2008 and 2009, all at the end of the winter when grass roots are in worst condition. Figure 3 shows the set-up of the simulator at the crest and seaward side of a dike and very close to a highway. The design and calibration of the Wave Overtopping Simulator has been described by Van der Meer (2007) and the test results of the first tested dike have been described by Akkerman et al. (2007-1 and 2007-2). Part of the tests in 2008 have been described by Steendam et al. (2008). A summary report on all the testing in 2007 and 2008 has been described by Van der Meer (2008). Evaluation of the tests in 2009 are underway and have partly been described in this paper.

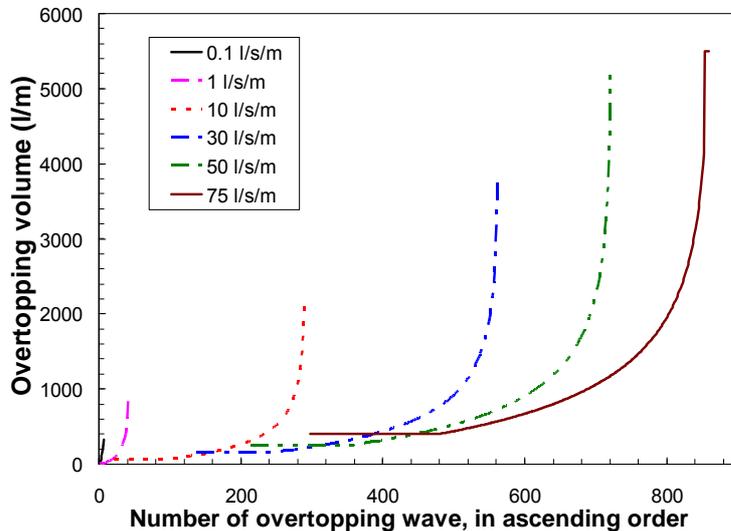
Figure 4. Distribution of overtopping volumes of waves for sea dikes and various mean overtopping discharges, as simulated by the Wave Overtopping Simulator.

expected conditions at sea: a larger significant wave height (as at sea dikes) will show fewer overtopping waves, but the volume in the overtopping waves will be bigger than for a smaller wave height (as for example at river dikes). All tests until now have assumed a significant wave height of 2 m with a wave steepness of 0.04 (using the peak period). Distributions of overtopping volumes for this condition and for various mean discharges are given in Figure 4.

Figure 4 clearly shows that for each mean discharge there are only a small number of waves that give large overtopping volumes. The general behaviour of wave overtopping can be described by a large number of fairly small overtopping waves and a few which are much bigger. These few but bigger waves often cause the damage to the inner slope.

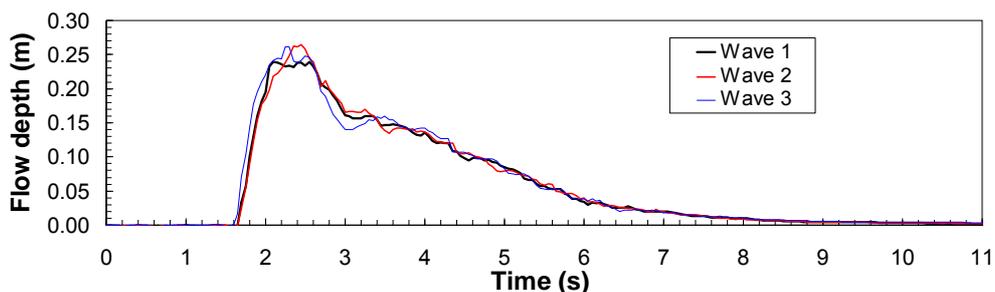
Figure 5. Record of flow depth with floating device for 3 overtopping waves of 3 m<sup>3</sup>/m

In the first years of testing it appeared to be very difficult to measure any hydraulic parameter on the inner slope, like flow velocity or flow depth. The velocities can approach 8 m/s and the water is very turbulent with a lot of air entrainment, see also Figure 2. Laboratory instruments have not been designed for this kind of conditions. In 2009 a lot of attention was focussed on improving the measurements. Amongst them a floating device to measure the flow depth and a high speed camera to measure front velocities of an overtopping wave. The floating device is a curved board which has been hinged about 1 m above the slope and which floats on top of the flowing water. The rotation at the hinge is measured and gives the flow depth. Figure 5 shows the record of this floating device for three consecutive overtopping volumes of 3.0 m<sup>3</sup> per m width each. Recording started exactly when the signal was given to open the valve. The overtopping volumes and the records of flow depth reproduce very nicely. The maximum flow depth is about 0.25 m.

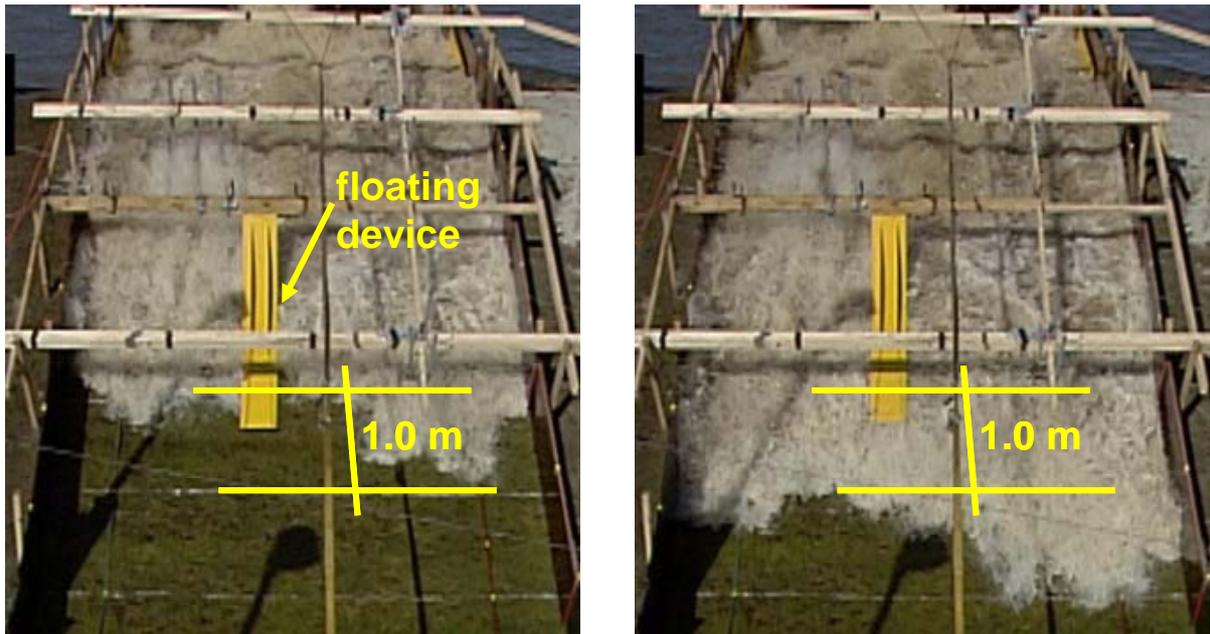
Figure 6. Two pictures of the high speed camera, where the front of the wave travelled 1.0 m in 0.18 s, giving a front velocity of 5.5 m/s

Figure 6 shows two pictures of the high speed camera, which took 50 frames per second. Contours with a distance of 1.0 m had been drawn on the grass of the inner slope. The duration over a distance of 1 m or 2 m gives the front velocity.

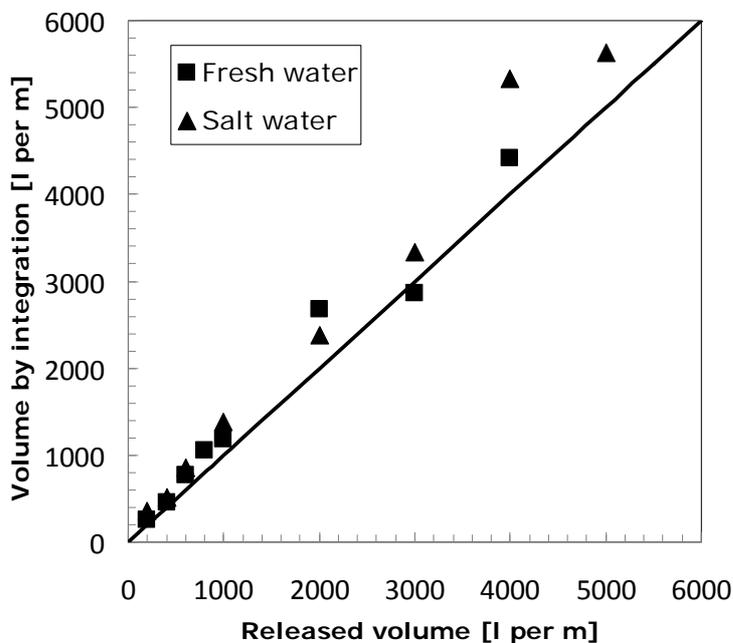
Figure 7. Released volumes from the Simulator versus volumes found by integration over flow depth and front velocity.

time and multiplying it with the velocity. It is assumed that the front velocity is similar to the maximum depth averaged velocity and that flow velocity and flow depth have the same *shape of record in time*. Figure 7 gives the released volumes versus the volumes found by integration. Measurements were performed with fresh water as well as with salt water, the main difference being that the size of air bubbles in salt water is much smaller than in fresh water. The integrated volumes are about 10% bigger than the released ones (except for 3000 l per m) showing that the air entrainment might be about 10%.

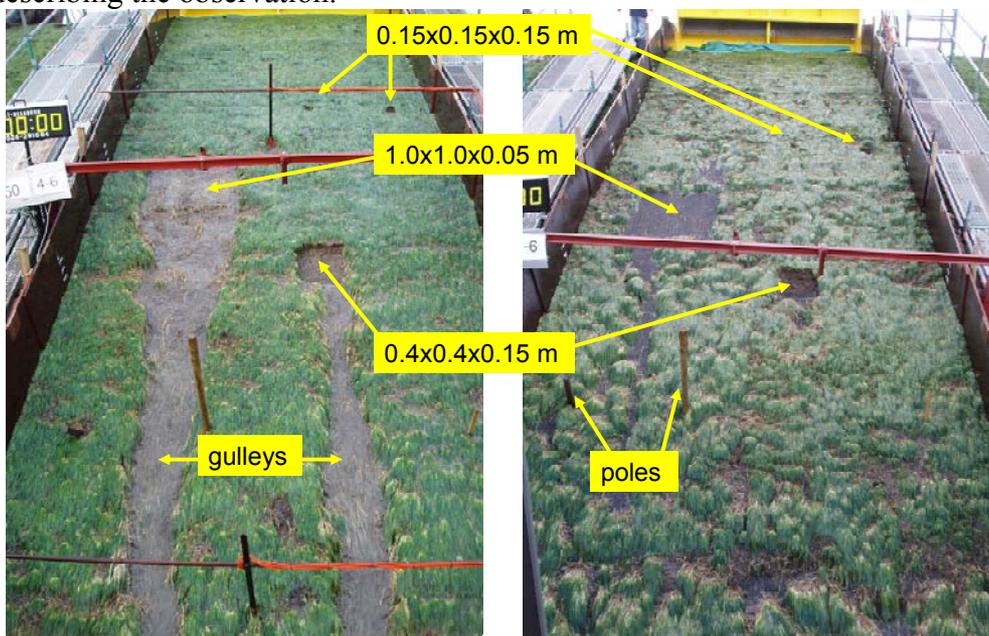
Figure 8. Final result Delfzijl, Groningen, sections 1 and 2.

No damage after 50 l/s per m. Left: test section 1 of the present dike after manual initiation of damage (four holes in the slope: 1x1x0.05 m; 0.4x0.4x0.15 m; in the upper part two holes 0.15x0.15x0.15 m) and after 6 hours with 50 l/s per m. Gully development for the two largest holes, none for the smaller. Right: a reinforced section 2 with geotextile, again after manual initiation of damage, where no gulleys were developed.

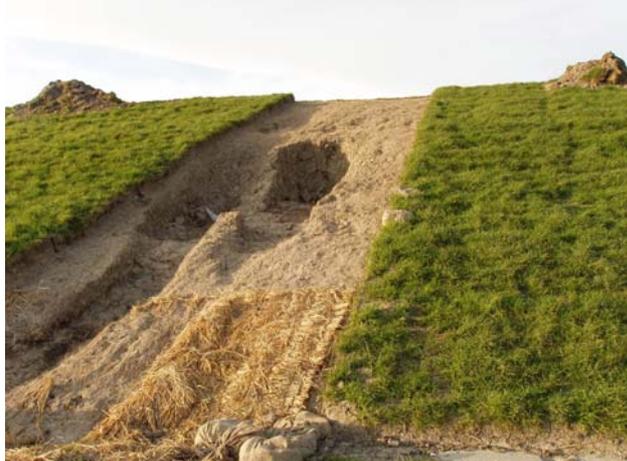
Figure 9. Delfzijl, Groningen, section 3.

Bare clay (0.2 m grass cover was removed). Mean discharges of 1; 5; and 10 l/s per m, each during 6 hours. Ongoing erosion during each condition, which resulted in head cut erosion: a horizontal part with a vertical slope; the vertical slope erodes by lumps of clay from the vertical front and the hole increases upwards.

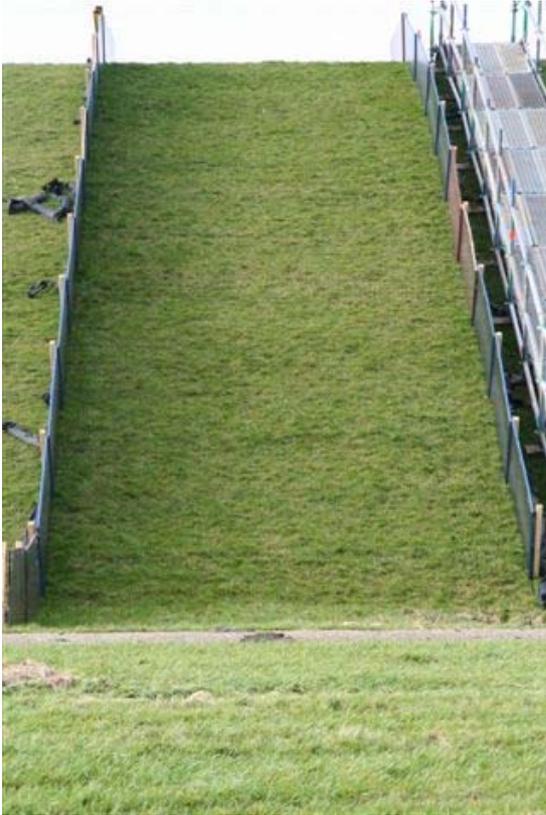
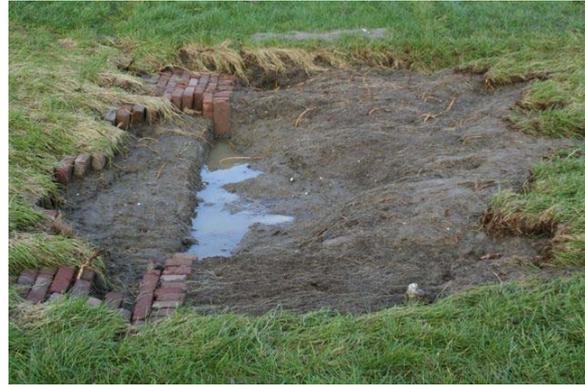
Figure 10. Final result Boonweg, Friesland, sections 1 and 2.

No damage after 75 l/s per m. In the last hour of 75 l/s per m damage to the toe (hidden path of brick stone, see photo right).

It seems that the large erosion resistance of the inner slope of a dike is determined by the *combination* of grass and clay. The grass cover or mattress seems stronger (Boonweg, Figure 10) if it grows on a sandy clay. Such a grass cover may resist even up to 75 l/s per m, but if significant damage occurs, the clay layer is not very erosion resistant (Figures 11 and 12). On the other hand, a good quality clay does not produce a very strong grass cover (it is difficult for roots to penetrate into the clay) and the grass may rip off for overtopping discharges around 30 l/s per m (Figures 18 and 20). But in that case the remaining good quality clay layer, still reinforced with some roots, has a large erosion resistance against overtopping waves (Figure 18).

Transitions from slope to horizontal are probably the most critical locations for initial and increasing damage (Figures 10, 11, 13, 14, 17, 19 and 21). During the tests this was often the transition from the inner slope to the toe of the dike, with or without a maintenance road. The tests in 2009 were focused on these kind of transitions. Damage was initiated by a mean discharge of 10 l/s per m or more. As the damage occurred at the lowest part of the inner slope it will take time for damage to extend to the crest level and subsequently cause a dike breach. Transitions higher on the inner slope (cycle paths, stability or piping berms with or without maintenance road, tracks of tractors, roads crossing the dike), which have not yet been investigated, might be more critical. Further investigation may give more confirmative conclusions.

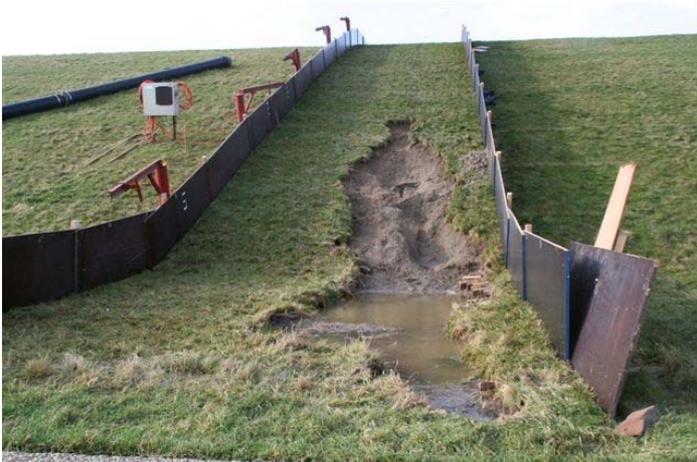
Figure 11. Final result Boonweg, Friesland, section 3.

Initial damage during 75 l/s per m and gully development in the clay layer. The damage extended to the toe where the hidden path with brick stone eroded too. The damage did not (yet) extent through the clay layer and did not reach the sand core. Final result after 75 l/s per m.

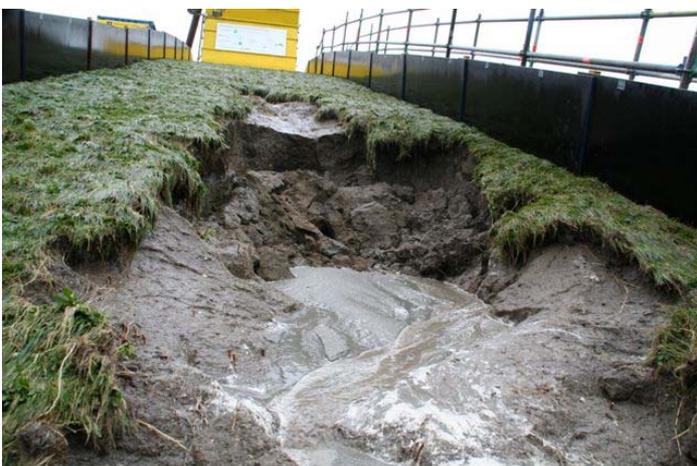
Figure 12. Final result Boonweg, Friesland; section 4.

After 5 hours and 51 minutes with 75 l/s per m. The sand core has been eroded to at least 1 m depth and the right side wall is about to collapse. Final result about 45 minutes after first damage was observed.

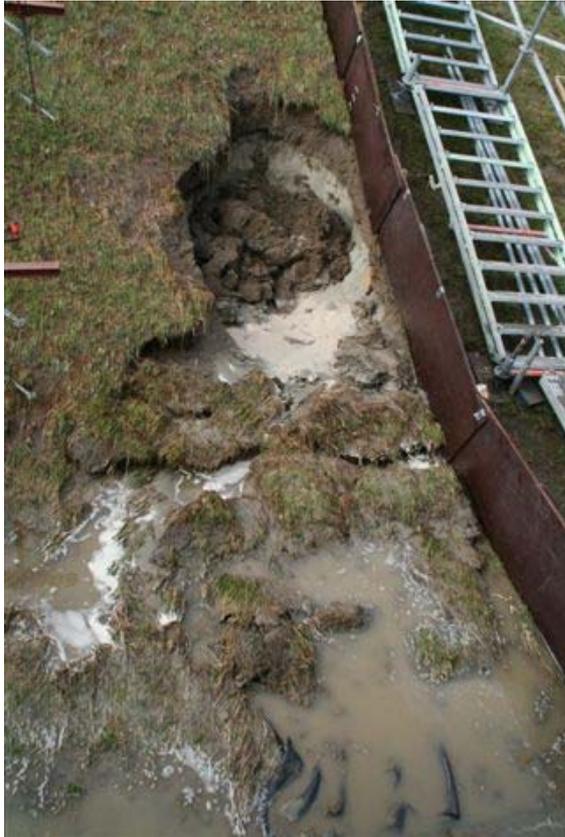
Figure 13. Final result St Philipsland, Zeeland.

After the final 50 l/s per m test. Slope 1:2.3, bad grass coverage. Damage at the horizontal part (the toe) was created (the lower part of the picture). During this test a hole in the slope was developed, which eventually reached the sand core. The transition from clay layer to sand core is clearly visible at the hole in the inner slope and a deep hole in the sand core was the final result. Finally, the remaining part between the hole at the inner slope and the hole at the toe slid down due to a large overtopping wave.

This leads to the conclusion that a good grass cover on a sandy clay and a worse grass cover on good clay show different failure mechanisms, but they show more or less similar strength against wave overtopping. The variability of the grass sod may, therefore, have less influence on the total strength than previously anticipated. This could lead to the conclusion that the way of maintenance of the grass has only minor effect on the strength of the inner slope. The test at St Philipsland may show that the bad grass *coverage* (small open areas without grass) on sandy clay may show less resistance (Figure 13).

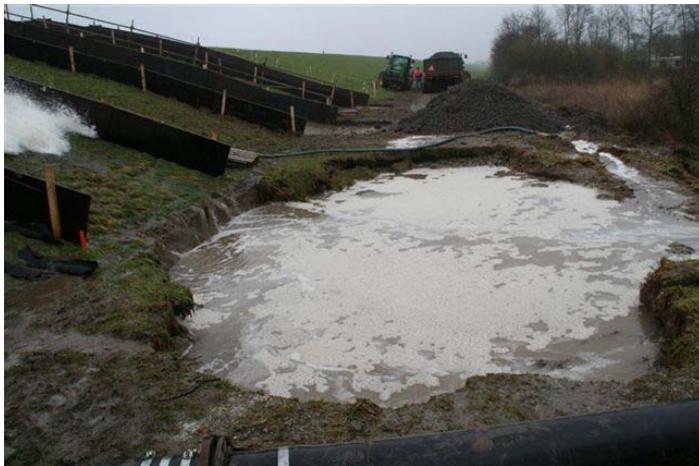
Figure 14. Kattendijke, Zeeland, section 1.

Damage to the rear side at the maintenance road, which started at 30 l/s per m. Removal of the whole maintenance road. Picture taken half way the 75 l/s per m test. The hole became at the end 15 m wide and about 1 m deep.

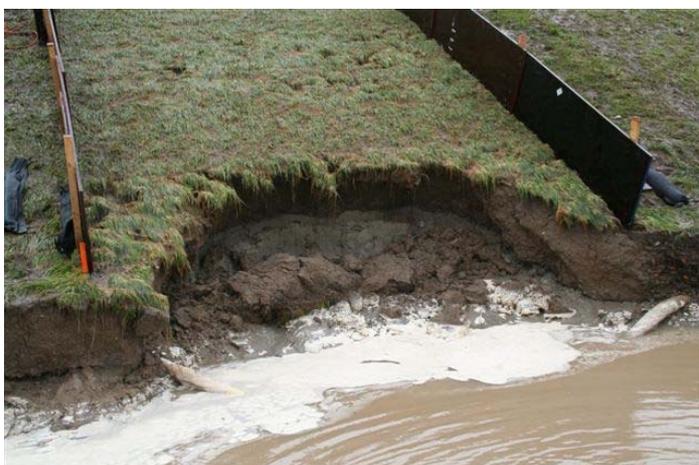
Figure 15. Final result Kattendijke, Zeeland, section 1.

The test with 75 l/s per m was stopped after 5 hours and 40 minutes as the hole in the maintenance road reached the start of the inner slope and increased upwards (head cut erosion). The sand core was clearly reached and the erosion at this stage was very fast (about 1 m in 10 minutes). The inner slope itself did not show any significant damage.

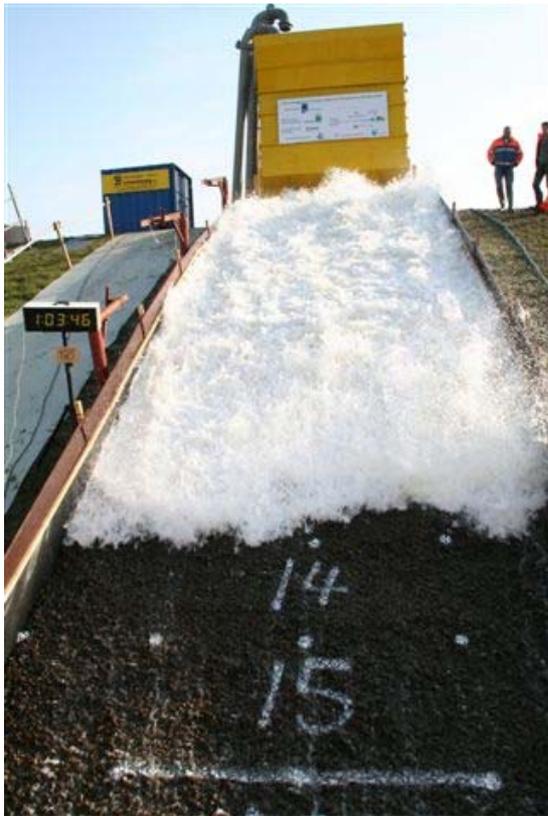
Figure 16. Kattendijke, Zeeland. Final test on elastocoast, section 3.

With two extra pumps a mean discharge of 125 l/s per m was realized. Both the elastocoast as well as the open asphalt concrete (section 4) did not show any damage.

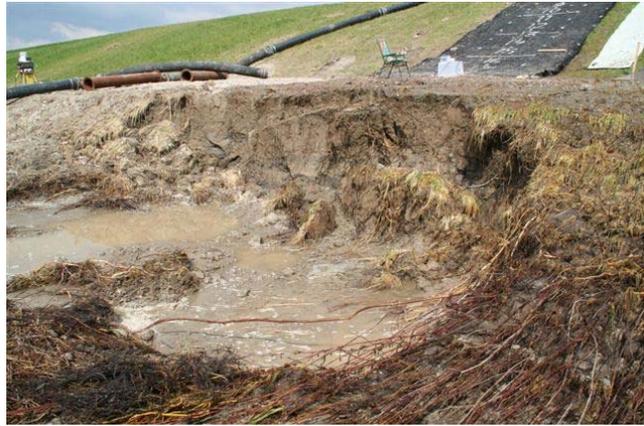
Figure 17. Final result Kattendijke, Zeeland; open asphalt concrete, section 4.

After 125 l/s per m. A large erosion hole was created beyond the maintenance road, about 1.5 m deep. The maintenance road itself was protected by plates and could not be eroded.

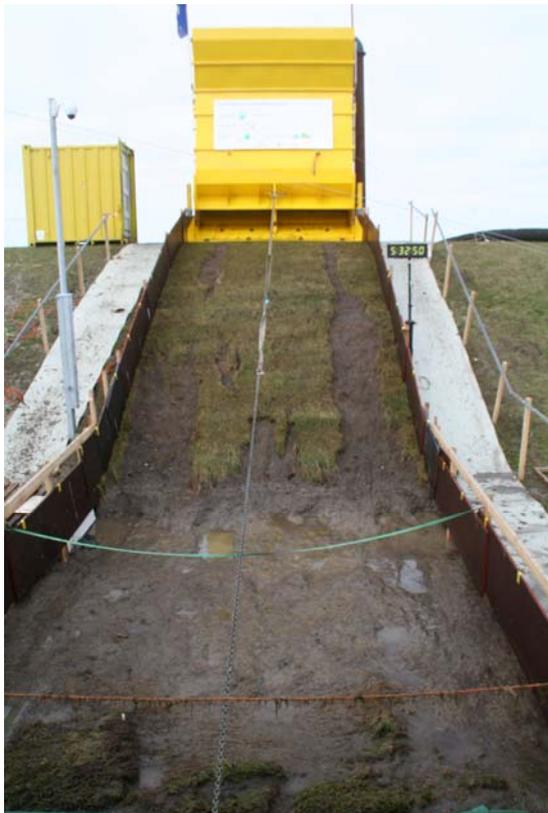
Figure 18. Afsluitdijk. Grass toe, section 1.

Grass ripped off on many locations on the slope and completely at the horizontal part, where a section of 4x4 m<sup>2</sup> was created without grass. The good clay (still with roots) showed hardly any erosion and resisted without problems 75 l/s per m. Erosion holes near toe about 0.4 m deep.

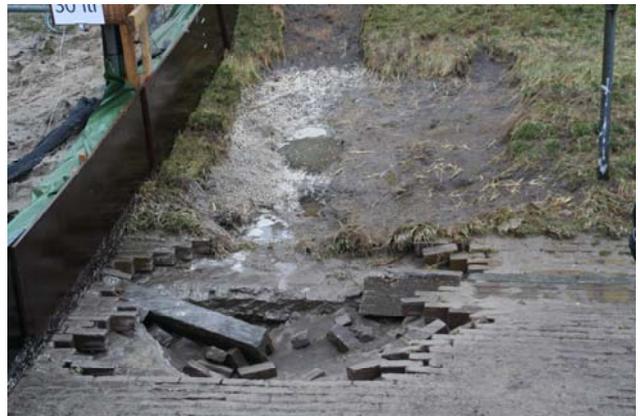
Figure 19. Afsluitdijk. Parking area, section 2.

Some ripping off of grass near the toe. Damage to the bricks and fast development of damage as they were placed on sand. This was the reason to stop the test already after 30 l/s per m.

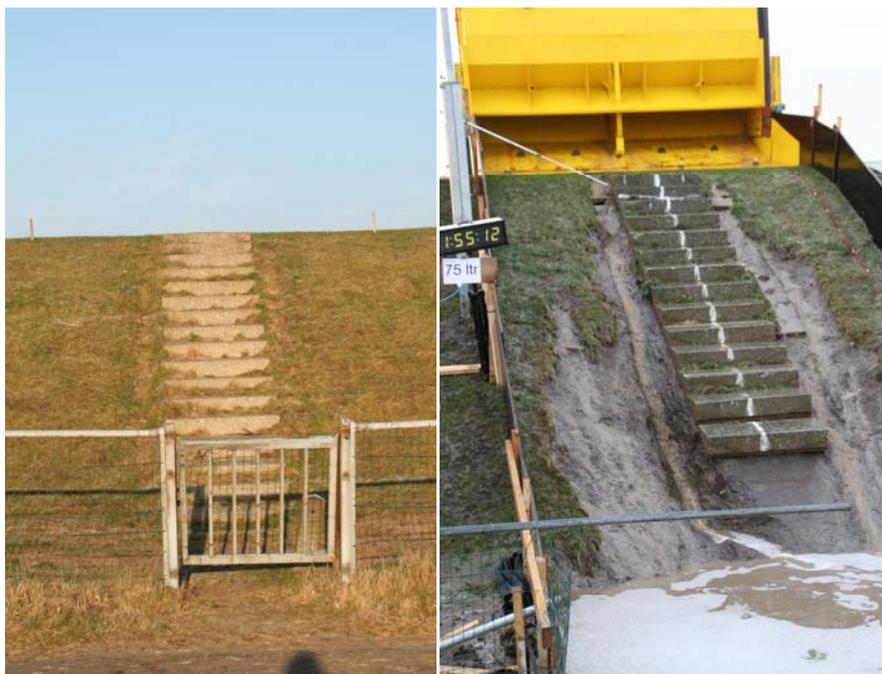
Figure 20. Afsluitdijk. Staircase with fence, before and after testing, section 3.

Left: before testing and right: after 2 hours of 75 l/s per m. The concrete staircase is near failure. Grass ripped off the slope, but gully development occurred only along the staircase where concentration of flow was observed. Hardly damage to the clay layer.

Small obstacles like poles did not show any erosion. Small holes from mice and moles did not initiate damage to the grass cover layer. Also a fence (Figure 20) and a little bigger pole (0.15 m by 0.15 m) showed no initiation of erosion. The grass around a fence at the toe of the dike had some influence on initiation of erosion, probably due to larger forces in this area. An obstacle like a concrete staircase on the inner slope was totally destroyed at a stage with 75 l/s per m overtopping (Figures 20 and 21). It should be noted, however, that also here the dike itself was not in danger, due to the large erosion resistance of the clay. Still, further research may give more final conclusions on other large obstacles.

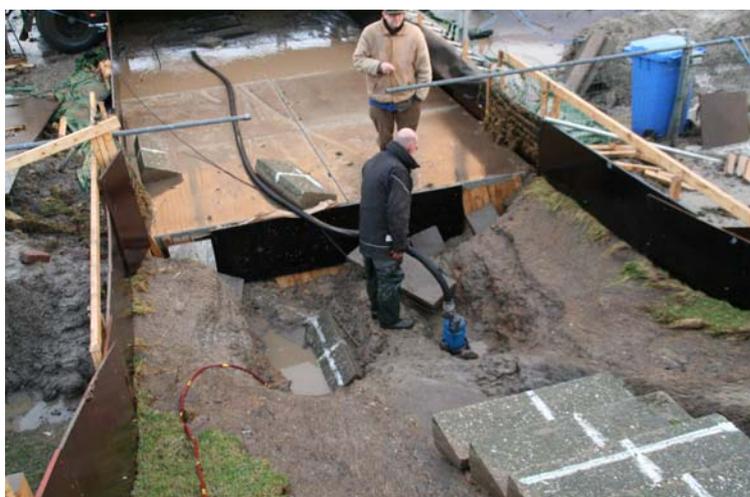
Figure 21. Afsluitdijk. Concrete staircase, section 3.

The brick path to the staircase was completely destroyed, as well as the fence gate. Two erosion holes developed at the toe, due to the concentrated flow along the staircase. Holes about 1 m deep, but not reaching the sand core (cover by 0.4 m clay and 1 m boulder clay). Situation after 2 hours of 75 l/s per m.

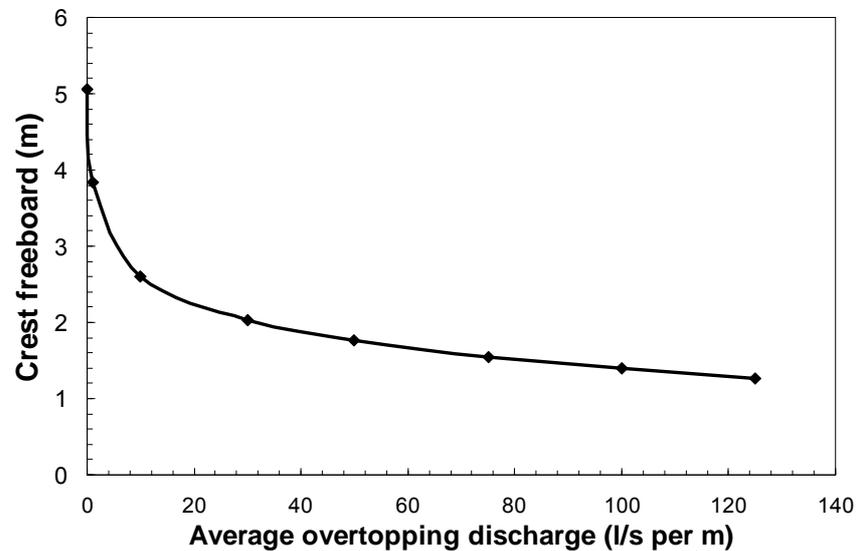
Figure 22. Relationship between overtopping discharge and required crest freeboard ( $H_s=2$  m;  $s_{op}=0.04$  and  $\cot\alpha=4$ ).

The answer is of course dependent on the actual situation, like wave conditions considered and geometry of the dike. Assuming similar situations as assumed for the wave overtopping tests (significant wave height of 2 m, wave steepness of 0.04 and an outer slope of 1:4) the result is given in Figure 22.

A tolerable overtopping discharge of 1 l/s per m leads to a required crest height of 3.84 m. If this discharge is increased to 10 l/s per m, the required crest height reduces by 1.23 m, which is about 30% reduction! If we want another 30% or 1.23 m reduction (a required crest height close to 1.4 m) means that the tolerable overtopping discharge becomes 100 l/s per m. That would be totally unacceptable for a grass slope. Due to the shape of the curve the effect is largest if small allowable overtopping discharges are increased. The effect is relatively smaller for increasing even more.
