WAVE OVERTOPPING RESISTANCE OF GRASSED DIKE SLOPES IN VIETNAM

Le Hai Trung¹, Jentsje van der Meer², Nguyen Quang Luong³, Henk Jan Verhagen¹ and Gerrit Jan Schiereck¹

The resistance of various grassed slopes against wave overtopping has been appraised by means of the Wave Overtopping Simulator in situ for a couple of years in Viet Nam. Destructive test results show that a dike slope covered with grass could suffer a certain overtopping discharge not smaller than 20 l/s per m. During testing it was difficult to predict when a slope starts to be damaged, however, damages tend to follow a more or less similar process of development. The concept of “erosional indices” and the method of “cumulative overload” (van der Meer et al., 2010) are applied to the simulator tests in Viet Nam. Critical velocities were then estimated for different kind of grassed slopes.

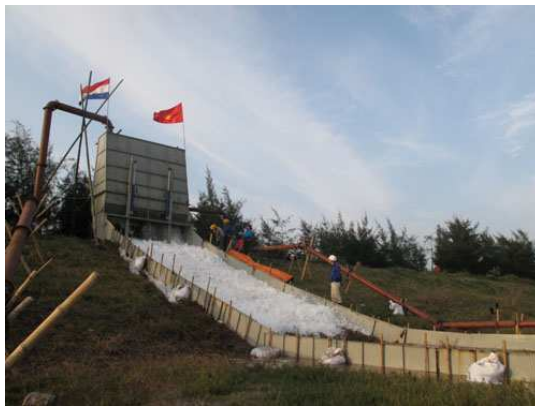
or disassembled and moved from place to place in a short time. When working, the simulator is continuously filled with a certain and constant discharge of water and emptied at predefined moments through bottom valves in a way that the volumes simulate the overtopping wave tongues on the dike crest and then on the landward slope. The maximum capacity is $5.5 \text{ m}^3/\text{m}$ giving a total volume of 22 m^3 for a 4 m wide simulator. With this size a mean wave overtopping discharge of up to 100 l/s per m can be generated. Figure 1 gives an impression of the Simulator releasing an overtopping wave on the grass slope in situ.

Figure 1. Wave overtopping simulator.

The Wave Overtopping Simulator was first developed in the Netherlands in order to test real grassed dike slopes in situ, Van der Meer et al., (2006, 2007, 2008 and 2009). With the experience of testing for a couple of years, the original design was adjusted to make the second Simulator, a Vietnamese version. The machine is a water reservoir which can be easily either assembled

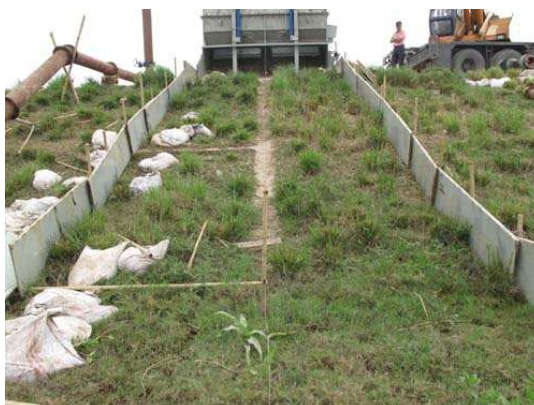
Figure 2. Test point TT_03, mixture of Bermuda and Vetiver grass.

Since 2009, destructive tests have been performed on three sea dikes in the North of Viet Nam. Vetiver grass (*Vetiveria Zizanioides*) and Bermuda grass (*Cynodon Dactylon*) are the most common species on the dike slopes. In Hai Hau - Nam Dinh, the dike slope was covered with mainly Bermuda grass and sometimes Casuarina trees could be found as well. Three slope sections were tested and denoted as TL_01, TL_02 and TL_03. In Thai Thuy – Thai Binh, within a dike stretch of 50 m, a combination of Bermuda grass and Vetiver grass within concrete frames was tested at three locations: TT_01, TT_02 and TT_03 (Figure 2), respectively.

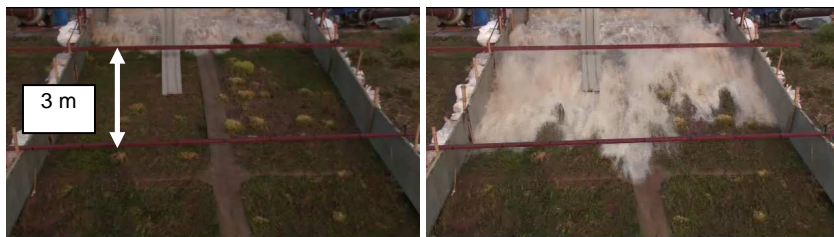
To analyse the front velocity movies of water flowing on the dike slope were watched at a low speed or in sequence of frames. It can be seen in Figure 3 that the front part of a 500 l/m flow traveled over a distance of 3 m within 0.8 seconds giving a front velocity of $3/0.8 = 3.75$ m/s.

Figure 3. Movement of the front of a wave over 3 m within 0.8 s, giving a front velocity of 3.75 m/s.

Flows released from the Simulator are discontinuous and moreover very turbulent with high density of air bubbles. Conventional instruments used in the laboratory are not designed to measure characteristics of this kind of flow. A digital camera was applied to capture the front velocity on the dike slope. Based on the differences in positions of the front part of the overtopping flow over a certain distance, and with the time delay between successive images, front velocities can be derived. Van der Meer et al. (2010) found that front velocities represent well the velocity at the top of the flow as well as the depth-averaged velocity in the layer. Measurements were implemented at two positions between $x=(2 \sim 5)$ m and $x=(5 \sim 8)$ m with x is the distance on the slope from the dike crest.

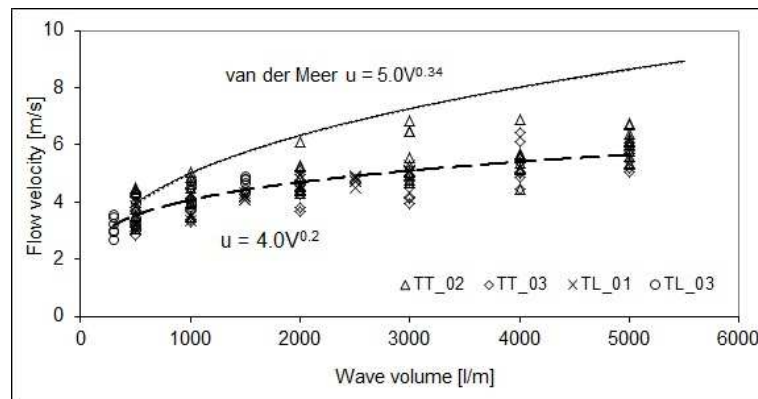
Figure 4 graphically demonstrates the front velocity, u , versus the overtopping wave volume, V , obtained from hydraulic measurements at four test locations in Nam Dinh and Thai Binh. In general, increasing volumes generate higher flow velocities on the dike slope and a relation between the front velocity and the overtopping wave volume and can be given by:

$$u = 4.0V^{0.2} \quad (u \text{ in m/s and } V \text{ in m}^3/\text{m}) \quad (1)$$

Figure 4. Front velocity on the slope as function of overtopping wave volumes.

This relation is slightly different from what was found by Van der Meer et al. (2010), where the coefficient was 5.0 and the power was 0.34 as follow:

$$u = 5.0V^{0.34} \quad (2)$$

This difference can be due to the difference in geometric specification of the dike cross sections in the Netherlands and Viet Nam. Equation (1) is used in all further calculation in this paper.

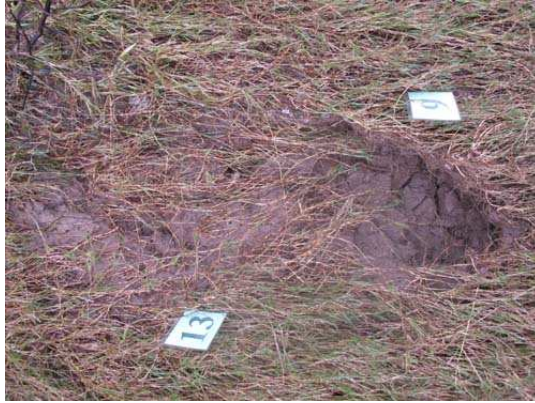
Figure 5. First damage on a Bermuda grass slope, section TL_03.

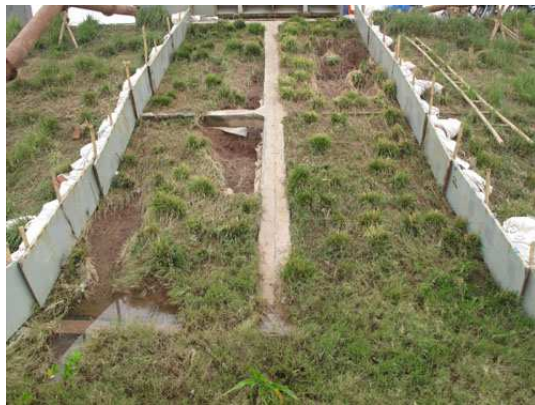
Figure 6. Various damages on a mixed grass slope, section TT_03.

The Thai Thuy – Thai Binh dike is constructed with good clay, the dike crest level is at +5 m above MSL and 6.0 m wide, paved with concrete of 20 cm thick. The grassed slope is 9 m long from crest to toe and the inclination is 1:3. Bermuda grass was about 4 to 5 years old while Vetiver grass was planted in May, beginning of the rainy season and about 6 months before testing. It is recommended to grow Vetiver from young plants and the time of planting should be scheduled during the rainy season (Robert). Three slope sections were selected with different quality of grass cover and different configurations of the concrete frame. At section TT_01, the first damage happened after 4 hours tests with 20; 40 and 80 l/s per m. The slope failed after that 4 hours of 100 l/s per m. Section TT_02 showed a similar resistance when the first damage occurred after 4 hours tests with 20; 40 and 80 l/s per m. A discharge of 120 l/s per m was then applied resulting in the slope failure after 1 hour of testing. The third section TT_03 showed earlier damage after 4 hours tests with 20 and 40 l/s per m and 2 hours of 80 l/s per m. After 2 more hours of 80 l/s per m, various damages could be observed on the slope, as can be seen in Figure 6. The third section failed after 2 extra hours testing with 100 l/s per m.

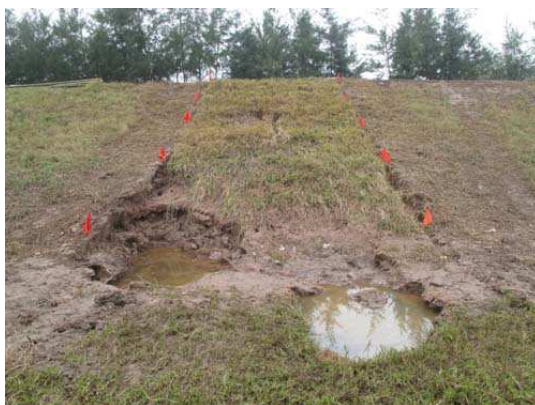
Figure 7. Failure of a Bermuda grass slope, section TL_01.

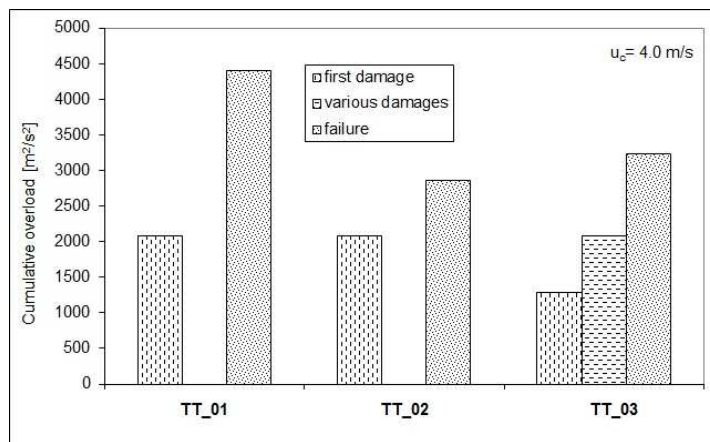
Figure 8. Comparison of cumulative overloads for various damage criteria, mixture of Bermuda and Vetiver grass slope, $u_c = 4.0$ m/s, flow velocity $u = 4.0V^{0.2}$.

The first damage criterion is not a consistent parameter as it may depend on whether a weak spot does exist on the slope surface under investigation. The second criterion “various damaged locations” was only observed at test location TT_03. Therefore, the third criterion “Failure” with cumulative overload value of 3500 $[\text{m}^2/\text{s}^2]$ was used to compute the critical velocity at three test locations in Thai Binh. A critical velocity of 4.0 m/s, which was derived from a process of trial and error, that gives a correct value of 3500 $[\text{m}^2/\text{s}^2]$ for Failure criterion at TT_01, TT_02 and TT_03, respectively. The overtopping wave volume that in accordance with this velocity is 1.01 m^3/m . When critical velocity of 4.0 m/s is applied, the first and second damage criteria get the following values:

First damage: $\sum (u^2 - u_c^2) = 1812 [\text{m}^2/\text{s}^2]$ wrt 500 $[\text{m}^2/\text{s}^2]$ in Vechtdijk

Various damages: $\sum (u^2 - u_c^2) = 2076 [\text{m}^2/\text{s}^2]$ wrt 1000 $[\text{m}^2/\text{s}^2]$ in Vechtdijk

The large discrepancy between results in Thai Binh and Vechtdijk of the First damage and Various damaged locations criteria can be explained by the sandy body of Vechtdijk dike while in Thai Thuy – Thai Binh the dike was constructed with good clay and covered with a mixture of 4-year-old Bermuda grass and 6-month-old Vetiver.

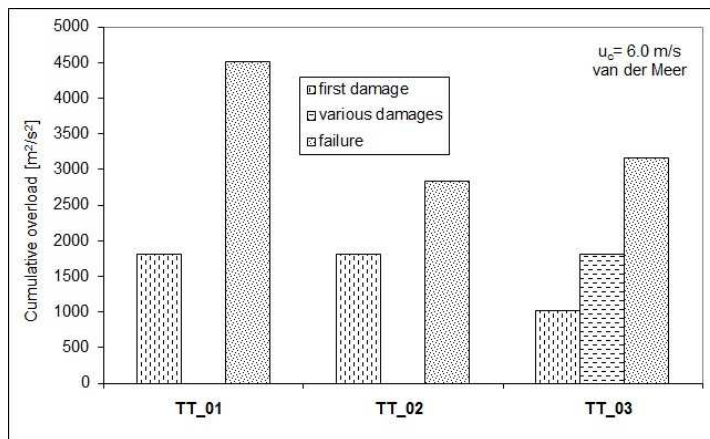
Figure 9. Comparison of cumulative overloads for various damage criteria, mixture of Bermuda and Vetiver grass slope, $u_c = 6.0$ m/s, flow velocity $u = 5.0V^{0.34}$.

Another calculation was also made by using Equation (2) derived from hydraulic measurement of Van der Meer et al. (2010). To satisfy the condition of Failure criterion, a much higher critical velocity of 6.0 m/s was found. As a result, the first and the second criteria get smaller values, which are alternatively 1539 [m²/s²] and 1802 [m²/s²], compared to those obtained by using Equation (1), see Figure 8 and Figure 9. It can be seen that different way of transforming flow velocity may considerably influence the critical velocity of a grass slope. In the following part, verification of the cumulative overload method is made with the test results achieved in Hai Hau – Nam Dinh.

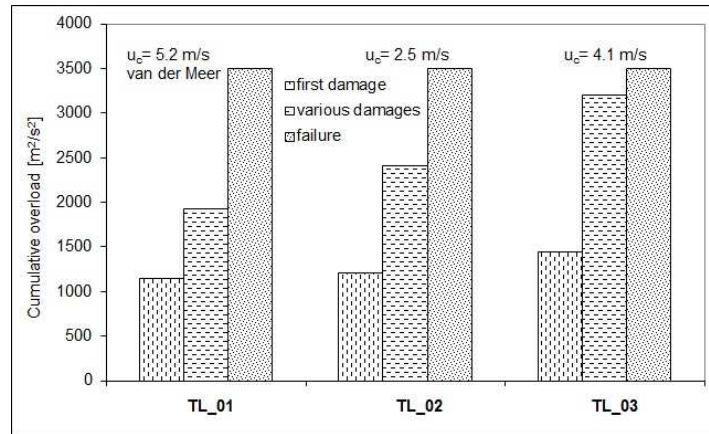
Figure 11. Comparison of cumulative overloads for various damage criteria, Bermuda grass slopes, flow velocity $u = 5.0V^{0.34}$.

A sensitivity analysis was made by applying the relation between flow velocity and overtopping wave volume Equation (2) in calculating the critical velocity. Much larger values were achieved to fulfil the Failure criterion, 5.2 m/s for TL_01, 2.5 m/s for TL_02 and 4.1 m/s for TL_03, with regard to 3.7 m/s, 2.1 m/s and 3.1 m/s when using Equation (1). Values of cumulative overloads computed for two velocity equations are depicted in Figures 10 and 11, respectively. With the exception of the First damage criterion, which is a

constant verification parameter, the cumulative overloads of the first and the second damage criteria are smaller when the velocity equation of van der Meer is used.
