Wave Overtopping Simulator Tests on Sea Dikes in Viet Nam

Hai Trung Le, Jentsje van der Meer and Henk Jan Verhagen

Abstract

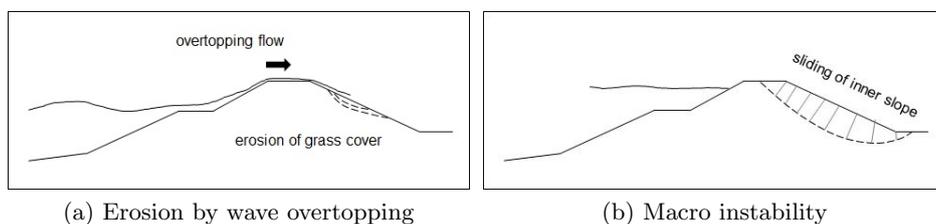
Figure 1: Failure mechanisms of landward slopes.

Wave overtopping may damage the crest and the landward slope of a sea dike covered with grass. In principle, two different mechanisms can be distinguished (see Figure 1). The first one is fast overtopping flow, which can damage the grass cover on the crest and the landward slope. If initial dam-

age or erosion occurs, it can extend to the material layers underneath and may possibly lead to dike breaching. The second mechanism mainly occurs on steep slopes (especially between 1:1.5 and 1:2.0) due to water infiltration and sliding. This sliding may directly cause dike collapse. However, it is not likely to be due to wave overtopping as such, but rather due to large quantities of water infiltrating the dike body. This process may be aggravated by heavy rainfall. It is also possible for such failures to take place on slopes which are gentler than 1:3.

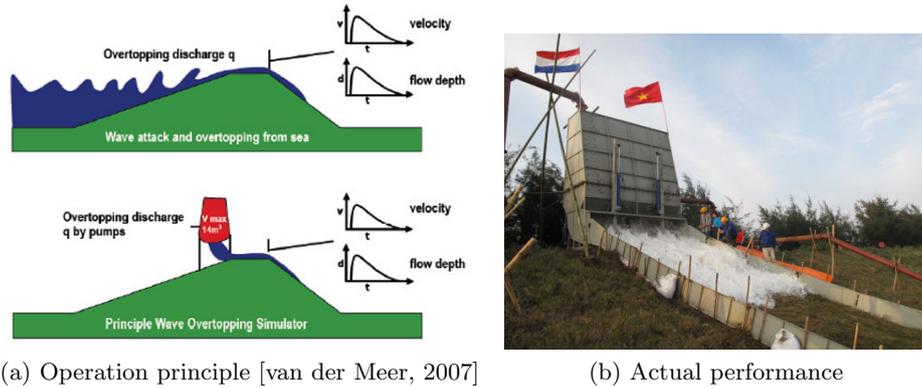
Figure 2: Wave Overtopping Simulator.

The Simulator is a water reservoir which is easy to transport from one place to another and quickly assembled or dismantled. When working, the simulator is continuously filled with a certain and constant discharge of water and is emptied at predefined moments through two butterfly valves at the bottom. The released water volumes simulate (generate) the overtopping wave tongues on the dike crest and then on the landward slope. The underlying principle is that it is not necessary to simulate the entire overtopping wave but only the water tongue on the dike crest and then the landward slope. Figure 2 illustrates the principle of the simulator and shows how it releases water on a grass slope. As long as the velocity and the depth of the

The Vietnamese simulator is 4 m wide (along the dike stretch), 2 m thick and 5.5 m high giving a maximum unit volume of 5.5 m^3 per m of width and a total volume of 22 m^3 . With this dimension a mean wave overtopping discharge of 100 l/s per m can be simulated. The machine is divided into two parts for convenience of transporting. The open width of the butterfly valve is 0.8 m giving better simulation of the water overtopping on the dike crest. The hydraulic pump opening and closing the valves is attached to the machine body. The vertical position of the simulator can be adjusted by six hydraulic legs. Two pumps with a respectively capacity of 22 and 55 kW respectively were used to fill the Simulator. Last but not least, a 250 kVA generator supplied power to all devices and equipments deployed during the tests.

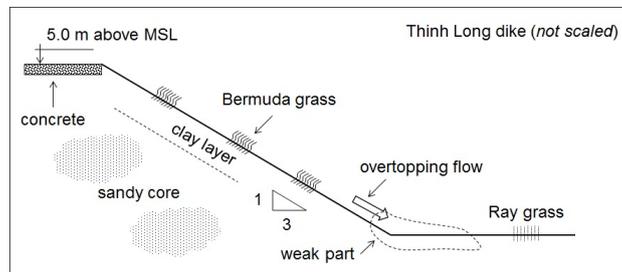
Figure 3: Cross-section of the Think Long sea dike.

The first was in Nam Dinh province, where Think Long dike was constructed of a sand core and an outer layer of clay. The dike crest level is at +5 m above Mean Sea Level (MSL) and 4.5 m wide, paved with 20 cm thick concrete. The dike toe was about 10 m long and was covered with Ray grass (*Panicum Repens*). The 1:3-inclination slope was 10 m long, and was covered with mainly Bermuda grass (*Cynodon Dactylon*), sometimes in combination with Casuarina trees. Three sections were selected to reflect different slope characteristics and quality: TL1 was a regular slope covered with good grass, TL2 had a big Casuarina tree in the middle, and TL3 had been eroded at several points before testing. Water was pumped from a brackish water canal parallel to the dike toe. The Think Long dike cross-section is graphically illustrated in Figure 3.

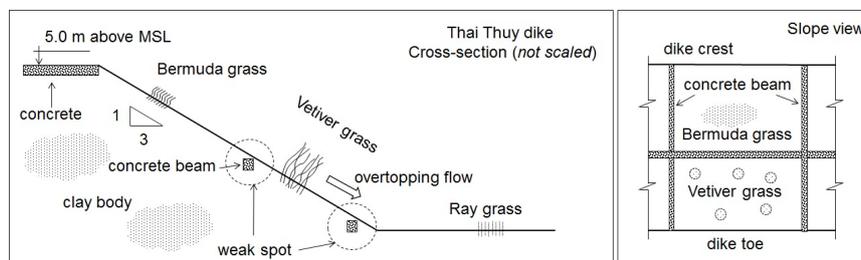
Figure 4: Schematization of Thai Tho sea dike.

The second site was on a estuary dike in Thai Tho commune, Thai Thuy district, Thai Binh province. A combination of Bermuda grass and Vetiver grass (*Vetiver Zizanioides*) on the riverside slope was tested at three positions: TT1, TT2 and TT3. The dike body was constructed of good clay, the 1:3 slope was reinforced with concrete frames from crest to toe. These sections were chosen to have different concrete beam configurations and grass quality. The horizontal berm was regularly covered with a dense sward of Ray grass. Water was pumped from Tra Ly river. A schematization of Thai

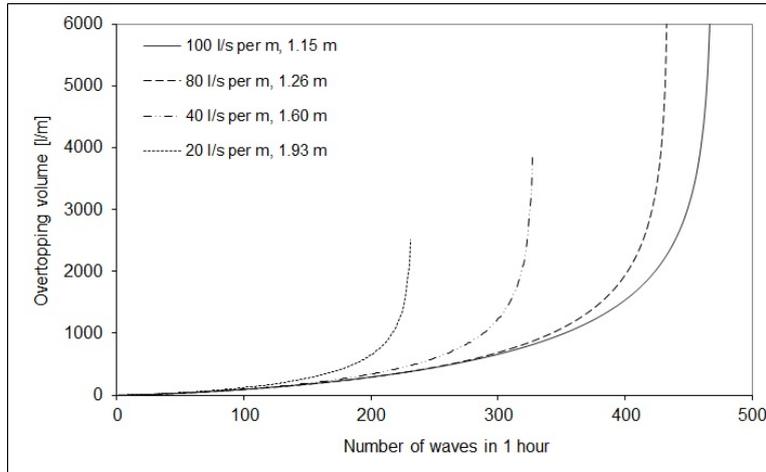
Figure 5: Distributions of overtopping volumes with different values of mean discharge.

Each simulated storm is a distribution of overtopping volumes which is computed with the above wave condition and a given discharge. The procedure and formulae of the computation is given in EurOtop [2007]. In Figure 5, the vertical axis gives the overtopping volume, V , while the horizontal axis gives the number of waves, N_w , in ascending order. In reality, wave overtopping is a random process and for that reason, the volume order depicted in Figure 5 is randomized to control the simulator.

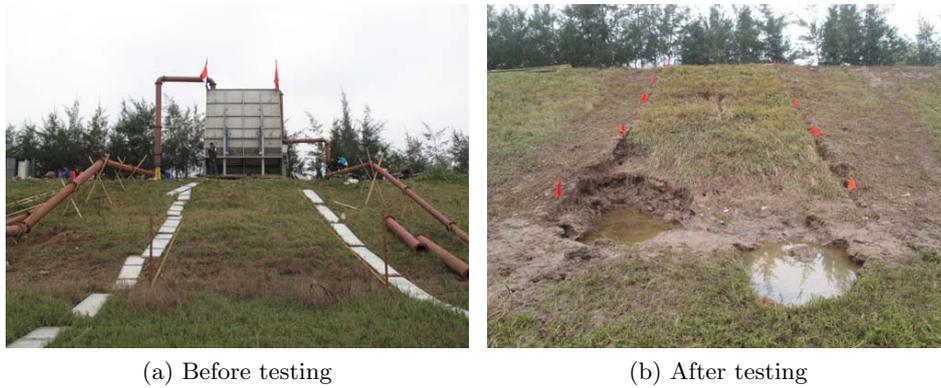
Figure 6: Grass cover at Think Long TL1 section, maximum applied discharge $q_{max} = 70$ l/s per m.

At the section TL1, the slope started to be eroded after three 4 hour discharges of 10, 20 and then 40 l/s per m. After that, 1 hour of 70 l/s per m was applied and damage was clearly recognised at various points on the steep part and at the toe. Testing two more hours with 70 l/s per m seriously damaged the grass cover, and the test was stopped. Figure 6 compares the condition of grass cover before and after testing at the TL1 section. Figure 7 shows how the slope profile changed under the impact of overtopping flow. The profile was measured parallel to the left side wall (facing the simulator gate) with a distance of $a = 2.5$ m. The vertical axis gives the distance from the Sea Water Level (SWL) in centimetres and the horizontal axis gives the distance from the crest edge where the grass cover starts in metres.

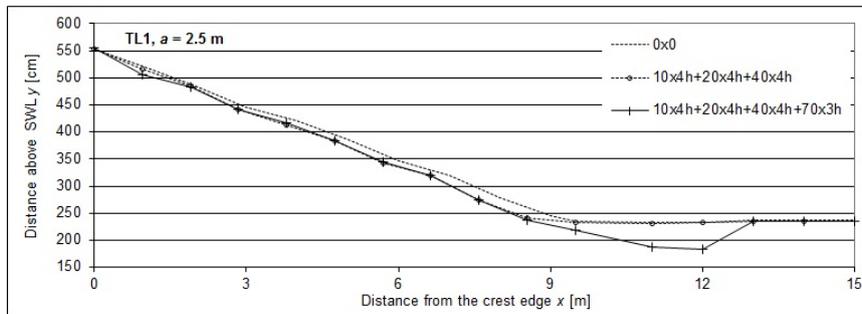
Figure 7: Changes of the slope profile induced by overtopping flow, distance from the left side wall $a = 2.5$ m, section Think Long TL1. 0x0 is the initial profile; 10x4h+20x4h+40x4h is the profile measured after 4 hours of 10, 20 and 40 l/s per m each.

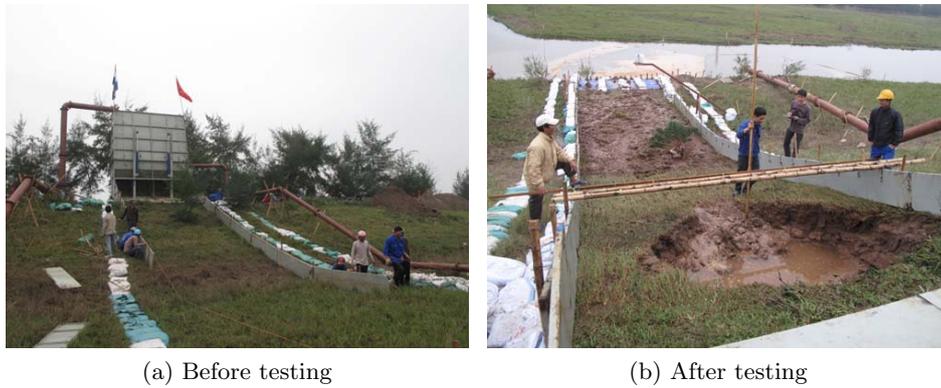
Figure 8: Grass cover at Think Long TL2 section, maximum applied discharge $q_{max} = 20$ l/s per m.

with 10 l/s per m, the first damage extended from an existing hole towards the tree. After 2 more hours of 10 l/s per m and 30 minutes of 20 l/s per m, the tree was swept away, thus resulting in a large hole with a length of 3 m along the slope and a depth of about 1 m, as can be seen in Figure 8. The change of the slope profile in time measured 2.0 m away from the left side wall is depicted in Figure 9.

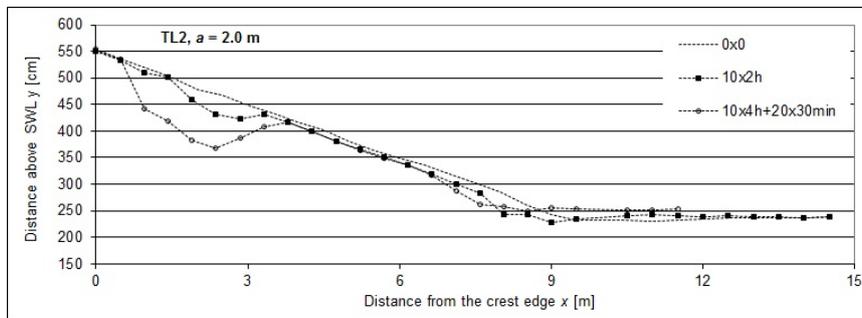
Figure 9: Changes of the slope profile induced by overtopping flow, distance to the left side wall $a = 2.0$ m, section Think Long TL2. 0x0 is the initial profile; 10x4h+20x30min is the profile measured after 4 hours of 10 l/s per m and 30 minutes of 20 l/s per m.

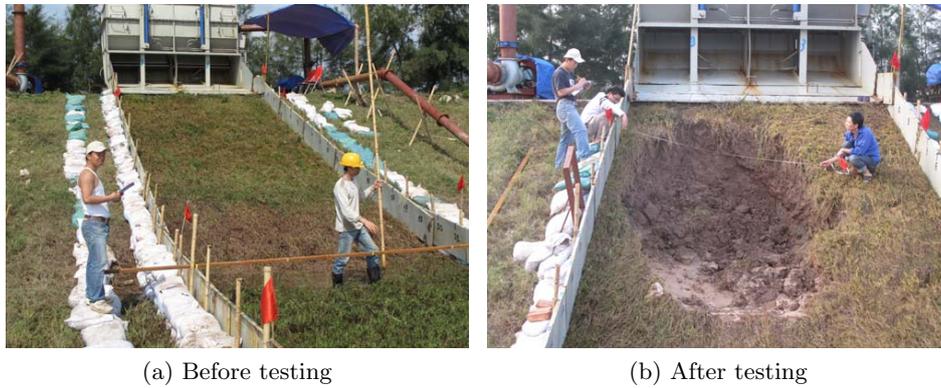
Figure 10: Grass cover at Thin Long TL3 section, maximum applied discharge $q_{max} = 40$ l/s per m.

slope stability. The initial and final condition of the grass cover are shown in Figure 10, and the development in time of the profile at $a = 1.5$ m is given in Figure 11.

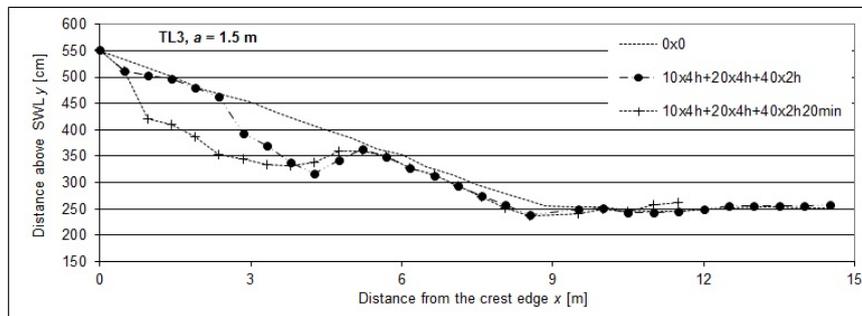
Figure 11: Changes of the slope profile induced by overtopping flow, distance to the left side wall $a = 1.5$ m, section Thin Long TL3. 0x0 is the initial profile; 10x4h+20x4h+40x2h20min is the profile measured after 4 hours of 10 and 20 l/s per m each, and 2 hours and 30 minutes of 40 l/s per m.

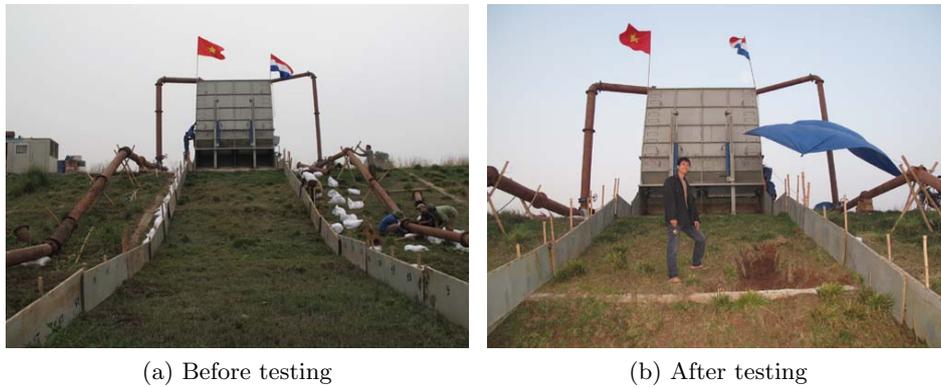
Figure 12: Grass cover at Thai Tho TT1 section, maximum applied discharge $q_{max} = 100$ l/s per m.

At section Thai Tho TT1, Bermuda grass was dominant while Vetiver clumps were scattered. The first damage took place above the horizontal concrete beam after three 4 hour tests of 20, 40 and 80 l/s per m. The slope failed after that 4 hours of 100 l/s per m. The initial and final condition of the grass cover are shown in Figure 12. Figure 13 illustrates the profile development in time at a distance of $a = 3.0$ m from the left side wall.

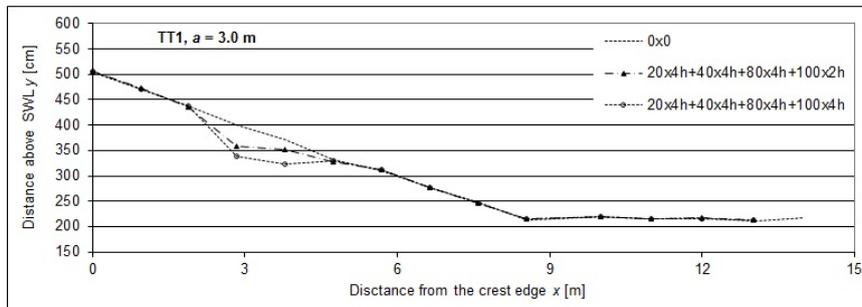
Figure 13: Changes of the slope profile induced by overtopping flow, distance to the left side wall $a = 3.0$ m, section Thai Tho TT1. 0×0 is the initial profile; $20 \times 4h + 40 \times 4h + 80 \times 4h + 100 \times 2h$ is the profile measured after 4 hours of 20, 40, 80 and 100 l/s per m each.

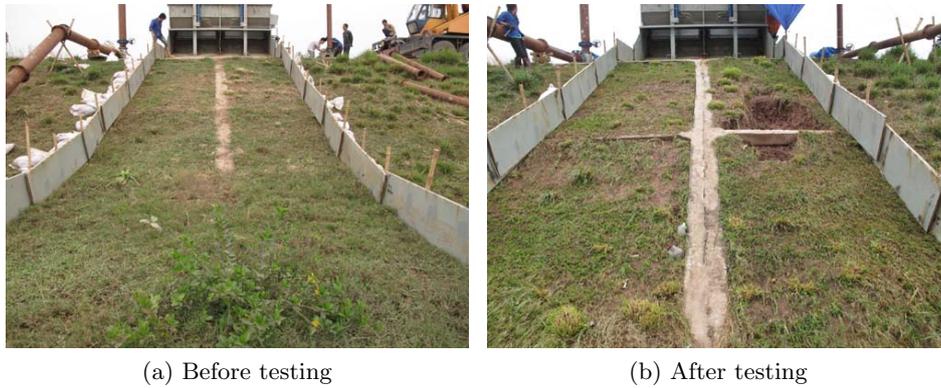
Figure 14: Grass cover at Thai Tho TT2 section, maximum applied discharge $q_{max} = 120$ l/s per m.

damaged after 4 hours of 20, 4 hours of 40 and 4 hours of 80 l/s per m. One hour of 120 l/s per m was then applied, thus resulting in the slope failure. As shown in Figure 14, there was a hole under the horizontal concrete beam after testing. Repair to this kind of erosion is technically not easy, because it is difficult to compact soil under the beam. The slope profile with the deepest hole after testing is presented in Figure 15.

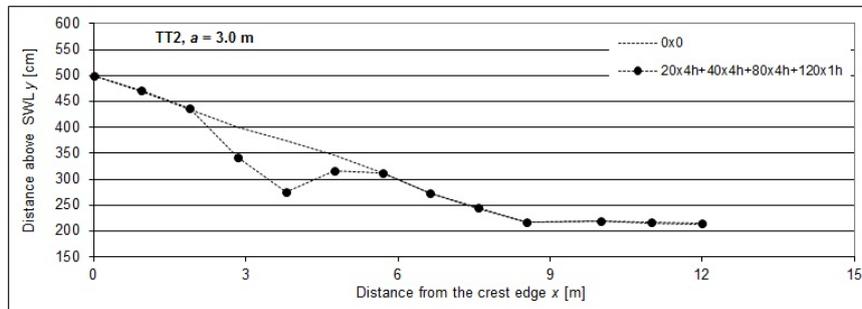
Figure 15: Changes of the slope profile induced by overtopping flow, distance to the left side wall $a = 3.0$ m, section Thai Tho TT2. 0x0 is the initial profile; 20x4h+40x4h+80x4h+120x1h is the profile measured after 4 hours of 20, 40 and 80 l/s per m each and 1 hour of 120 l/s per m.

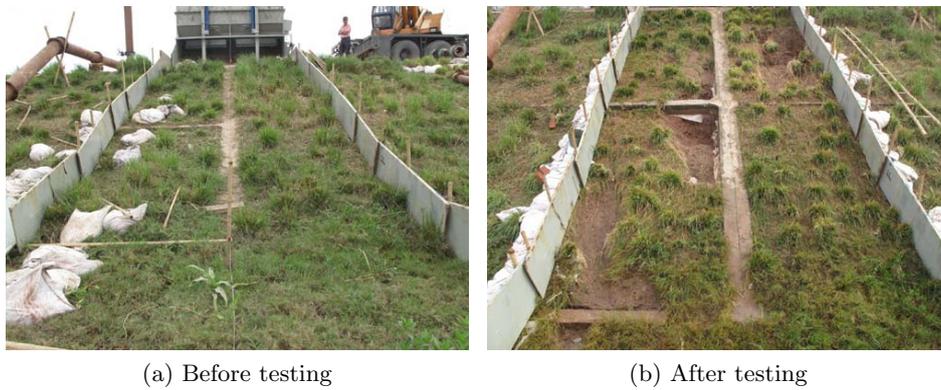
Figure 16: Grass cover at Thai Tho TT3 section, maximum applied discharge $q_{max} = 100$ l/s per m.

The third section TT3 showed first erosion after 4 hours of 20 and then 40 l/s per m, and 2 hours of 80 l/s per m. Erosion was observed at various points after 2 more hours of 80 l/s per m. The section failed after 2 more hours testing with 100 l/s per m. Damage extended in the flow direction creating a hole 3 m long by 1 m wide (see Figure 16). Figure 17 compares the slope profiles on both sides of the concrete beam.

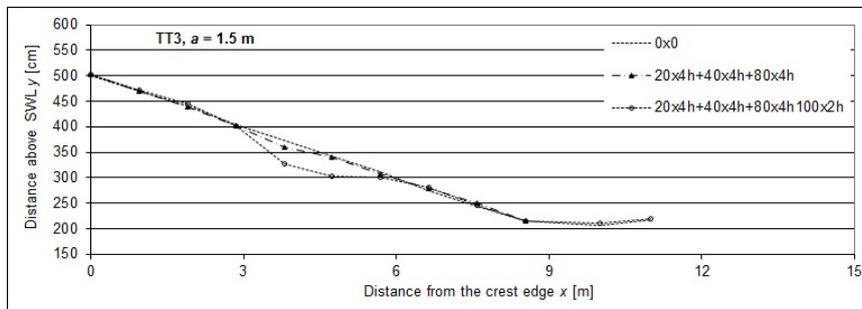
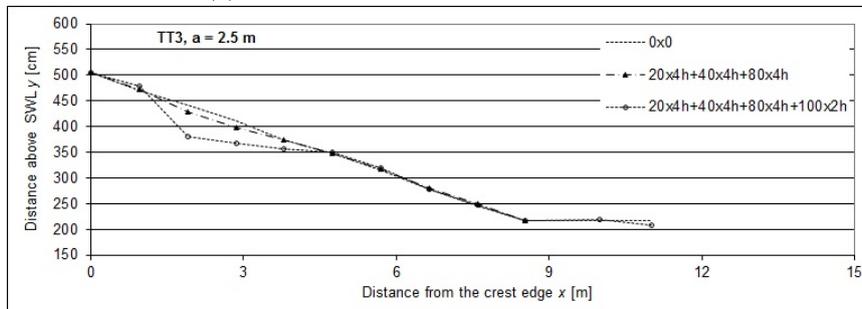
(a) Distance to the left side wall $a = 1.5$ m

(b) Distance to the left side wall $a = 2.5$ m

Figure 17: Changes of the slope profiles induced by overtopping flow, section Thai Tho TT3. 0x0 is the initial profile; 20x4h+40x4h+80x4h+100x2h is the profile measured after 4 hours of 20, 40 and 80 l/s per m each and 2 hour of 100 l/s per m.

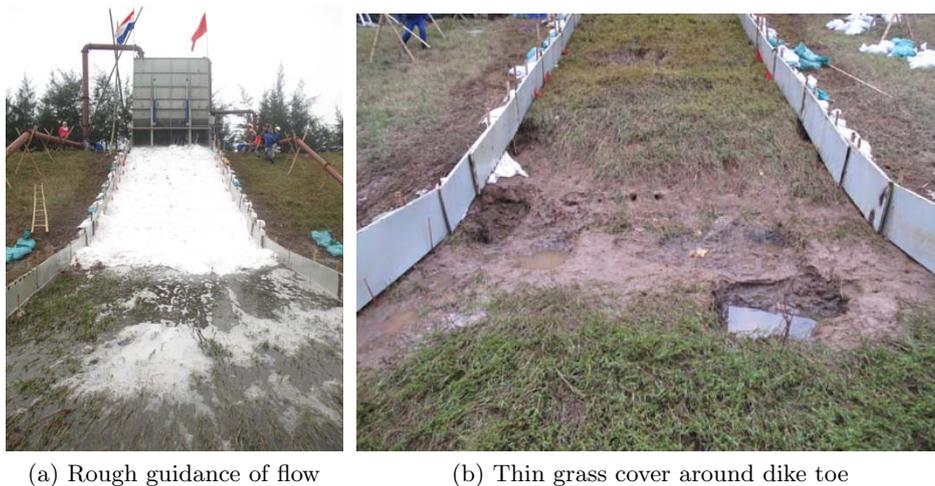
Figure 18: Damage around the transition between the steep part and the horizontal toe at TL1.

Section Thinh Long TL1 was eroded at the transition between the slope and the horizontal toe under a discharge of 40 l/s per m. At the transition area, Bermuda and Ray grass was poorer than on the higher part of the slope and the lower part of the toe (see Figure 18, right panel). Due to the thin cover of grass, soil was more directly exposed to overtopping flow, which was enhanced by the rough guidance in the flow course. Similarly, damage also took place at the sharp transitions from steep part to berm or toe in previous tests at Afsluitdijk and Vechtdijk in the Netherlands [Steendam et al., 2010].

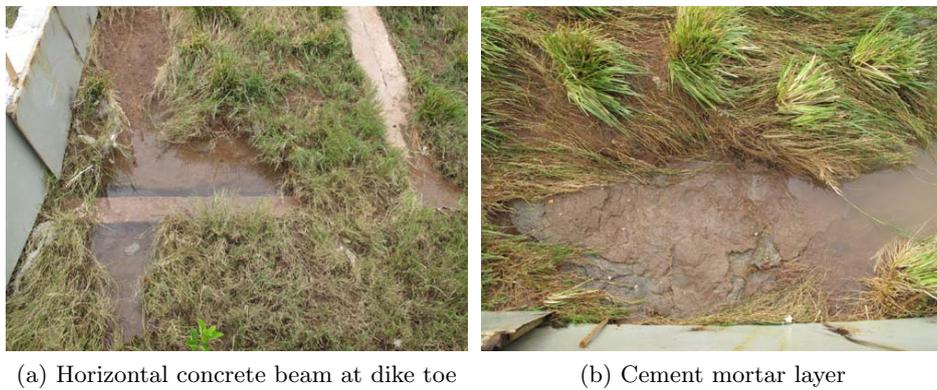
Figure 19: Damage around the transition between the steep part and the horizontal toe at TT3.

The damage at TT3 dike toe is shown in Figure 19. When the top layer of grass sod (about 10 cm thick) was eroded, a concrete beam and a thin layer of cement mortar were found preventing grass roots from penetrating deeply the dike body. As a result, there were four separate elements with weak connections the grass sod, the mortar layer, the concrete beam and the soil body. Therefore, the grass sod and the mortar layer were easily eroded to reveal the body of soil underneath. The damage at the geometrical transition was possibly facilitated by the existence of different material layers.

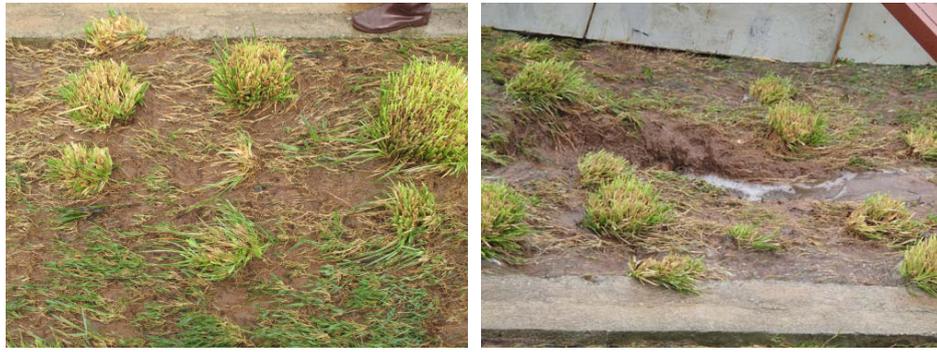
(a) Thin cover of Bermuda

(b) Erosion among Vetiver clumps

Figure 20: The grass-covered slope of Thai Tho dike.

Thai Tho dike slope was divided into separate cells by a system of concrete beams. The development of Bermuda and Vetiver grass covering these cell surfaces was not proportional. As can be seen in Figure 20, Vetiver clumps were cut off to expose a thin cover of Bermuda grass. The Vetiver grass overwhelmed the mat grass; in addition, grass was poorer and soil surface was lower (due to soil settlement) around the concrete beams than in the centre of the cells. Flow might concentrate among separate clumps due to the high shape of Vetiver, and around the concrete beams due to the uneven transition from soil to concrete. As a result, trenches were formed as depicted in Figure 20 and 16. Using different grass species and concrete frames might cause slope discontinuity, making it vulnerable to overtopping flow attack. Hewlett et al. [1987] recommended avoiding any feature that causes flow concentrations such as local gullies and low areas. However, more

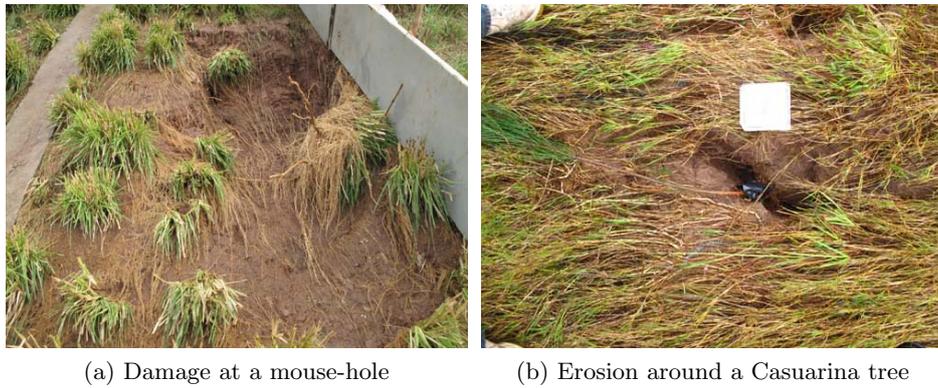
Figure 21: Damage starts at eroded holes on grass-covered slopes.

It is hardly possible to prevent grass cover from being eroded or damaged by animal activities, dike inspection, and dike maintenance. At section TT3, erosion was first recognised at a mouse-hole as shown in Figure 21. Especially, small holes had been dug and then filled again to plant *Casuarina* trees at Think Long dike. These holes were quickly eroded by an overtopping rate of 10 l/s per m (see Figure 21) and then extended by larger discharges. However, small holes made by mice or moles did not initiate erosion under discharge of up to 50 l/s per m at Sint Jacobiparochie, the Netherlands [Steendam et al., 2008]. When the discharge was increased to 75 l/s per m, an area of 0.5 m² was lifted up below these spots. Accordingly, damage easily starts or extends from potentially weak points existing on a grass-covered dike slope, which should be regularly monitored and repaired.

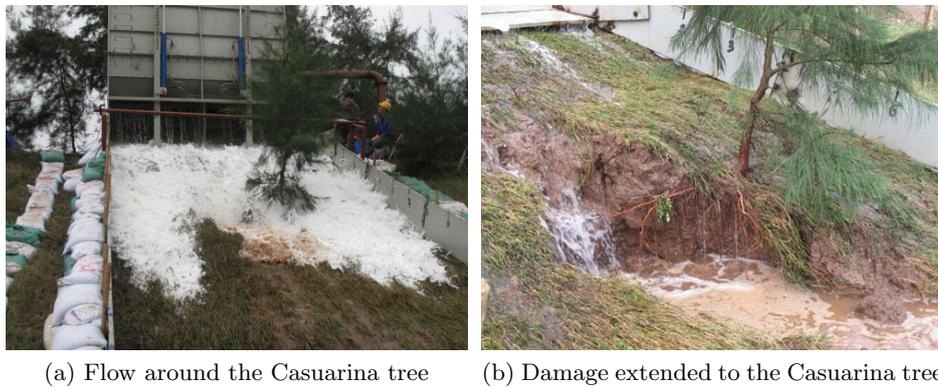
Figure 22: Flow and damage around the 7-cm-trunk Casuarina tree, Think Long TL2 section.

At section TL2, damage started from an existing hole and then extended toward the 7-cm-trunk *Casurina* tree. Overtopping flow eroded and carried away soil aggregates held by roots, gradually reducing the connection between the tree and the slope. The anchoring force became weaker and weaker, finally resulting in the tree's collapse. The amount of surrounding

soil associated with this collapse was more considerable than what could be swept away by a grass sod erosion because the larger root system of the Casuarina tree in both diameter and length. The large trunk also caused flow blockage, hence increasing force intensity. Figure 22 gives impressions of the flow and damage around the Casuarina tree at section TL2.
