Wave Overtopping Resiliency of Grass and Turf Reinforcement Mats on Sandy Soils

Summary

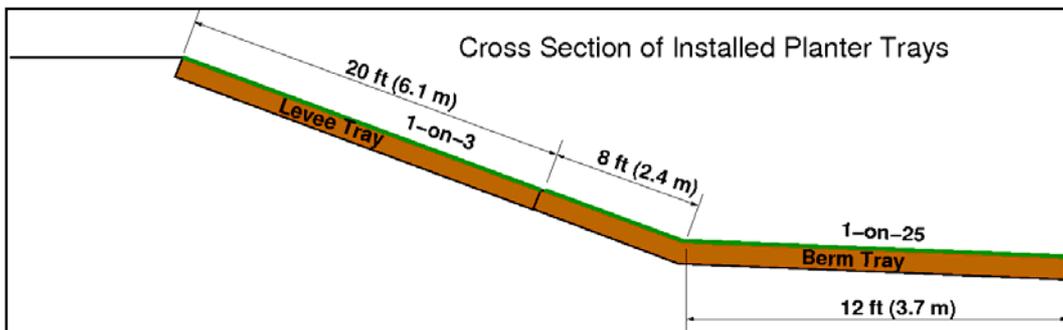
The landward dike slope geometry was reproduced using a straight levee tray and a bent berm tray having dimensions as shown in Figure 1. Pea gravel was placed in the bottom 5 cm of the 30.5-mm-deep trays, and the remaining depth was filled with compacted soil.

Figure 1. Planter tray dimensions and slope geometry.

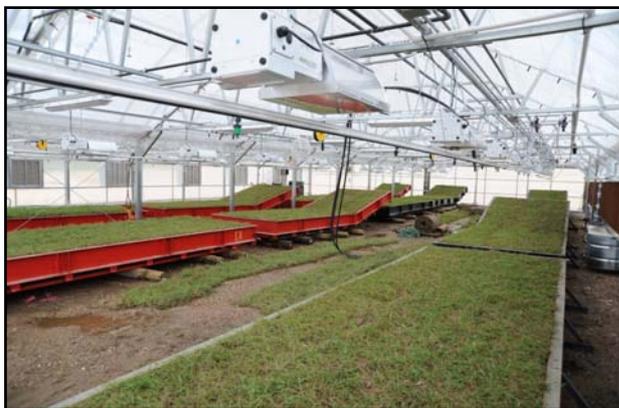
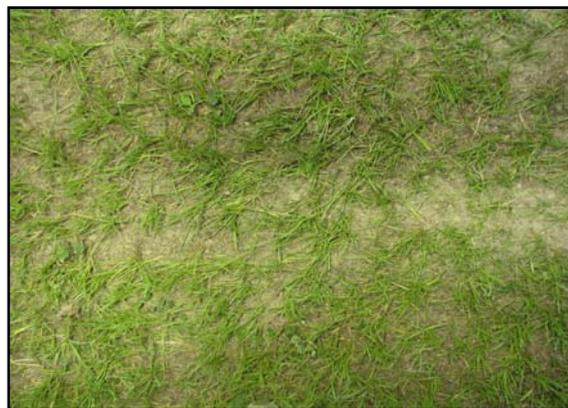
After the soil was placed in the trays and compacted, Bahiagrass (*Paspalum notatum* Flüggé) sod harvested in Florida and shipped to Colorado was installed and grown under greenhouse conditions at temperatures and humidity typical of Florida’s climate. A process was developed to cut back the grass coverage on the trays to 50% (± 5%) of the surface area to replicate expected dike conditions in Florida. The left-hand photograph of Figure 2 shows several of the planter tray sets in the greenhouse one week after sod installation, and the right-hand photograph illustrates an overhead close-up of a tray reduced to 50% (± 5%) grass coverage. Turf reinforcement mats (TRMs) were installed in two of the tray sets prior to sod establishment.

Greenhouse One Week After

Fifty-Percent Grass Coverage

Figure 2. Test tray preparation.

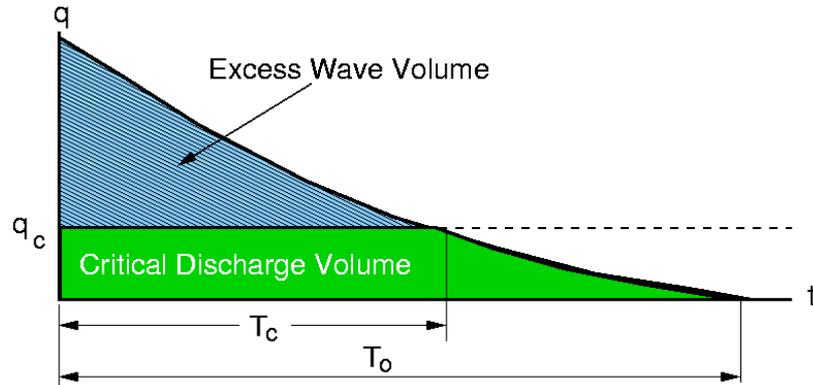
Hughes (2011) expanded Dean et al.’s concept of cumulative excess work (CEW) by assuming the distributions of velocity and flow thickness in individual overtopping waves could be approximated as triangular saw-tooth shapes. The instantaneous discharge in an overtopping wave was assumed to be the product of the velocity and flow thickness as shown in Figure 3. Thus, the volume of an overtopping wave (V_w) was estimated to be

where q_p is the peak discharge and T_o is the duration of individual wave overtopping. The excess work in the overtopping wave is represented by the sum of the discharge (i.e., wave volume) above a critical discharge as indicated in the idealized wave shown in Figure 3. Based on Dean et al. (2009), Hughes (2011) derived the critical discharge (q_c) as a function of critical velocity (u_c), landward-side slope angle (θ), Fanning friction factor (f_F), and gravity (g) as

Figure 3. Excess wave volume above the threshold for an idealized wave.

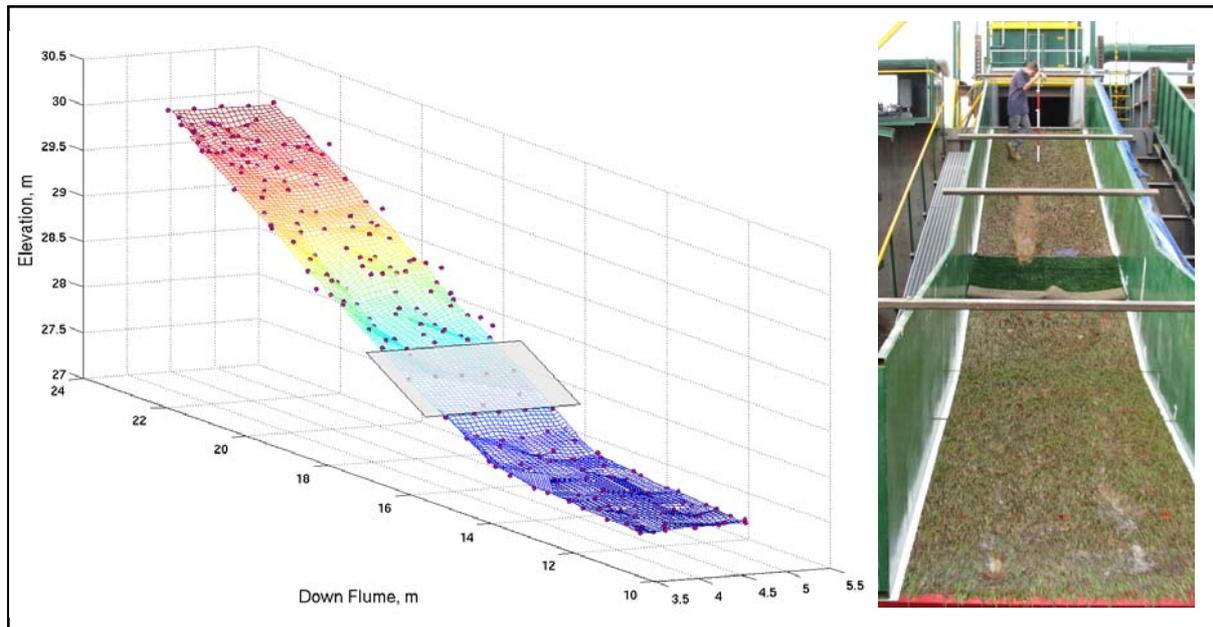
Figure 4 shows a three-dimensional surface constructed from survey points at the end of grass-only Test 5 when grass failure was declared. The photograph in Figure 4 shows the actual grass surface represented in the survey. Note the transition mat of artificial turf located at the junction between the

two trays. This transition mat helped to reduce potential edge effects caused by the necessary use of two adjoining trays.

Figure 4. Uniform mesh fitted to survey data (left) and grass damage (right).

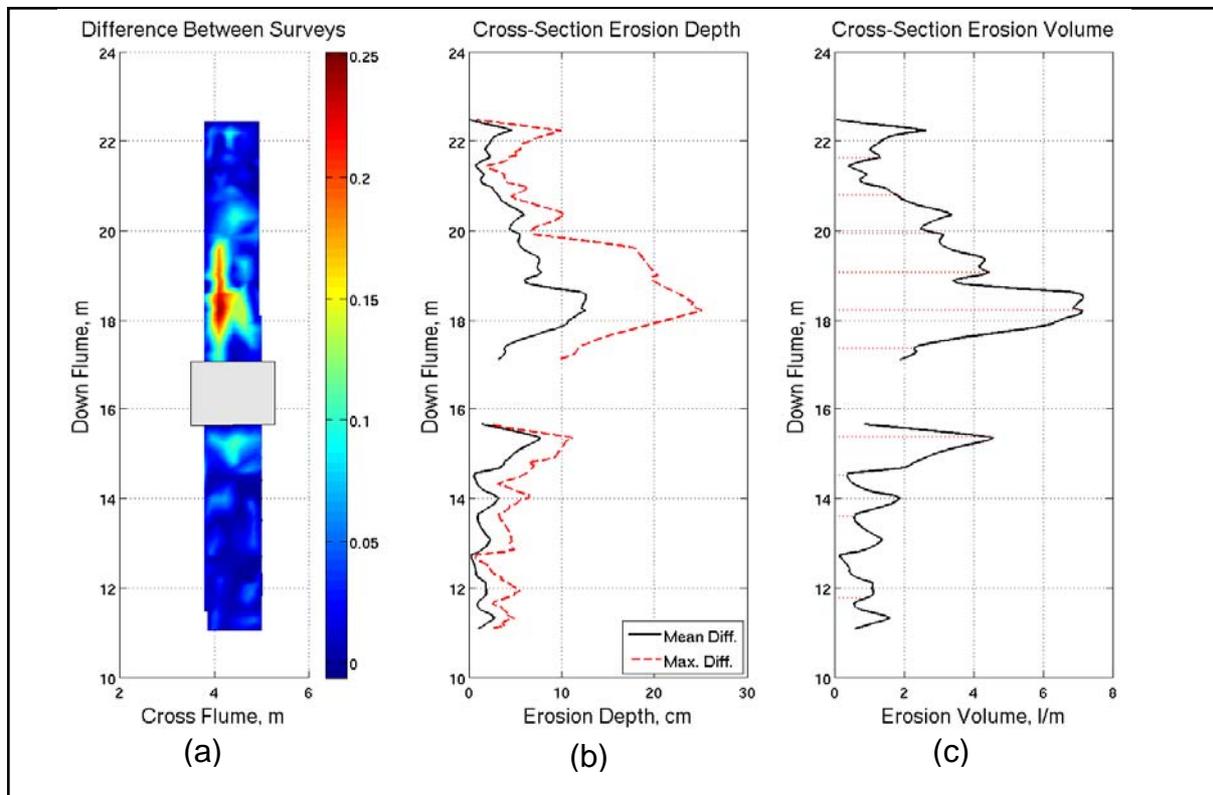
Figure 5(a) shows the difference (m) between initial and final Test 5 surveys. Figure 5(b) indicates the variation in cross-flume mean and maximum depths (cm). The cross-flume eroded volume per unit flume width (l/m) is shown in Figure 5(c). Similar comparisons were made for all intermediate surveys for each test sequence.

Figure 5. Cumulative erosion at end of Test 5.

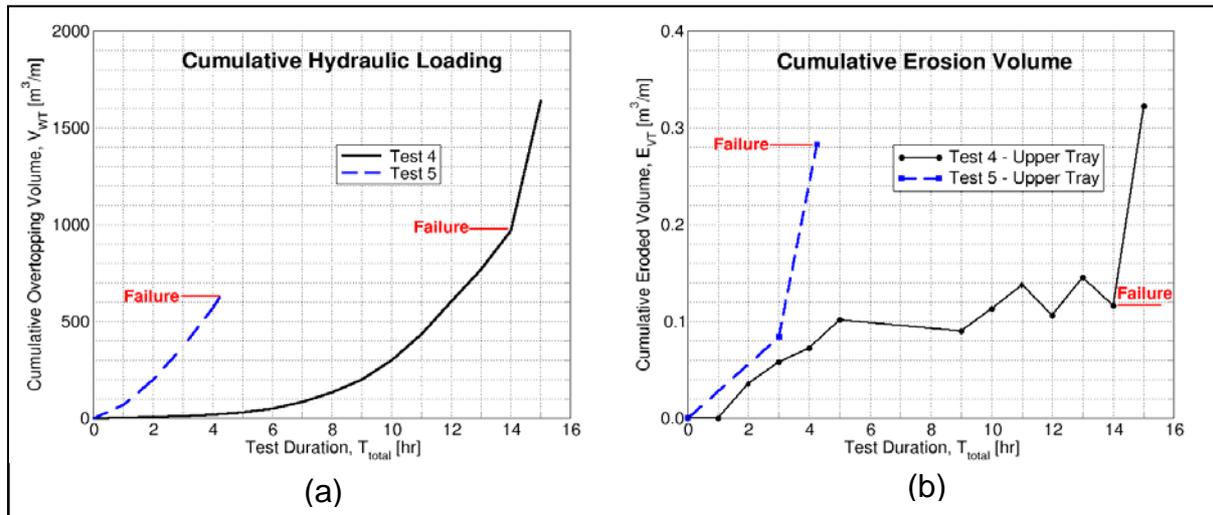
Test 4 was the first test conducted with the sandy soil, so the wave overtopping loading was initially very low (0.9 l/s/m), and then increased slowly for each subsequent hour of testing. The cumulative overtopping water volume for Test 4 is shown as a function of time by the solid line in Figure 6(a). Grass failure (subjective opinion of the researchers) occurred after 14 hours as indicated on the plot. Test 5 hydraulic loading was more aggressive as indicated by the dashed line in Figure 6(a), and grass failure occurred after just 5 hours. The progression of cumulative eroded volume per unit width over the entire upper tray length (6.1 m) is shown in Figure 6(b) for both grass-only tests. The cumulative erosion lines should be monotonically increasing, but errors associated with fitting a geometric surface to limited survey data resulted in some surveys calculating less erosion volume than the previous survey. Nevertheless, the erosion trend appears to be reasonable, and the similar shape of cumulative hydraulic loading and cumulative erosion in time suggests a direct relationship between loading and erosion.

Figure 6. Grass-only cumulative loading (left plot) and cumulative erosion (right plot).

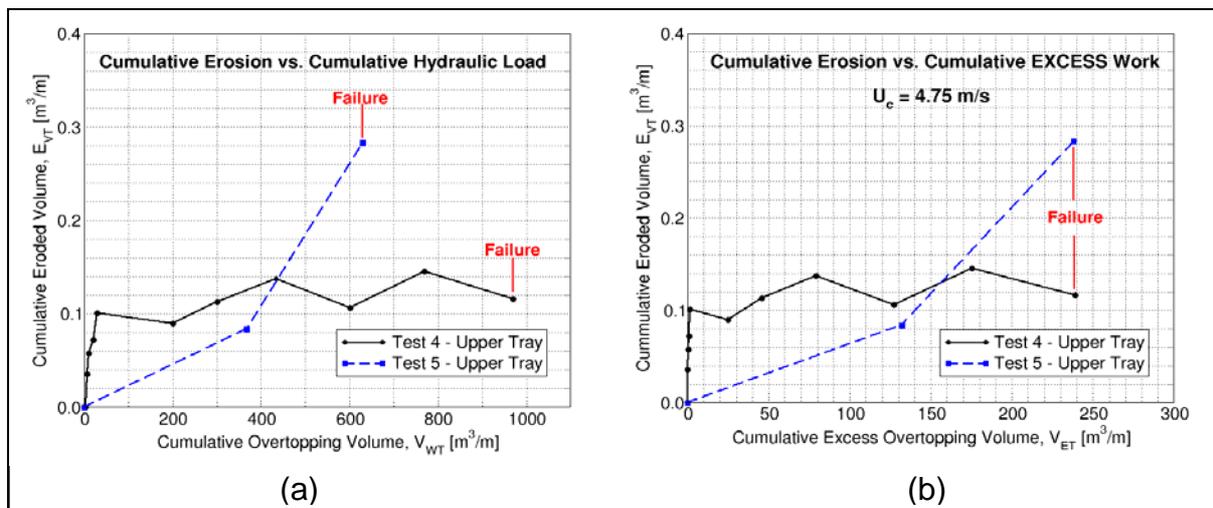
Figure 7(a) plots cumulative erosion volume as a function of cumulative overtopping water volume for the two grass-only tests. Both tests follow similar trends despite the fact that the wave conditions and the loading sequences were different. Test 5 had more total eroded volume at the declared point of failure, and this was probably due to different development of the scour areas caused by local variation in grass and soil resiliency.

Figure 7. Erosion vs. hydraulic load (left plot) and excess work (right plot).

Van der Meer et al. (2010) applied their cumulative hydraulic loading model to in-situ wave overtopping tests on sandy soil. They reported that a critical velocity of $U_c = 4.0$ m/s provided positive damage correspondence between wave overtopping tests conducted using different incident wave conditions. In a similar manner, the cumulative EXCESS wave volume was calculated for the different wave conditions of Tests 4 and 5 using several different values of U_c in the CEW method. Assumed friction factor was $f_F = 0.015$, and the landward-side slope was 1V:3H. The best match was obtained for $U_c = 4.75$ m/s as shown in the plot of Figure 7(b) where grass failure is associated with a cumulative excess overtopping volume of about $V_{ET} = 240$ m³/m.

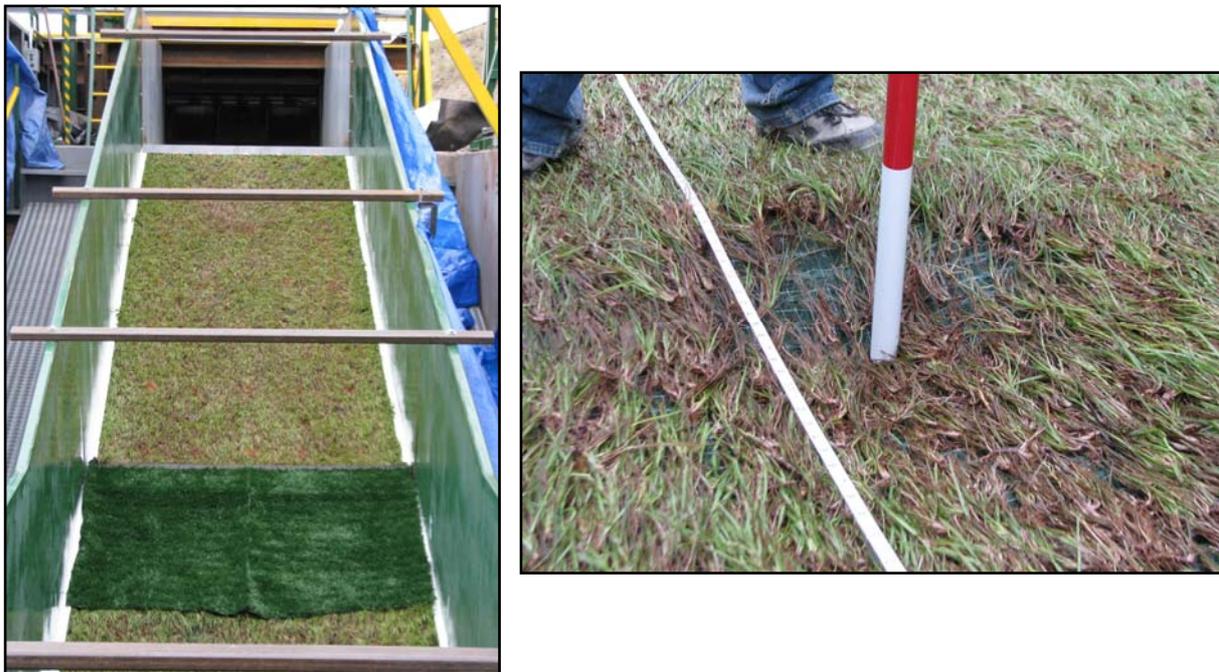
The two tests of grass sod reinforced with turf reinforcement mats varied only in TRM manufacturer, loading sequence, and slightly different soil type. The same sod species was used in each test. The left-hand photograph in Figure 8 shows the relatively intact grass on the upper levee tray at the conclusion of Test 6. The right-hand photograph shows an area just down-slope of the transition fabric where sod and grass were separated and soil loss occurred beneath the TRM. Note the depression in the mat from the survey rod during soil surface erosion measurements.

Figure 8. Grass reinforced with TRM (Test 6).

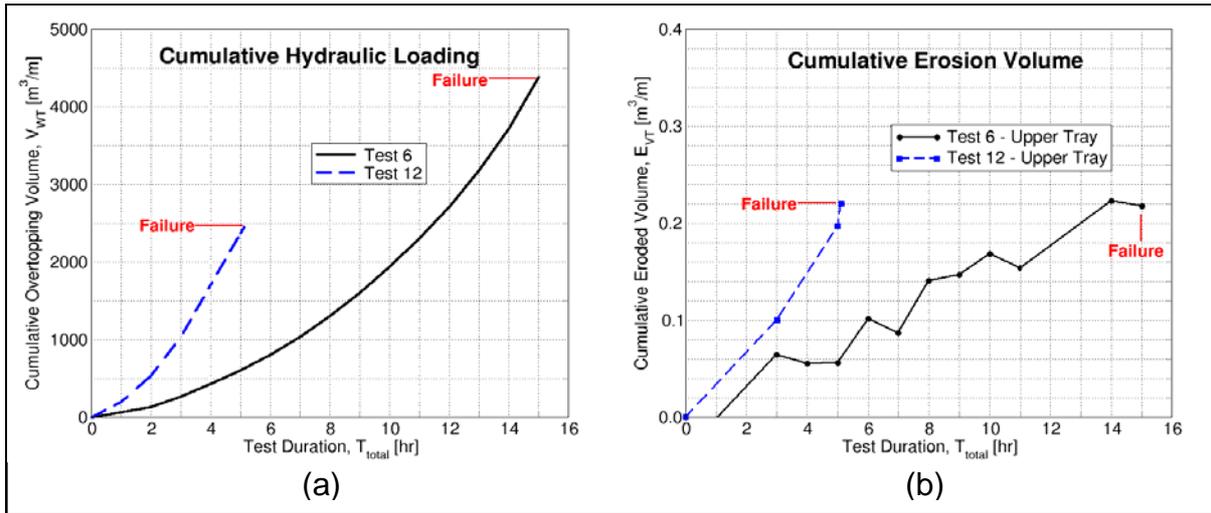
The cumulative overtopping water volume for Tests 6 and 12 are shown as a function of time in the Figure 9(a). Failure due primarily to loss of soil beneath the TRM is indicated on the plot for both tests. Test 12 hydraulic loading was more aggressive, and failure occurred after 5.1 hours compared to failure at 15 hours for Test 6. The progression of cumulative eroded volume per unit width over the entire upper levee tray length (6.1 m) is shown in Figure 9(b) for both tests.

Figure 9. Grass+TRM cumulative loading (left) and cumulative erosion (right).

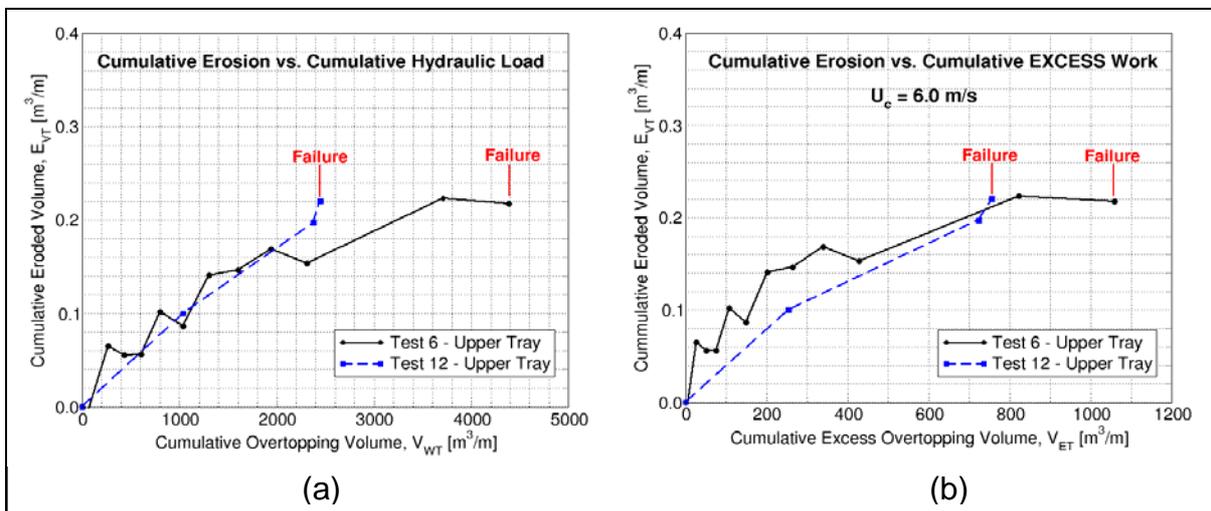
Figure 10(a) shows the correlation between cumulative erosion volume and cumulative overtopping water volume for the two grass+TRM tests. The erosion progression of each test was more closely aligned with each other compared to the grass-only tests. Even though the wave conditions were the same, the applied loading sequence was different, soil types were slightly different (see Table 1), and the TRMs were made by different manufacturers. At declared failure, the total eroded volume on the upper tray was nearly the same for the two tests. The additional protection provided by the TRM appears to have reduced the influence of soil/grass local variations and contributed to erosion being more consistent between tests.

Figure 10. Erosion vs. hydraulic load (left plot) and excess work (right plot).

Application of the cumulative excess work methodology for a reasonable range of critical velocities failed to provide a good match between the two tests. A comparison of cumulative excess work for the two tests with $U_c = 6.0$ m/s is shown in Figure 10(b). Whereas the two cumulative erosion volume lines show similar trends, it is tentatively concluded that the difference in cumulative excess work at failure may be related to root-holding differences between the TRM products. If this was the case, then the cumulative excess work methodology cannot be calibrated for these tests because more than just incident wave condition and loading contributed to damage. It should be noted that both TRMs would continue to provide levee slope protection well beyond the level indicated here without jeopardizing the levee crest. The TRM proved to be very effective in limiting head-cutting (upstream erosion progression), even when grass has been damaged and soil has been eroded beneath the mat.

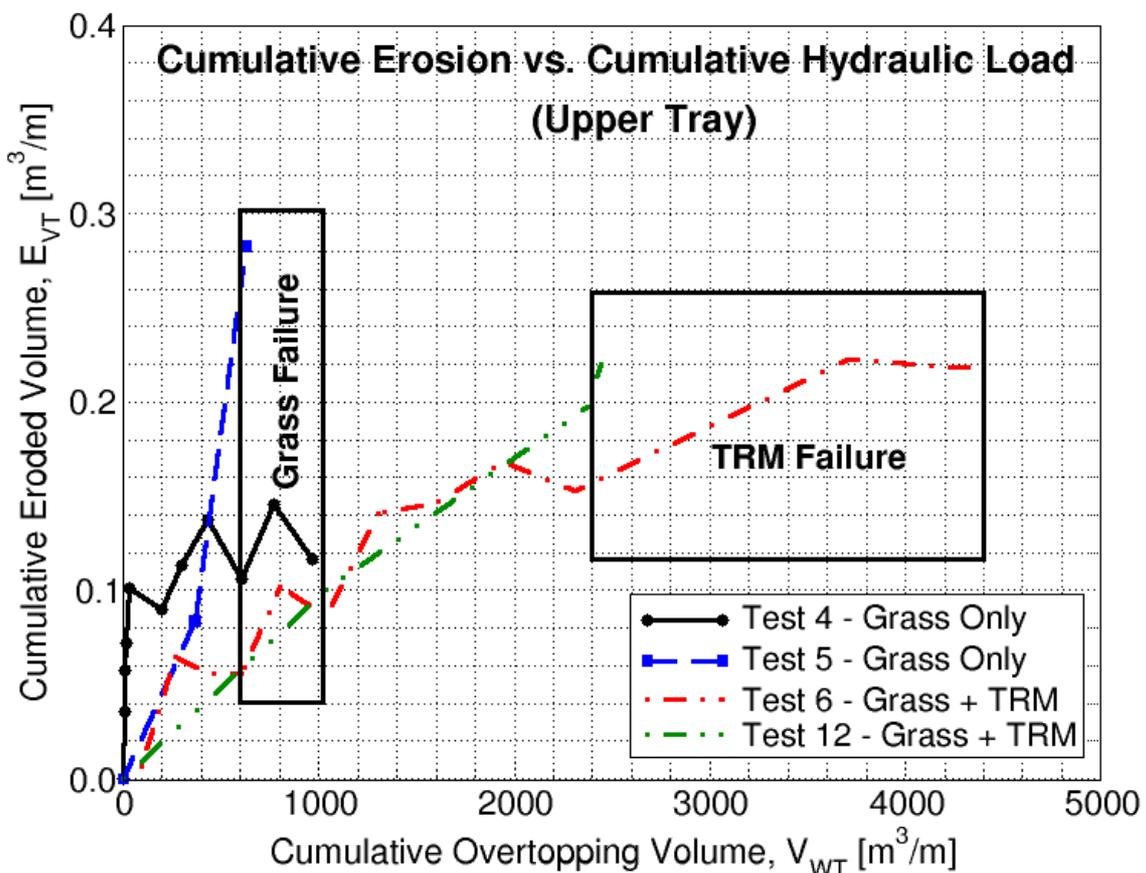
Figure 11 summarizes the cumulative eroded volume all four tests as a function of cumulative overtopping water volume. The ranges of perceived grass failure are shown on the figure. Bahiagrass reinforced with a TRM was able to sustain between 2 and 4 times the cumulative hydraulic loading as Bahiagrass without reinforcement. It seems reasonable that grass+TRM should have greater erosion resistance than grass alone because the TRM is integrated with the grass to provide greater plant stabilization as well as functioning as a direct barrier between the soil and fast-flowing water. Admittedly, the declaration of grass failure was based on engineering judgment rather than a defined criterion; but the indicated grass failure levels fell considerably short of a condition that would jeopardize the levee crest integrity.

Figure 11. Summary of grass-only and grass+TRM test performance.

These results were obtained for grass coverage of 50%. Therefore, the use of a TRM provides increased slope resiliency and a more robust system in areas where climate or management practices may result in grass coverage of 50%. The difference shown in Figure 11 between grass-only slopes and grass reinforced with TRM maybe not be the same when grass coverage is substantially greater than 50%.
