WEIGHT AND STABILITY ASSESSMENT OF SINGLE LAYERS OF ORDERLY PLACED OR PITCHED NATURAL ROCK

Nisa Nurmohamed¹, Gosse Jan Steendam² and Jentsje van der Meer²

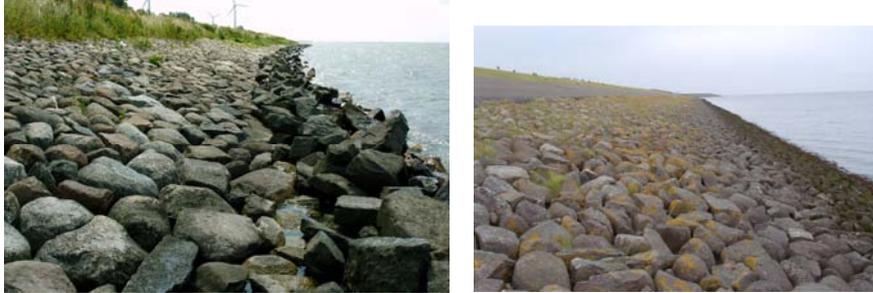
Figure 1. (left) Pitched rock slope along large lake with a randomly dumped rock berm in front and (right) Pitched rock slope along the Waddensea

Figure 1 gives an overall impression of these pitched natural rock slopes and The slope in the left picture of Figure 1 is situated along a large lake with a more or less constant water level. Around the water line a berm is present of loosely dumped quarried rock. The difference between randomly dumped and pitched rock is very clear. The right picture in Figure 1 gives a slope along the Waddensea, where tide and storm surge play a role.

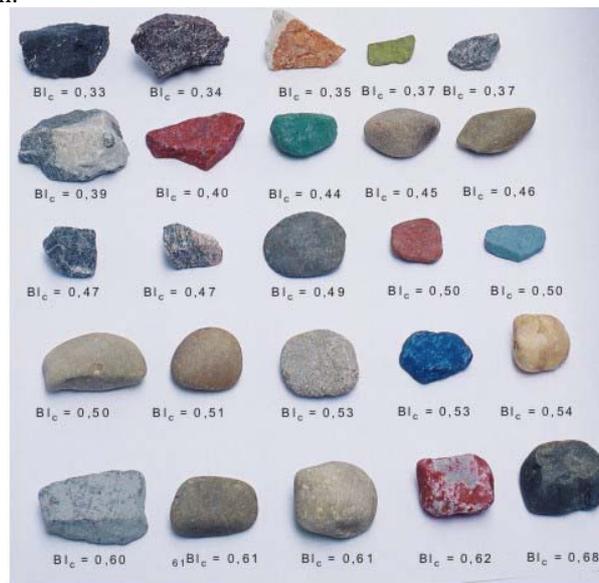
Figure 2. Different rock shapes ranked according to their blockiness coefficient BL_c

The photograph in Figure 2 as well as photographs in which the rocks were arranged by certain blockiness ranges, were used to assess the actual blockiness coefficient in reality on a protection, for each rock measured in a batch. It should

be noted that $BL_c = 1$ is according to a cube and a value of 0.52 describes a sphere. It appears that nice blocky shapes have the highest coefficients around $BL_c = 0.6-0.7$. Irregular shaped rock with triangular shapes have lowest values with $BL_c = 0.3-0.4$. More rounded shapes come close to a ball or sphere with values around $BL_c = 0.5$. The method was validated with natural rock in a stockpile. This method can be applied to normal rock protections if the rock size is not known.

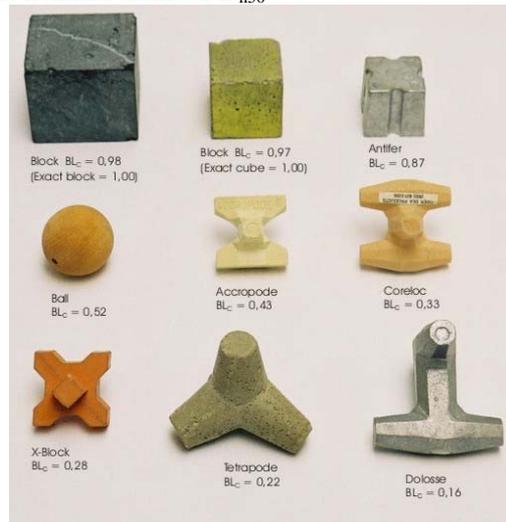
Figure 3. Blockiness coefficients for armour units

This idea was developed further and the final method can also be used for other rock structures or breakwaters to get a good measure of the actual grading of the rock on a built structure. First of all small rock samples with different shapes were gathered. All these small rocks were ranked according to their measured BL_c -value and photographs of this ranking were made. Figure 2 shows a picture of all 25 rocks in a ranking. Other armour units for coastal protection were taken and also the blockiness coefficients of these units were measured, just for comparison with rock. Figure 3 gives an overall view.

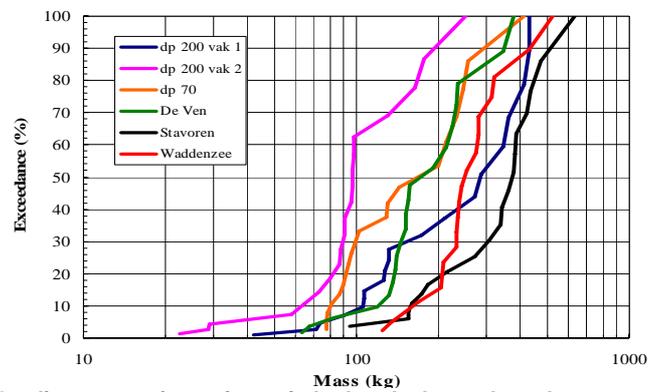
Figure 4. Grading curves for various pitched rock slopes, based on a non-destructive method to establish the weight of a rock

Various locations with pitched natural rock were analyzed in detail. Every time the three dimensions of 10 rocks were measured. The weight of each rock was established based on the guessed blockiness coefficient of each rock. The ten rocks together give a (rough) grading curve as shown in Figure 4. In this figure the grading curves of all locations are given. Table 1 gives a summary of the findings, such as the average mass M_{50} , the nominal diameter D_{n50} , the grading D_{n85}/D_{n15} the layer thickness and the average blockiness coefficient. The average mass was not established by reading the value on the 50% line, but by estimating a *straight line* through the grading curve, matching the trend of the grading between the 15% and 85% lines. Therefore, values in Table 1 differ from direct readings from the graph.

The average mass of rock varies between 100-350 kg with corresponding nominal diameters of 0.35 to 0.50 m. The grading of the rock is between 1.2 and 1.7, which is a normal grading for quarried rock in coastal protections. The blockiness coefficients in average are about $BL_c = 0.5$.

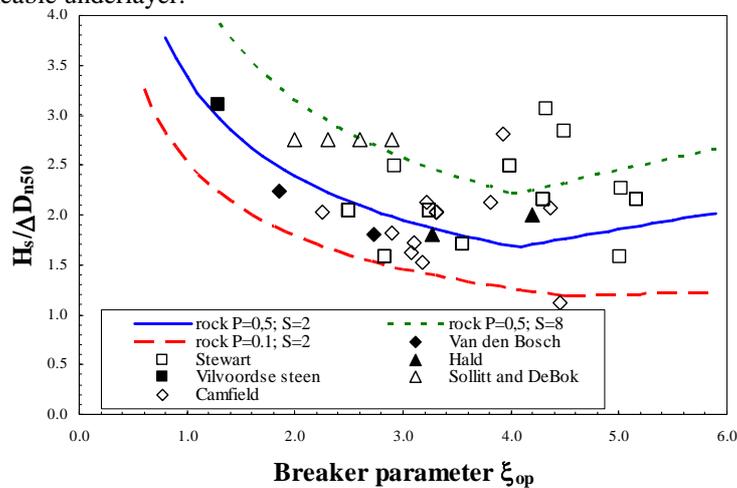
Figure 5. All results for a single layer of rock compared with stability of tw layers

Various researchers, however, have performed model tests on single layers of rock, where the rock was placed more carefully, but not pitched. Amongst them: Camfield (1996), Delft Hydraulics (1985), Hald (1998), Sollit and DeBok (1976), Stewart et al. (2003) and Van den Bosch (2001). It is clear that a randomly dumped single layer of rock is less stable than a two-diameters thick layer. This is, therefore, not the situation that should be regarded. If a single layer of rock is designed, more care should be taken to place the rock. It is not easy to describe what care exactly, but at least every stone should be placed individually and not dumped. The references given above all describe that the researchers have taken some care in placing their single layer of rock. The data from the research mentioned is described below and all together shown in Figure 5.

1:2 and the underlayer was permeable. Tests were performed with regular waves. A KD-factor of 29 was found for no “damage”. This gives $H/\Delta Dn50=3.87$. If it is assumed that a regular wave height has similar effect as the 2%-wave height in a random sea state, the stability factor can be calculated by dividing by 1.4 (being the ratio $H_{2\%}/H_s$ for relative deep water). This gives a stability factor of $H_s/\Delta Dn50 = 2.76$. This value is also shown in Figure 5 for the range $\xi_{op} = 2 - 3$.

All stability results together for a single layer of orderly placed rock are given in Figure 5. Each point gives “initial damage”. The definition is not very sharp, it could be one or a few rocks displaced, but also first movement without displacement. Some structures were a kind of revetment with an impermeable

Stability of a randomly placed double layer of rock can be described by Van der Meer, 1988. This can be considered as the real lower boundary for orderly placed rock. The formula is given in Figure 5 for $S=2$ and $S=8$ for $P=0.5$ (permeable underlayer) and for $S=2$ and $P=0.1$ (impermeable underlayer). Practically all model test results in Figure 5 are higher than the curve for an impermeable underlayer. Even many results are better than the curve for a permeable underlayer.

Curves for a classical rock protection of two layers of randomly placed rock do not match with the total result of the single layer results, although the trend for plunging and surging waves seem to be present. This means lower stability for increasing breaker parameter for plunging waves and increasing stability for increasing breaker parameter for surging waves.

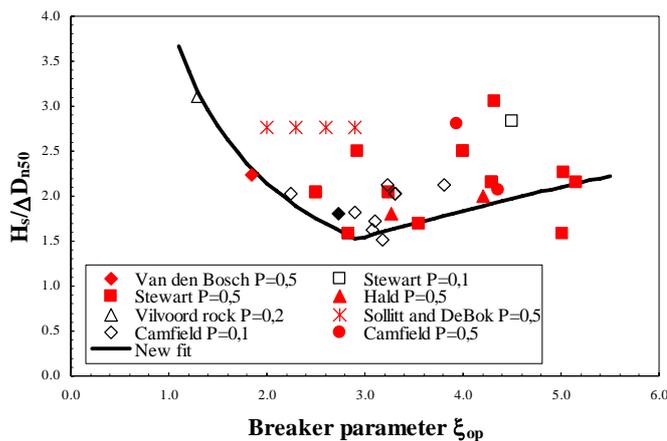
Figure 6. All results for a single layer of rock (solid symbols = permeable underlayer; open symbols=impermeable underlayer) compared with new fit as a lower boundary

The new fit in Figure 6 may be described by the following equations:

$$H_s/\Delta D_{n50} = 4 \xi_{op}^{-0.9} \text{ for plunging or breaking waves (left in Figure 6)} \quad (3)$$

$$H_s/\Delta D_{n50} = 0,8 \xi_{op}^{0.6} \text{ for surging or non-breaking waves (right in Figure 6) (4)}$$

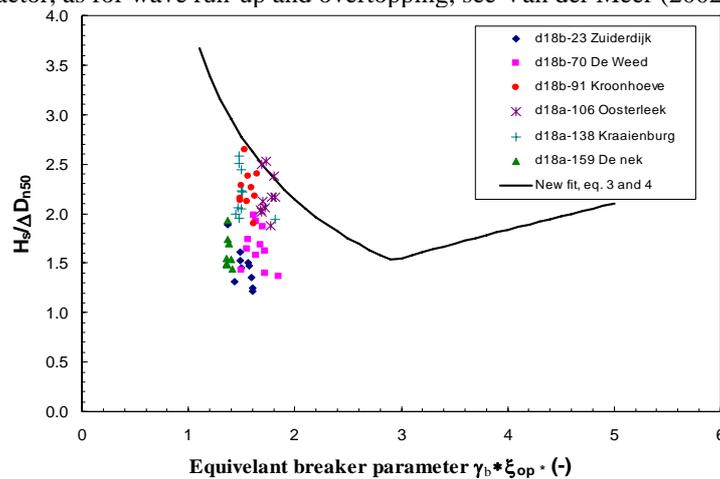
Figure 7. Hindcasted results for first location, based on limited data

This figure is very promising as some points are even on the new curve, where all data points can be considered as “no damage”! The problem, however, was that data was limited and based on conservative estimations in a safety assessment. This means that sizes that were possible taken on the lower side and effect of a foreshore was ignored. For a first safety assessment this is a right procedure, but not for the method of proven strength. For the method of proven strength it should be proven that a certain wave heights has indeed occurred on the structure and that the average size of the rock is not taken too small. This is all just opposite to a safety assessment.

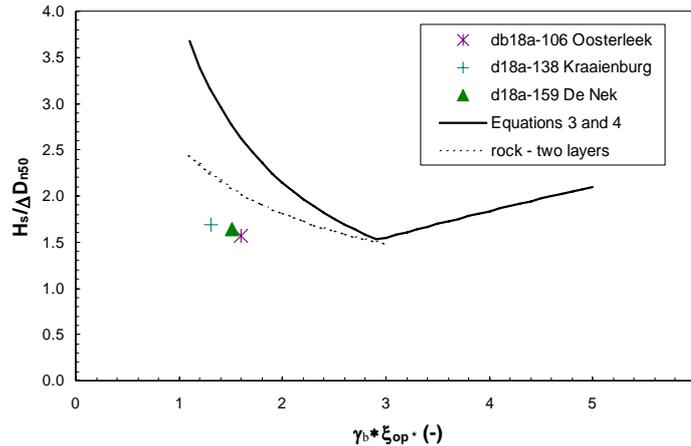
Figure 8. Hindcasted results for first location, based on detailed investigation

After the detailed investigation on the actual situation the same graph as in Figure 8 was constructed, but now with the real data. Only the largest storm was taken, giving the highest points close to the curve of Equation 3. Due to the larger rock than first assumed and the lower wave heights at the structure, the $H_s/\Delta D_{n50}$ -values reduced a lot. The data points are now even lower than the curve for start of damage for a classical two layers rock slope (Van der Meer, 1988).

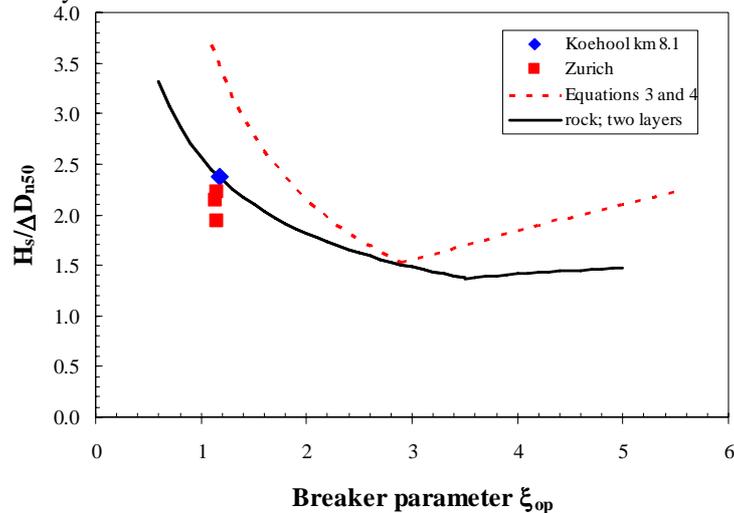
Figure 9. hindcasted results for second location (Zürich and Koehool)

Another location where the method of proven strength was applied, was along the Waddensea coast. The results are given in Figure 9. During storm surge the water level can raise 3 – 4 m and severe wave attack can be expected on the coastal protection. The storm on 3 January 1976 was a very severe one, which caused damage to revetments of some dike sections and which moved one rock in a single layer of pitched rock. The rock stayed within the layer, but moved to a position with the longitudinal axis perpendicular to the slope.

Also here the actual rock size was determined with the method described in this paper. The results of the SWAN-calculations were used to establish the wave height at the toe of the structure. Finally the stability graph was drawn, which is given in Figure 9.

Two locations along the Waddensea dike were chosen, one at Zürich (where the rock was moved) and one at Koehool, about 20 km north. Figure 9 gives the results for 3 water levels for Zürich, including the peak of the storm and the highest water level at Koehool. The data points are close to the stability curve for the classical two layers of rock, but still do not validate equations 3 or 4.

The result of this study was that the points marked in figure 9 shifted up to above the stability relation of two layers of rock. It is therefore concluded that a single layer of pitched natural rock is at least as stable as two layers of randomly placed rock. Because the derived data points are still below the lines of equations 3 and 4 these equations could not yet be validated.
