CHAPTER 152

Influence of rock shape and grading on stability of low-crested structures

Jentsje W. van der Meer¹

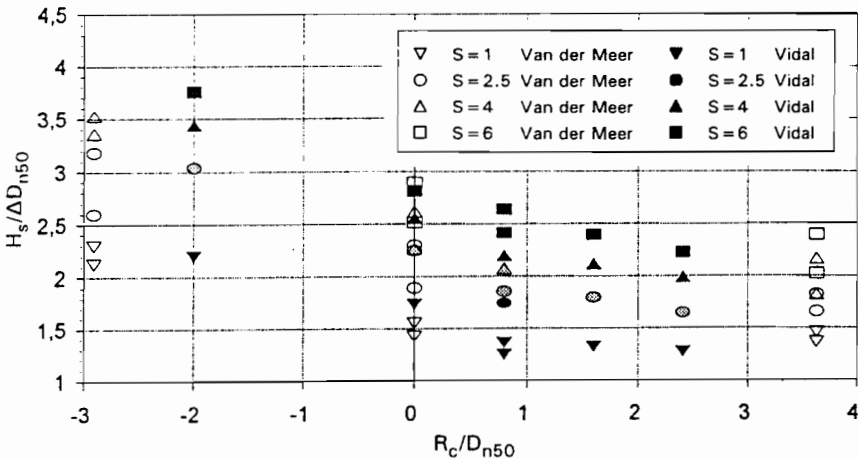
Figure 2. Stability at the front for fixed damage levels S

This figure shows that the two different data sets give a fairly good agreement, although some scatter is present. In order to make the analysis easier, in the following only start of damage will be considered. For the whole structure start of damage is given as $S = 2$. In order to remain consistent start of damage to the different segments separately should be lower, but in total again $S = 2$. The following distribution was chosen for start of damage: front 50% ($S = 1$), crest 25% ($S = 0.5$) and rear 25% ($S = 0.5$). The real distribution of the damage will vary with the freeboard. Fig. 3 gives the same data as Fig. 2 for the front, but now only for start of damage $S = 1$.

The parameters used by Vidal et al. are not fully the same as those by Van der Meer and Pilarczyk. Vidal et al. used a front slope with an angle of 1:1.5, whereas Van der Meer and Pilarczyk used 1:2. The comparison between the two test series was carried out as follows: from the damage curves various fixed damage levels S were chosen and the corresponding stability numbers were determined. Then figures were drawn of stability number against crest freeboard for the various damage levels. Fig. 2 gives an example of the front slope.

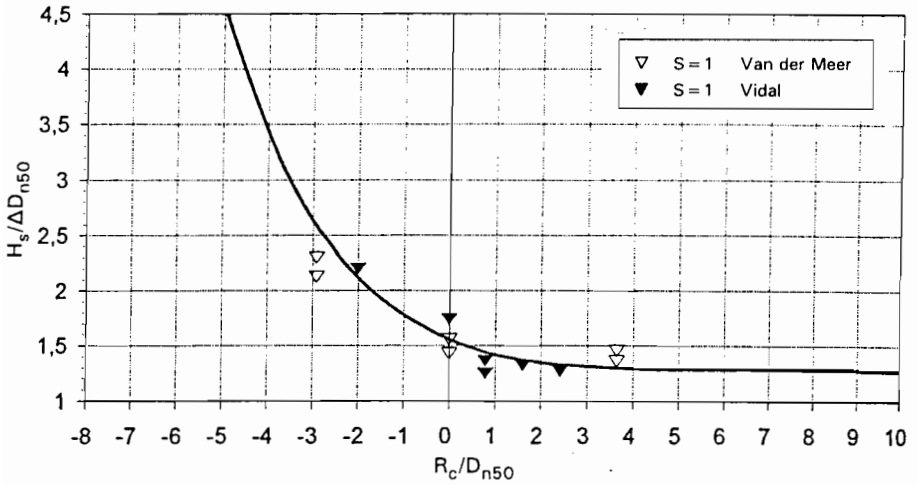
Figure 3. Stability front for start of damage

A curve is drawn through the data points and this curve is also extended beyond the range of test data. For positively increasing freeboard the value of the stability number can be determined easily. Because as the freeboard increases there will not be any more overtopping and the structure will behave according to the formulas by van der Meer (1988). The accompanying stability with the damage $S = 1$ is then $H_s/\Delta D_{n50} = 1.3$. For negatively decreasing freeboard the development is less easy to predict. However, it is evident that the stability will increase with a freeboard decreasing.

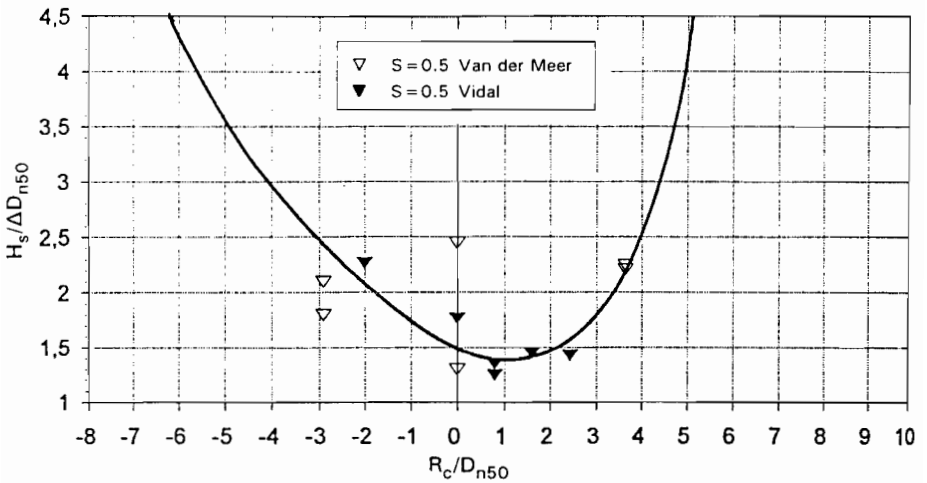
Figure 4. Stability of the crest for start of damage

Fig. 4 gives the data points for start of damage of the crest. Although some scatter is present, especially for the crest at the still water level, the trend is clear. The crest is most vulnerable for freeboards around the still water level. For high crest heights there will be hardly any or no overtopping and the curve will raise sharply. For negative freeboards the stability will increase with decreasing freeboards, more or less according to the front. Although the crest for large negative freeboards will show more damage than the front due to the wave attack directly on the crest for (very) low structures.

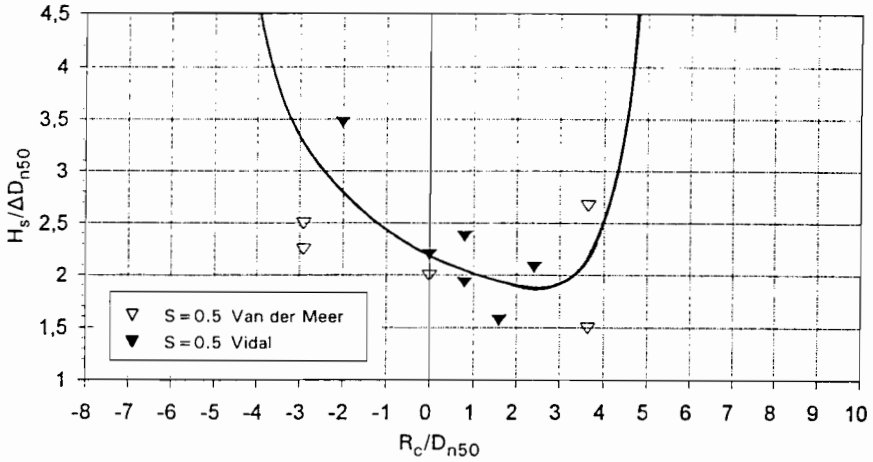
Figure 5. Stability rear for start of damage

Fig. 5 gives the data points for start of damage ($S=0.5$) for the rear. Considerable scatter is present. For increasing positive freeboards stability should increase as soon as overtopping waves can hardly reach the rear. Therefore, the curve should go up quite steep. Again the stability of the rear should increase for very low structures, according to front and crest.

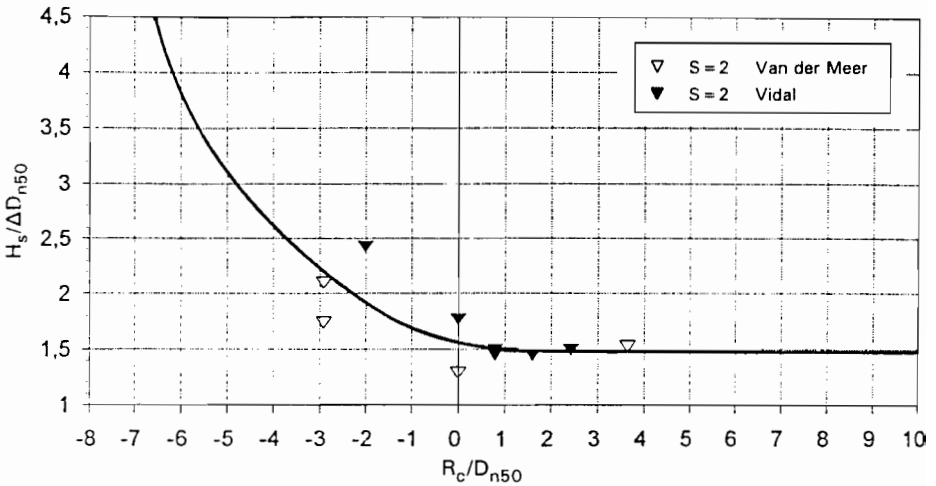
Figure 6. Stability of entire structure

The total stability is shown in Fig. 6 where the curve is similar to the one for the front side. All four graphs together give a design graph for stability of low-crested rubble mound structures at start of damage. This design graph is given in Fig. 7. The crest and front slope are always normative in this figure. The crest is normative for a crest under water up to a crest height of 1 to 2 D_{n50} . Above that level the front is the least stable segment.

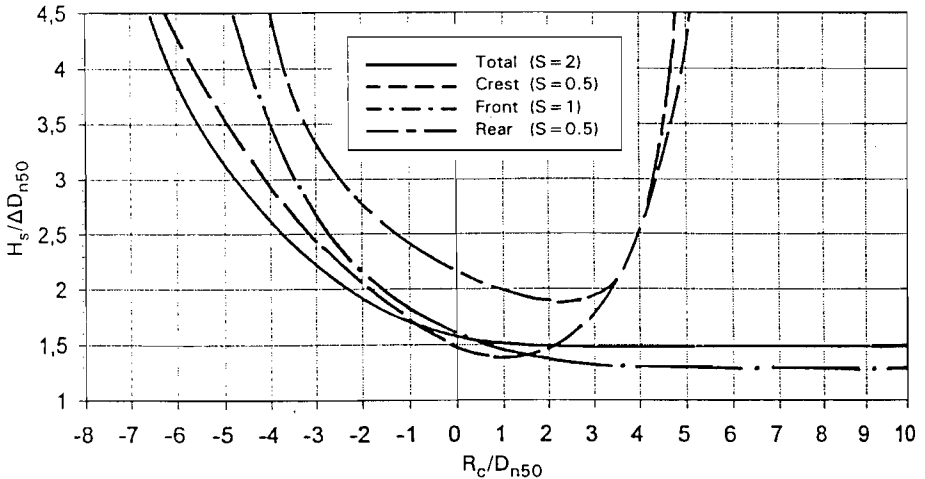
Figure 7. Design graph for low-crested rubble mound structures, for start of damage of various segments, front, crest, rear and entire structure

The design graph in Fig. 7 can be used in various ways. If the structure will be always under water it could be possible to use the armour layer only on the crest and to reduce the size at front side and rear. It is also possible to place the heaviest rock from the quarry at the least stable segment, which is determined from Fig. 7. Or one can design front, crest and rear with different rock gradings according to their required stability number. This may benefit the output yield curve of a quarry.

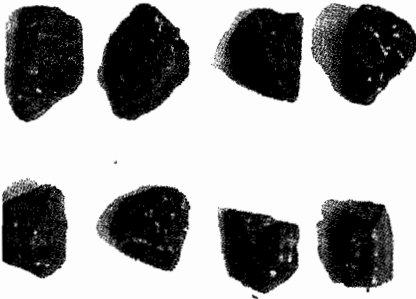
Type 1. Angular; $D_{85} / D_{15} = 1.25$
 $L/D > 2: 20\%$ $L/D > 3: 0\%$

Figure 10. Pictures of the six tested gradings

Table 2 shows the six different types of rock gradings and shapes. Three categories were used with angular rock, the same L/D -distribution, but with different gradings: $D_{85}/D_{15} = 1.25$ (uniform rock); 1.75 (normal grading); 2.5 (very wide grading). Two other categories were also made of angular rock, but had different L/D -ratio's. One of these categories had 40% rock with $L/D > 3$ (type 5). The sixth category was made of shingle which is very rounded rock. Fig. 10 shows a picture of each of the six different types of rock gradings.

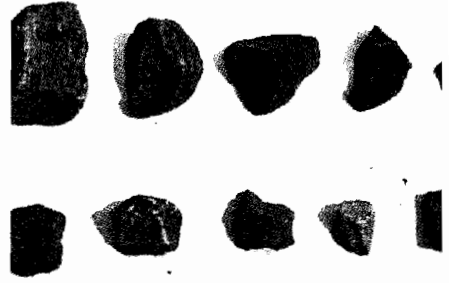
Type 2. Angular; $D_{85} / D_{15} = 1.75$
 $L/D > 2: 20\%$ $L/D > 3: 0\%$

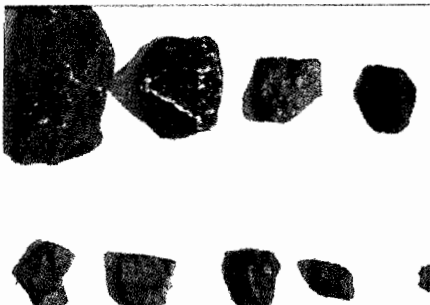
Type 3. Angular; $D_{85} / D_{15} = 2.50$
 $L/D > 2: 20\%$ $L/D > 3: 0\%$

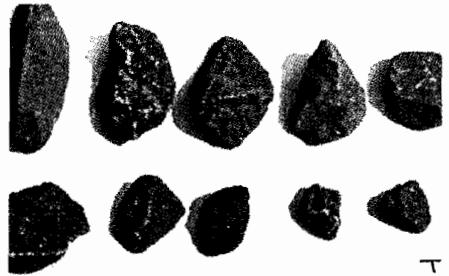
Type 4. Angular; $D_{85} / D_{15} = 1.75$
 $L/D > 2: 50\%$ $L/D > 3: 15\%$

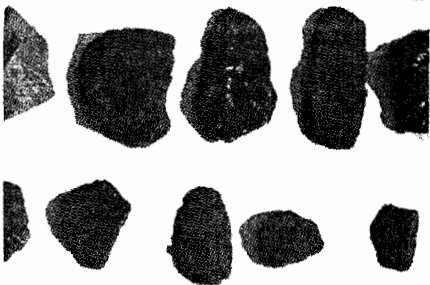
Type 5. Angular/flat; $D_{85} / D_{15} = 1.75$
 $L/D > 2: 80\%$ $L/D > 3: 40\%$

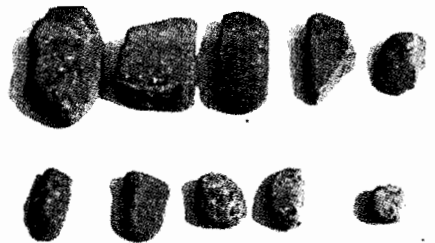
Type 6. Rounded; $D_{85} / D_{15} = 1.75$
 $L/D > 2: 50\%$ $L/D > 3: 15\%$

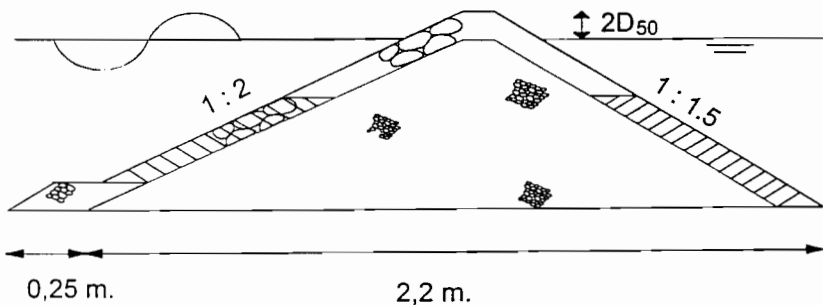
Tests were performed on a cross-section as given in Fig. 11. The prepared rock was placed on the upper sections only, as for the lower sections (shaded) no damage was expected. The seaward slope was 1:2, the rear 1:1.5. The water depth for all tests was 0.6 m, the structure height 0.67 m (crest freeboard of 0.07 m). The nominal diameter of the rock was around 0.035 m. Tests were performed with a Jonswap spectrum. The significant wave heights varied from 0.07 to 0.18 m. For each rock type two test series were done, one with a wave steepness of $s_p = 0.02$ (fairly long waves) and one with $s_p = 0.04$ (storm waves). A test series consisted of 6 to 7 test runs with different wave height in order to establish the damage curve (damage versus wave height). The structure was reconstructed after each test run (6 or 7 times during each test series). This procedure gives damage data that are independent and have no cumulative effect.

Figure 11. Tested cross-section

After each test run (of 1000 waves) the profile was sounded. Each time four cross-sections were measured with a sounding rod and a recording was taken every 0.039 m. Then the average profile was calculated and compared with the original profile. The final result was the damage area A_e and the damage S . The underside of the sounding rod had a circle shaped bulge with a radius of $0.5 D_{n50}$. The test data are given in Burger (1995).

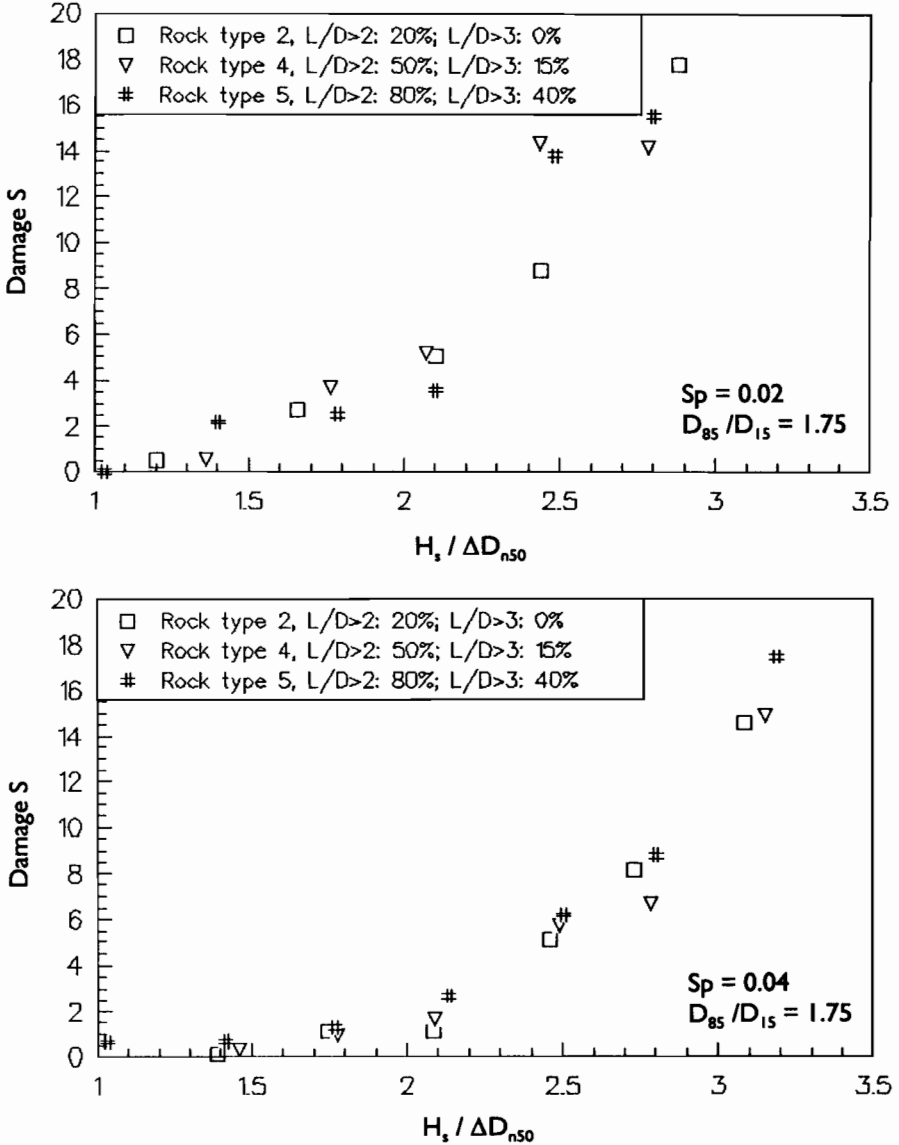
Fig. 12 gives the results of rock types 2, 4 and 5, which have similar gradings, but have different shapes of L/D . Rock type 2 is almost cubical, where

rock type 5 has many long and flat stones (see also Fig. 10). The upper graph of Fig. 12 gives the results for a steepness of 0.02 and the lower graph for 0.04.

The influence of the rock shape L/D can hardly be traced in Fig. 12. In particular at the wave steepness of 0.04 the three rock types virtually overlap; the

Figure 12. Influence of rock shape L/D on stability

results are virtually all on one line. With $s_p = 0.02$ there is no difference until a damage of $S = 4$; a little beyond that the more uniform material is more stable. At a yet higher stability number this is, remarkably enough, the least stable material.

Material factors of rock such as shape and grading appear to be of little influence on the stability of the armour layer of low-crested rubble mound structures. The length-width ratio L/D of the rock showed no influence at all on stability. A rock type with relatively many elongated/flat rocks is just as stable as a more uniformly shape rock type. There was hardly difference between the angular and rounded (shingle) shaped rock up to a damage of $S = 4-6$. After that the rounded rock showed a more progressive development of damage. Still the conclusion can be that also more rounded rock can be used for design of low-crested structures.

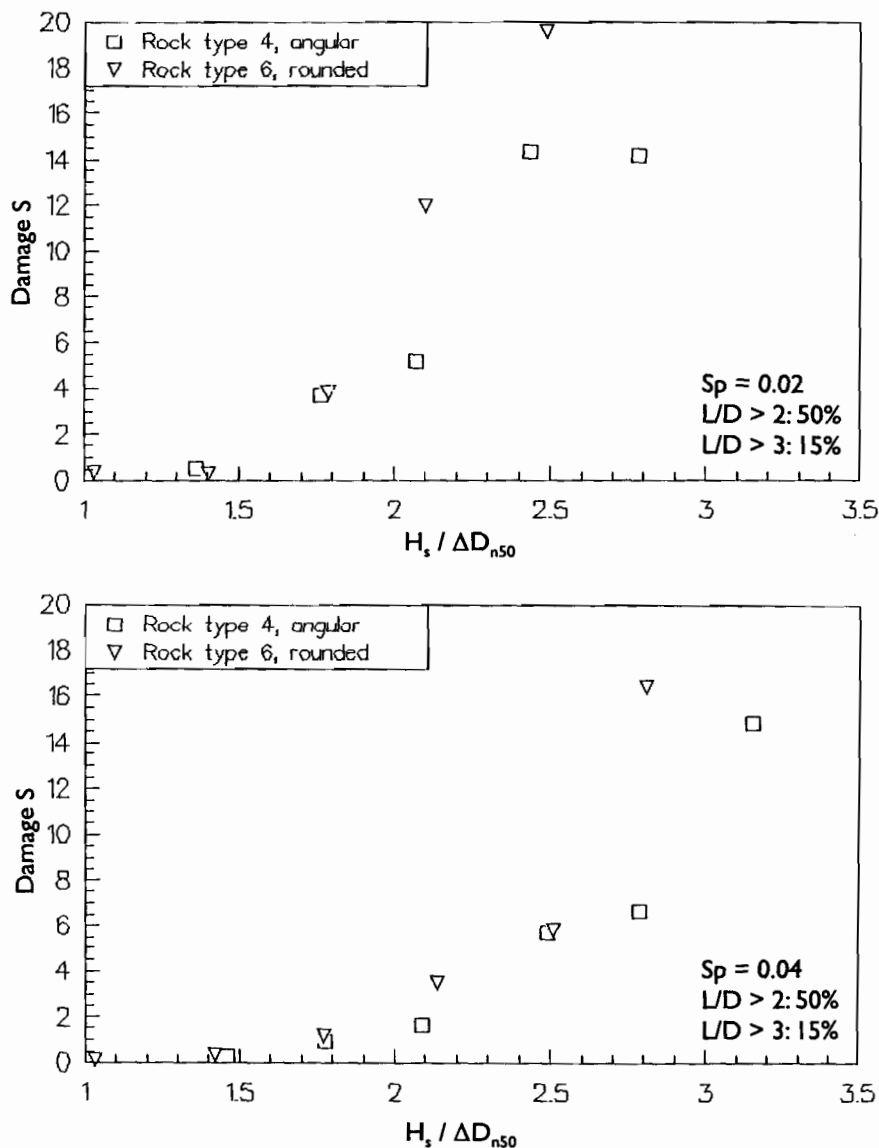
Figure 13. Influence of angularity on stability

In Fig. 13 the results of the angular and rounded rock are given. Rock type 6 is composed of round shingle. For a wave steepness of $s_p = 0.02$ the data points up to a damage of $S = 4$ overlap one another exactly. The damage curves

for $s_p = 0.04$ are similar up to $S = 6$. Apparently the rounded material does not roll that easily as one would expect. However, when it does start rolling, the development of damage will occur progressively in comparison to the angular material.

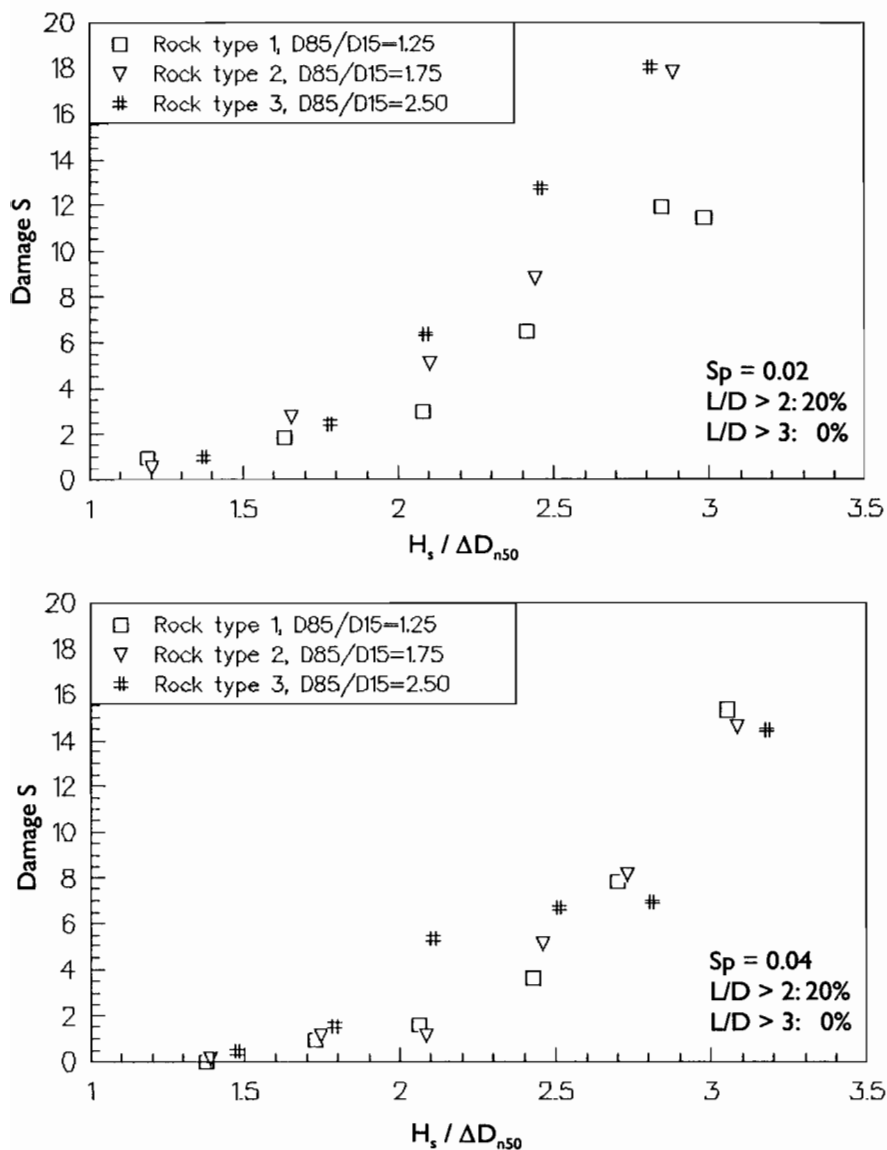
Figure 14. Influence of grading on stability

Fig. 14 gives the damage curves for the first three rock types which all have the same shape, but different gradings. Up to start of damage, $S = 2$, there is hardly any difference between damage development. Beyond that and with a wave steepness of 0.02 one can recognise a difference in damage development. There is hardly difference for the wave steepness of 0.04. The scatter in results is largest for the widest grading with $D_{85}/D_{15} = 2.5$. This is similar to tests performed at HR Wallingford, for a very wide grading with $D_{85}/D_{15} = 4.0$ (CUR/CIRIA-manual, 1991, page 271). There it is recommended not to use gradings with $D_{85}/D_{15} > 2.5$. The results in Fig. 14 show that upto this value the differences are small.

The grading has only little influence. It has no influence if the grading D_{85}/D_{15} is smaller than about 2. With $D_{85}/D_{15} = 2.5$ the stability can be the same, but the reliability of the results is smaller (the scatter is larger), probably due to unsorting of the grading, etc. It is recommended not to use gradings with $D_{85}/D_{15} > 2.5$.
