Wave overtopping resistance of grassed slopes in Viet Nam

Abstract

The Simulator was applied to test the resistance against wave overtopping of grass covered dike slopes in Viet Nam. Observation and measurement during destructive tests were performed to investigate the development process of damage induced by overtopping flow. Damages were likely to be initiated at transition of either geometry or materials, at eroded holes and around objects existing on the slope. Grass cover could withstand a certain overtopping rate that varies widely and in order of 10 l/s per m.

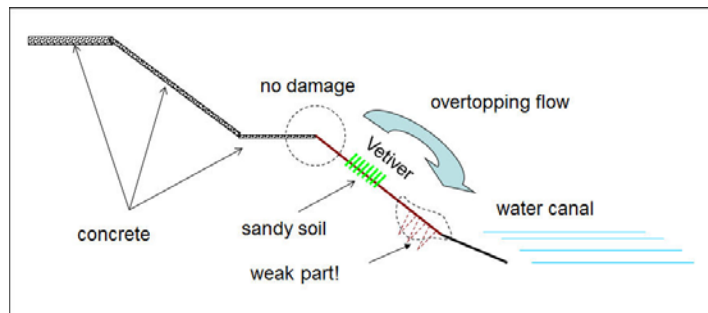
Figure 1: Do Son sea dike in Hai Phong, 2-year-old Vetiver grass on the low landward slope.

Destructive tests were performed on slope sections that were selected according to a set of criteria of operation and testing (Le et al., 2010). The pilot test was conducted in Do Son, Hai Phong where dike was reinforced with concrete on three sides: seaward slope, dike crest, upper part of landward slope and berm. The lower part of the landward slope was sandy soil covered with Vetiver grass (*Vetiveria Zizanioides*). Slope section DS_01 with inclination of 1:2 was tested and the Vetiver covered part was 5 m long, next to the dike toe was a water canal, Fig 1.

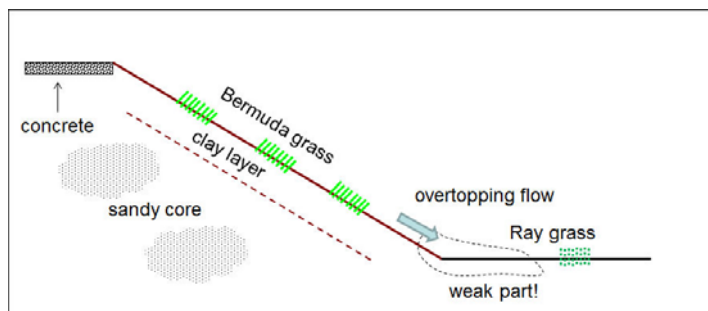
Figure 2: Thinh Long sea dike in Nam Dinh, 4-year-old Bermuda grass slope.

In Nam Dinh, Thinh Long sea dike with an inclination of 1:3 was tested and the slope was covered with Bermuda grass (*Cynodon Dactylon*) and sometimes Casuarina trees as well. The dike body was constructed by a sand core and a layer of clay with moderate quality, see Fig 2. The thickness of the clay layer was found to vary from 80 to 100 cm at 3 sections. On horizontal dike toe, it was Ray grass (*Hemarthria compressa*) that covered evenly toward a brackish water canal. Section TL_01: grass covered slope of 10 m long, relatively regular slope, no hole was found. TL_02: irregular slope, poorly covered with three different grass species (mainly Bermuda), 5 eroded holes and 7 Casuarina trees (amongst those, one with a trunk of 7 cm) were recognised. TL_03: relatively regular, covered with Bermuda grass and Crabgrass (*Eleusine indica*), 5 small Casuarina trees with diameter of 1 cm.

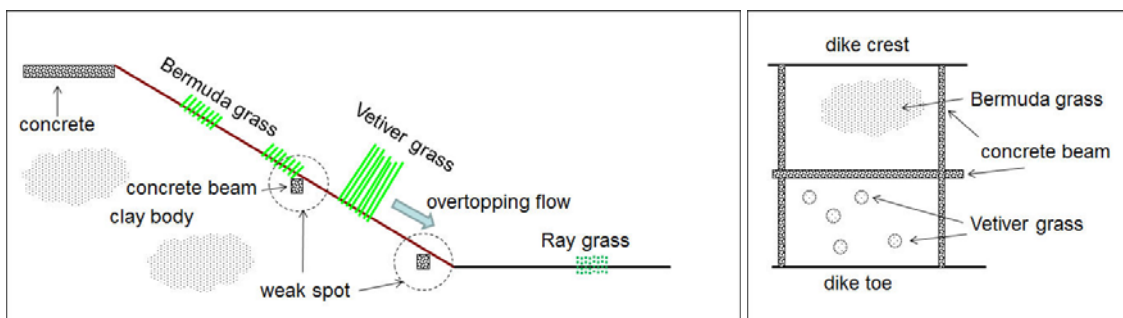
Figure 3: Thai Thuy sea dike in Thai Binh, a mixture of Bermuda and Vetiver grass on clay slope.

Within 50 m of the Thai Thuy dike stretch, 3 sections were tested. The slope inclination was 1:3. The dike body was constructed by good clay, a mixture of Vetiver and Bermuda grass was planted within concrete frames, see Fig 3. The horizontal berm was protected with a dense sward of Ray grass. Vetiver and Bermuda grass covered evenly section TT_01 and horizontal concrete beam was at the middle of the slope. TT_02: number of Vetiver clumps was few while Bermuda grass was dominant however with low density, concrete beams divided the slope section into 4 parts. TT_03: concrete beams divided the section into 4 parts, in which one was mainly covered with Vetiver while at the others both Vetiver and Bermuda grass could be found.

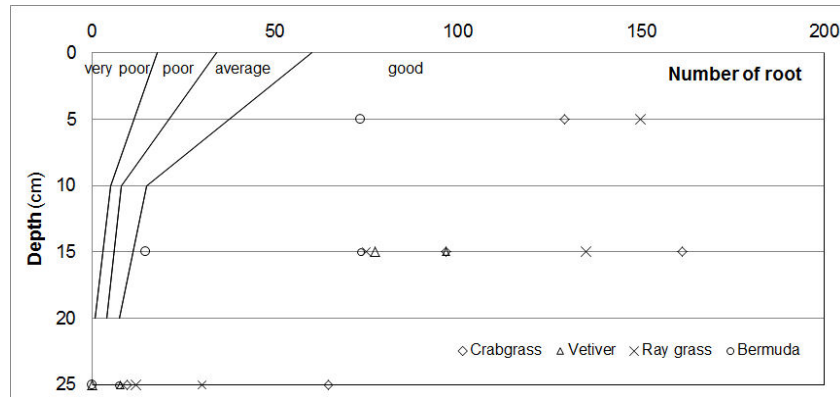
Figure 4: Classification of grass according to the Dutch guidelines VTV 2006.

The resistance against erosion induced by wave overtopping of a grass covered slope is solely determined by the quality of grass turf. According to the Dutch guidelines for safety assessments of dikes (VTV 2006), quality of a grass cover can be estimated by the amount of roots in depth. 8 samples of 4 different grass species taken on Thai Thuy dike were analysed to derive the number of roots. In general, the quality of the tested grass slopes were far beyond “good” criterion of VTV, Fig 4. It should be noted that the growing condition of grass in Viet Nam and the Netherlands are obviously different and grass species are themselves different.

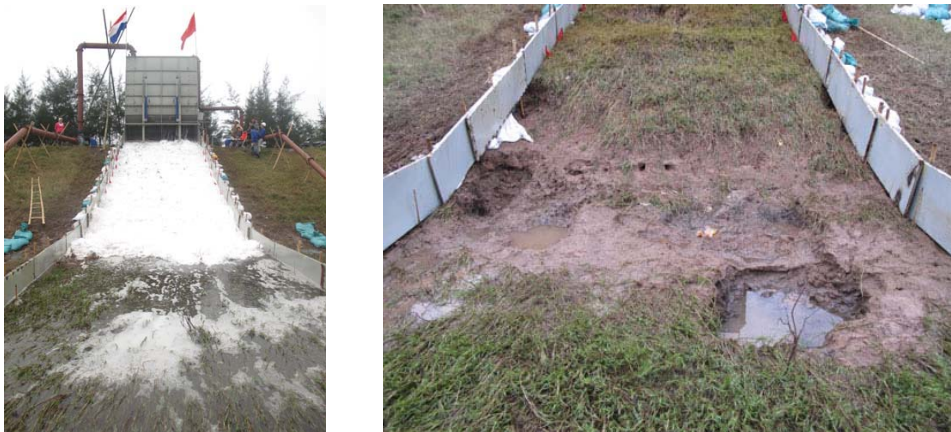
Figure 5: Rough guidance of overtopping flow (left) and damages (right) at dike toe, TL_01.

Section TL_01, slope surface was regular and covered with Bermuda grass, horizontal toe was covered with Ray grass. Around the transition between these two parts, grass cover was rather poor that clay was exposed directly to overtopping flow. Besides, at the transition acting force seemed larger than on the slope due to the rough guidance of overtopping flow, see left panel of Fig 5. Damages were therefore caused to take place at the dike toe, a geometry transition, right panel of Fig 5.

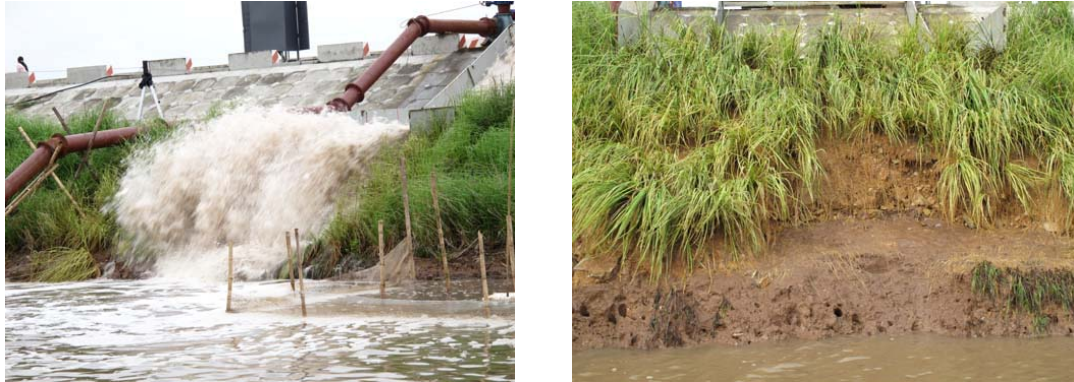
Figure 6: Overtopping flow flying from the berm attacks the dike toe.

Section DS_01, bare soil was first eroded and subsequently Vetiver clumps were swept away at the transition between the low part of the slope and the canal bank as can be seen in Fig 6 right panel. It could be explained by the water flow with high energy flying into the air from the end of the concrete berm to attack the dike toe more or less vertically, Fig 6 left panel. Interestingly, the first row of Vetiver clumps next to the concrete berm was first hit by overtopping flow however these clumps remained intact till the end of the test, they were only forced to lie down.

Due to the long and straight root system, when Vetiver clumps were eroded and swept away hole with very steep wall was formed. The eroded hole was enlarged in upward direction under attack of overtopping flow. This is similar to the head-cut mechanism that is the last stage of an erosion process described by Valk (2009) consisting of: initial situation, scour hole due to surface erosion, transition and head-cut erosion. Scour hole due to surface erosion can be compared to the formation of trenches amongst separate Vetiver clumps and transition of surface erosion to head-cut erosion is like when these trenches get sufficient depth to split Vetiver clumps from the slope.

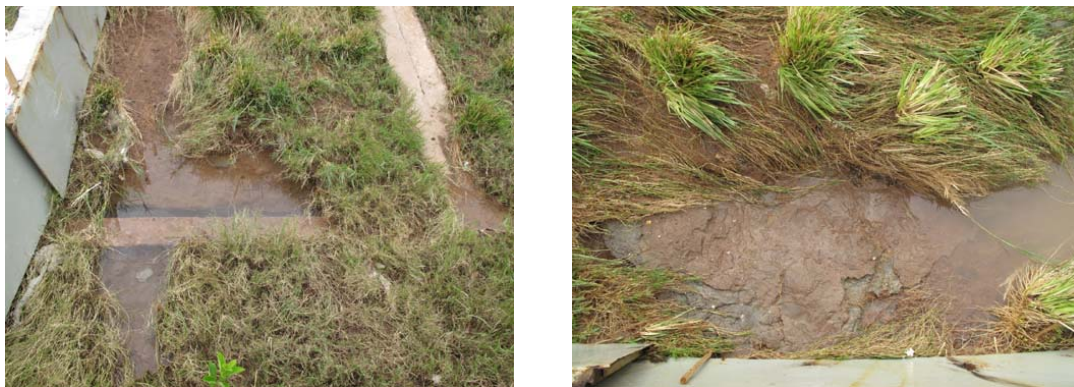
Figure 7: Left: concrete beam was exposed. Right: mortar layer under a top grass sod.

Fig 7 left panel gives an impression of a damage at dike toe that expose the horizontal concrete beam, section TT_03. When the top layer of grass sod (about 10 cm) was eroded, a thin layer of mortar was found, Fig 7 right panel. The mortar layer prevented grass roots from penetrating deeply dike body underneath. As a result, the connection either between the top soil layer and the mortar layer or between the mortar layer and the soil body were weak. Therefore, either the top grass sod or the mortar layer were easily eroded to expose the underneath body of soil. The damage at geometry transition was facilitated by the transition of material.

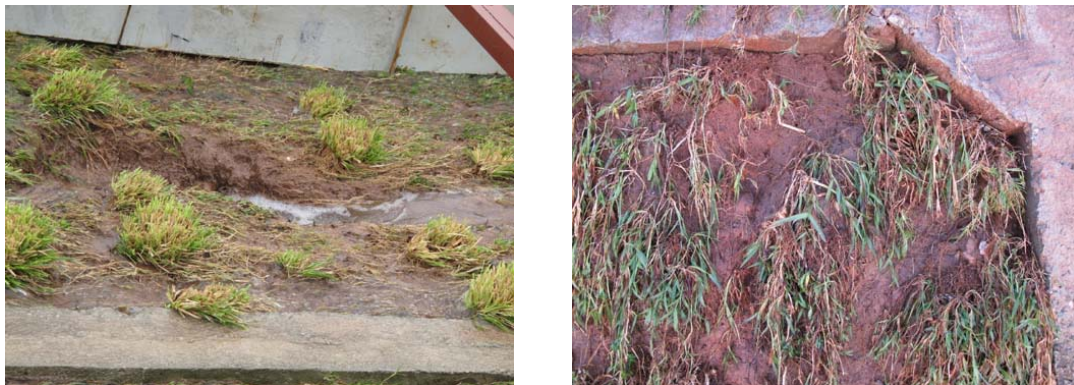
Figure 8: Left: damages amongst Vetiver clumps. Right: poor cover of Bermuda grass and settlement of soil around concrete beams,

sparse. Bermuda grass predominantly protected the dike slope. More Vetiver clumps were planted on the riverside slope in May 2010, beginning of the rainy season and about 6 months before testing. In November, when destructive tests were carried out, Vetiver clumps were growing well and about 1 m high. As can be seen in Fig 8, left panel, Vetiver sward was cut off to expose the thin cover of Bermuda grass. It was Vetiver grass that overwhelmed the mat grass. Due to the high shape of Vetiver clumps, flow tended to concentrate amongst close clumps, as a result, trenches were formed. The more soil was eroded the deeper the trenches became. Sufficiently deep trenches split Vetiver clumps from the slope, the slope was therefore damaged. As described above, at section DS_01 damages were also first initiated amongst separate Vetiver clumps where soil directly exposed to overtopping flow. The existence of more than one species of grass caused discontinuity of the dike slope, weak spots were often found at these transitions of different grass species.

Transition between grassed soil and concrete beam could be potential vulnerable spot where grass cover was often poor and soil surface was settled down, Fig 8 right panel. Poor cover of grass might be due to a low root density in top soil layer and uneven surface around the beam would introduce flow concentration. Combination of these two features caused higher chance of erosion around the concrete frames as illustrated in Fig 9 left panel.

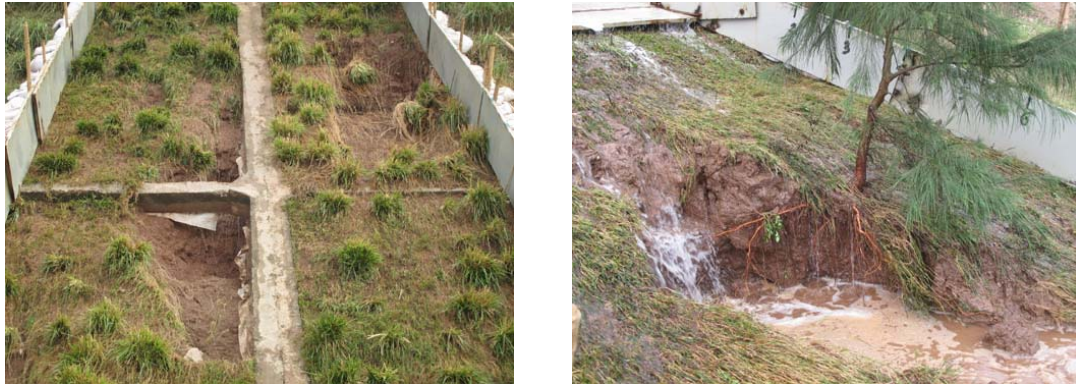
Figure 9: Left: damage around concrete frames. Right: damage extension to the Casuarina tree.

At section TL_02, damage was first started from an existing hole. Later on, it was rapidly extended to reach the Casuarina tree. Overtopping flow eroded and carried away soil aggregates hold by the root system that the connection between the Casuarina tree and the dike slope became increasingly weak. The anchoring forces were reduced smaller and no longer sufficient to retain the tree anymore, the Casuarina fell down. Due to the large trunk of about 7 cm wide, the Casuarina tree also caused flow blockage, force intensity was hence increased. Situation of the Casuarina tree before its collapse is shown in Fig 9, right panel.

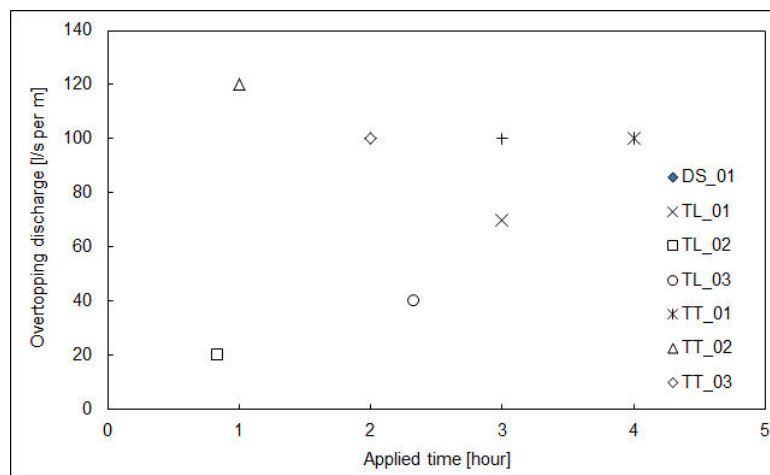
Figure 9: Maximum overtopping rate vs. applied time at 7 tested sections in Viet Nam.

A small number of destructive tests performed in Do Son, Think Long and Thai Thuy has given an impression of the resistance of different grass covered slopes against wave overtopping. At section DS_01, the low slope covered with 2-year-old Vetiver grass was severely damaged after 3 hours of 100 l/s per m. Test replications on a short dike stretch in Think Long, about 50 m long, revealed that strength of grass slope could vary considerably. At TL_01, the maximum applied discharge was up to 70 l/s per m lasting for 3 hours. TL_02 could withstand a overtopping rate of 20 l/s per m. Slope section TL_03 failed after more than 2 hours applying 40 l/s per m. Three tests performed within a 50 m dike stretch in Thai Thuy showed that the maximum applied discharge was likely to be consistent and not less than 100 l/s per m.

If the effect of smaller discharges that were applied before the maximum rate is not taken into account, the maximum rate and its applied time (time to failure) at each tested section are plotted in Fig 10. It can be seen that overtopping resistance of grass slope varies enormously from 20 to even more than 100 l/s per m. This high variability is due to the difference in geometry and soil/ grass characteristics of the tested sections and the length effect.
