# DESTRUCTIVE WAVE OVERTOPPING TESTS ON GRASS COVERED LANDWARD SLOPES OF DIKES AND TRANSITIONS TO BERMS

Gosse Jan Steendam<sup>1</sup>, Jentsje W. van der Meer<sup>2</sup>, Bianca Hardeman<sup>3</sup>, André van Hoven<sup>4</sup>

*Keywords:* dikes; levees; prototype tests; overtopping; wave overtopping simulator; grass erosion

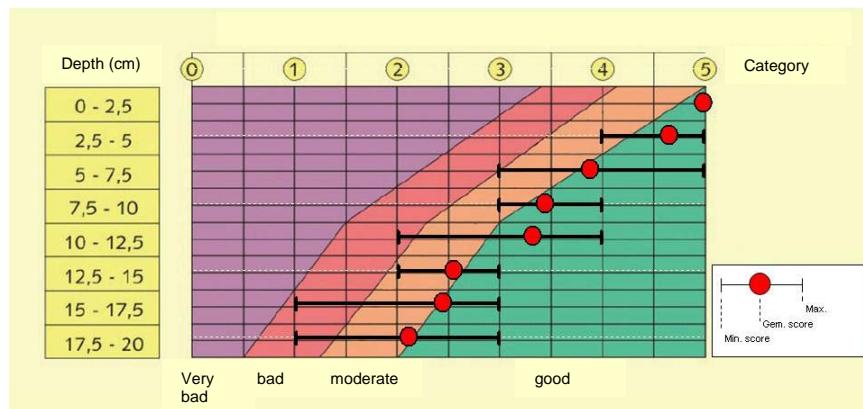
Figure 3. Average score according to VTV2006 of quality of the root system, February 2009

Figure 3 shows that the root system at the Afsluitdijk was in a good condition (average number of roots, represented by categories, in each depth segment in the green area). Also it was found that the quality during winter did not decrease. With that it has to be noticed that the winter of 2008 / 2009 was very moderate with temperatures just incidentally below freezing point. Nevertheless, also during other winters it has been seen that the root system stays in fairly good condition in the Dutch climate. The same results were found at the Vecht dike.

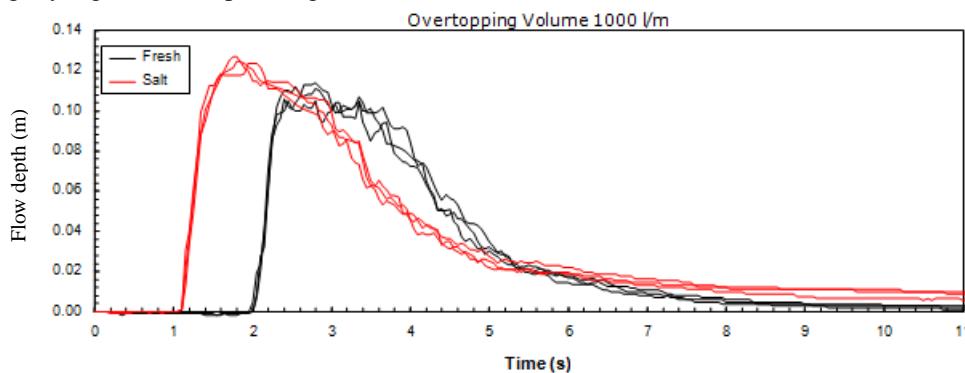
Figure 7 shows that waves tend to stretch. Larger overtopping waves have a longer duration. Also from the measurements it was found that larger overtopping waves have higher front velocities. From the comparison between the use of salt water and fresh water it could be concluded that salt water gives slightly higher flow depths (Figure 8).

Figure 8. Difference in Flow depths between fresh and salt water (Overtopping volume 1000 l/m)

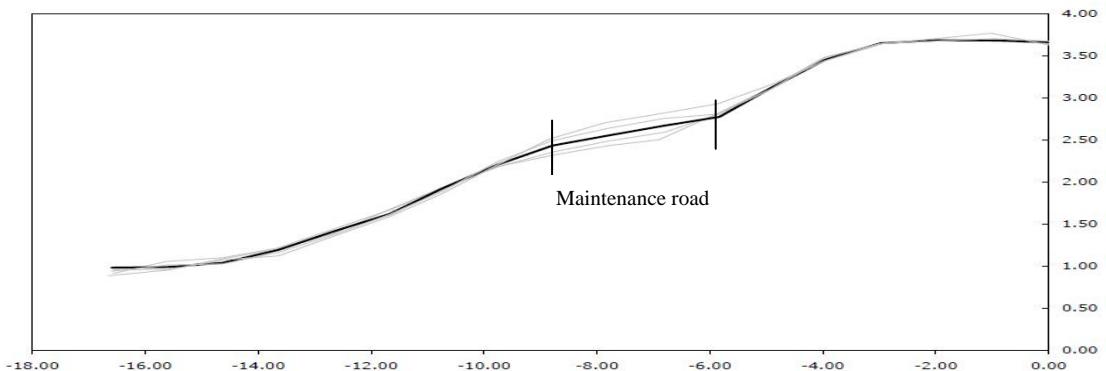
Figure 16. Cross section V1 (measures in meters)

Test section V1 was situated at the river side of the dike. It contained a crossing of a maintenance road consisting of concrete 40 cm x 40 cm x 12 cm bricks that allow for grass growth. The road crossed the river slope at an angle. The crest was covered with the same concrete bricks. Figure 16 shows a cross section.

Just above the maintenance road deep track was present, showing a vertical ridge against the concrete bricks.

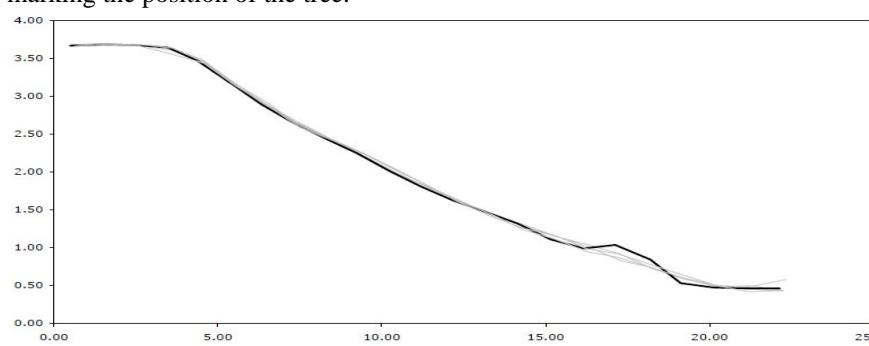
Figure 20. Cross section V2 (measures in m)

At the second test section at the Vecht dike a large tree (trunk 0.8 m wide) was present at the toe of the dike (Figure 19). Figure 20 shows a cross section. This cross section shows the slope to be somewhat hollow with the bump marking the position of the tree.

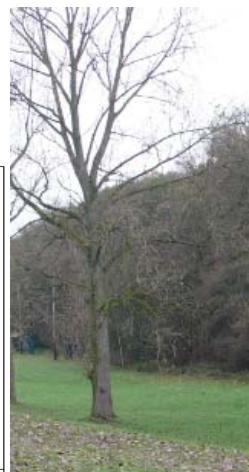
Figure 19. Tree at the landward berm

**Results of test series V2.** At the 5 l/s per m test the grass cover around the tree disintegrated showing a lot of near surface roots from the tree. The damage developed fast at the 10 l/s per m test (Figure 21).

In the 30 l/s per m test the surface of the slope did not change much. The damage at the tree increased. In the next test (50 l/s per m) the damage at the tree expanded to over 4 m<sup>2</sup> and sand was washed out. The test was stopped after 5½ hours; the dike at the tree was considered to have failed (Figure 21 on the right).
