## **Erosion strength of inner slopes of dikes against wave overtopping**

**Preliminary conclusions after two years of testing  
with the Wave Overtopping Simulator**

**Version: 1.1**

**Date: August 2008**

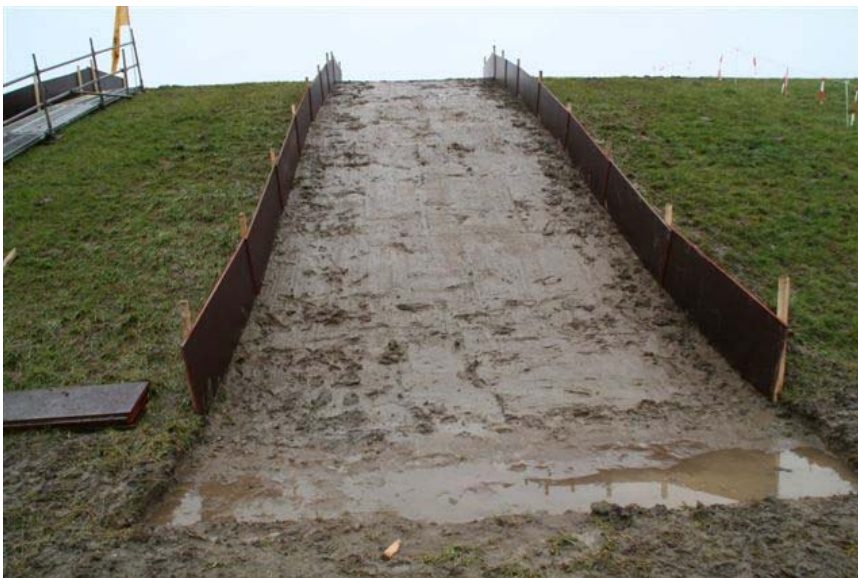
4. The transition from crest to inner slope never showed any damage.
5. Elastocoast and open asphalt concrete did not show any damage at 125 l/s per m. A small repair with cold asphalt disappeared immediately.

Figure 29. Kattendijke, Zeeland. Construction of test section with elastocoast and open asphalt concrete. A 5 cm grass cover was removed, an open geotextile was placed and then covered with 10-15 cm elastocoast or open asphalt concrete.
