# FIELD MEASUREMENTS OF VERY OBLIQUE WAVE RUN-UP AND OVERTOPPING WITH LASER SCANNERS

Patrick Oosterlo, TU Delft, [P.Oosterlo@tudelft.nl](mailto:P.Oosterlo@tudelft.nl)

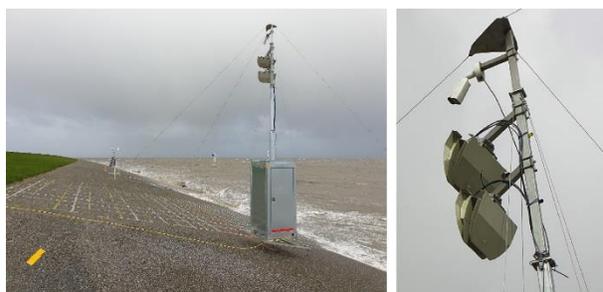
Figure 2 - Left: New laser scanner system next to the overtopping tanks on the dike in the Eems-Dollard estuary. Right: from the bottom to the top: Laser scanner 1, laser scanner 2, video camera.

An extensive field measurement project is being performed in the Eems-Dollard estuary in the north of the Netherlands for a period of 12 years. The measurements started in 2018, measuring wind, water levels, waves and wave run-up and overtopping. The estuary consists of deep channels and shallow tidal flats and is part of the Wadden Sea, a shallow shelf sea, see Figure 1. A particular aspect for this area is that the dike design conditions are characterized by very obliquely incident waves, up to 80° relative to the dike normal. As the reliability of the models as used for the Dutch dike safety assessment has not been sufficiently validated for such conditions, the aim of the measurements is twofold. First, to better understand the processes yielding nearshore wave conditions, ultimately leading to improved numerical prediction models. Second, to better understand the processes related to oblique wave run-up and overtopping, leading to improved prediction methods. In the project, the wave overtopping is measured with four wave overtopping tanks built into dikes at two locations. The laser scanner system of Oosterlo et al. (2019) has since been upgraded and has now been placed next to two of the overtopping tanks on the dike in the Eems-Dollard estuary to measure during actual severe winter storms, see Figure 2.

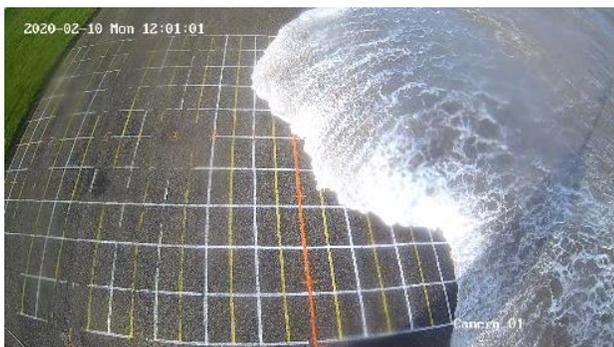
Figure 3 - Snapshot of a very oblique wave running up the slope during storm Ciara.

The focus of the paper will lie on the measurements performed during storm Ciara. Storm Ciara was an extratropical cyclone that hit large parts of northern Europe starting on 7 February 2020. Measurements were performed from 10 to 12 February 2020. Ciara was the first actual storm that was measured with the laser scanner system, and immediately tested the system to the extreme. Ciara was a highly unique storm, with offshore directed wind at the measurement location and waves that turned somewhat on the shallow flats in front of the dike to become almost alongshore directed waves at the dike. Hence, Ciara caused highly complex conditions at the measurement location with very oblique wave attack with angles of incidence up to 75°. This posed large challenges for measuring e.g. the 3D front velocities and the overtopping volumes and discharges, also see Figure 3.
