Validation of Cumulative Overload Method based on Tests by the new Wave Run-up Simulator

J.W. van der Meer^{1,2}, G.J. Steendam³, and A. van Hoven⁴

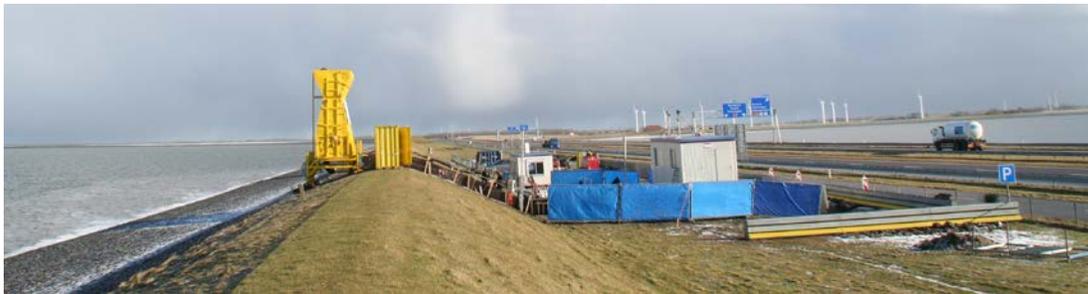
Wave Overtopping Simulator. The Wave Overtopping Simulator has been designed and constructed in 2006 and has been used since then for destructive tests on dike crests and landward slopes of dikes or levees under loading of overtopping waves. The setup of the Overtopping Simulator on a dike or levee is given in Figure 1, where the simulator itself has been placed on the seaward slope and it releases the overtopping wave volume on the crest, which is then guided down the landward side of the dike. Water is pumped into a box and released now and then through a butterfly valve, simulating an overtopping wave volume. Electrical and hydraulic power packs enable pumping and opening and closing of the valve. A measuring cabin has been placed close to the test section. The Simulator is 4 m wide and has a maximum capacity of 22 m², or 5.5 m³ per m width. Released volumes in a certain time are according to theoretical distributions of overtopping wave volumes, depending on assumed wave conditions at the sea side and assumed crest freeboard.

Figure 1. Set-up of the Wave Overtopping Simulator close to a highway.

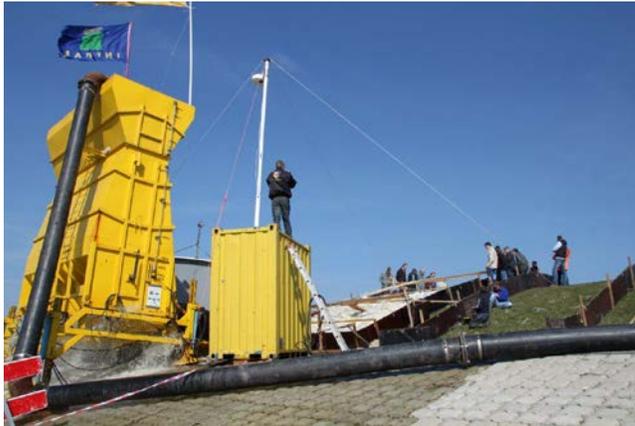
New Wave Run-up Simulator. The process of wave run-up was explored as well as a procedure for testing was developed, see Van der Meer *et al.* (2012). Then in 2012 a pilot test was performed on wave run-up simulation, but using the Wave Overtopping Simulator as an existing device. The Simulator was placed on a seaward berm and run-up levels were calibrated with released wave volumes and these were used for steering the process. In this way the largest run-up levels of a hypothetical storm and storm surge, which would reach the upper slope above the seaward berm, were simulated. Figure 2 gives the set-up of the pilot test and shows a wave run-up that even overtopped the crest, more than 3 m higher than the level of the Simulator.

Figure 2. The Wave Overtopping Simulator used in a pilot test on wave run-up simulation.

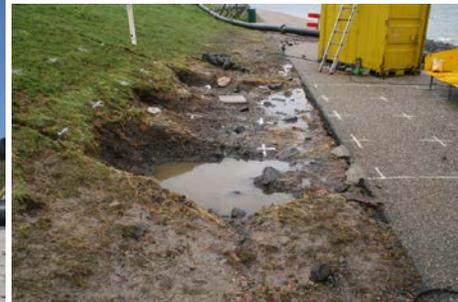
An example on damage developed by simulating wave run-up is shown in Figure 3. The up-rushing waves meet the upper slope of the dike and "eat" into it.

Figure 3. Damage caused by wave run-up simulation.

Cumulative overload by Pilot test in 2012. In 2011 a pilot test was performed at Tholen on run-up simulation, using the wave overtopping simulator, see Van der Meer *et al.* (2012). A similar set-up was used as for the tests described above with four test conditions with increasing (assumed) water level. Initial damage and several open spots occurred quite easily, all on the berm and transition to the upper slope. The grass quality was quite bad in this area. After the test there were three quite deep holes, two at the side walls and one in the middle, see Figure 3. Damage was more than several open spots, but certainly less than failure.

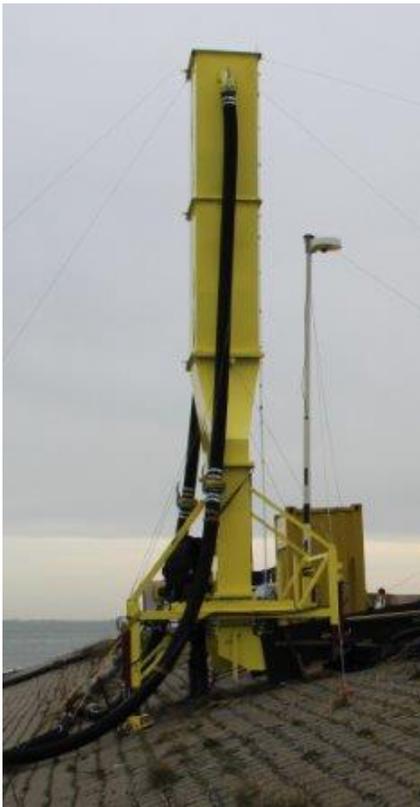
The pilot test gave valuable information on how testing in future could be improved, but also how a real Wave Run-up Simulator should look like. A Wave Run-up Simulator should have a slender shape, different from the present Wave Overtopping Simulator, in order to release less water, but with a higher velocity. At the end of 2013 such a new device was designed, constructed and tested, see Figures 4 and 5. And before spring 2014 the first tests on the upper slope of the seaward part

Figure 4. Wave Run-up Simulator seen from the side.

of a sea dike was tested. The box had a cross-section at the lower part of 0.4 m by 2 m, giving a test section of 2 m wide, see Figure 5. The upper part had a cross-section of 0.8 m by 1.0 m and this modification was designed in order to have less wind forces on the Simulator. The cross-sectional area was the same over the full height of the Simulator in order not to have dissipation of energy during release of water. The overall height is more than 8 m.

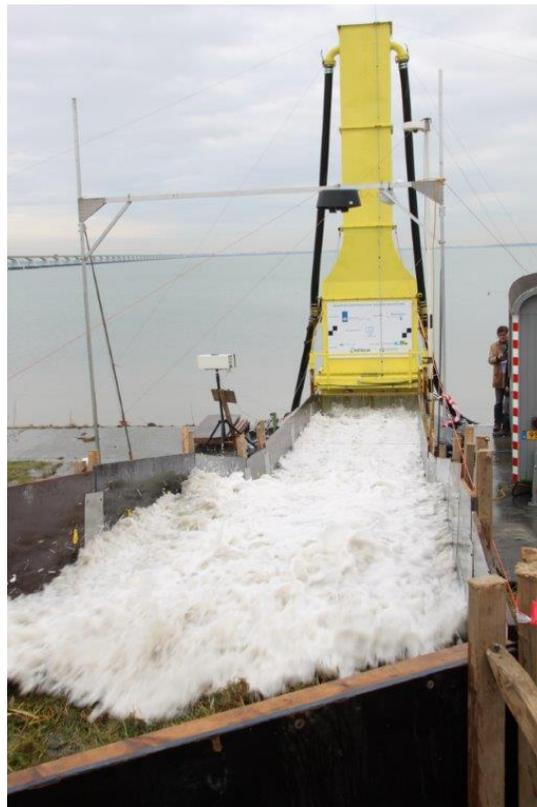
Figure 5. The Wave Run-up Simulator in action.

A new type of valve was designed to cope with the very high water pressures (more than 7 m water column). A drawer type valve mechanism was designed with two valves moving horizontally over girders. In this way leakage by high water pressures was diminished as higher pressures gave a higher closing pressure on the valves. This new Wave Run-up Simulator was calibrated against a 1:2.7 slope. The largest run-up was about 13.5 m along the slope, this is about 4.7 m measured vertically. Besides transitions from down slope to berm and berm to upper grassed slope, also a stair case was tested by wave run-up, which was completely destroyed.

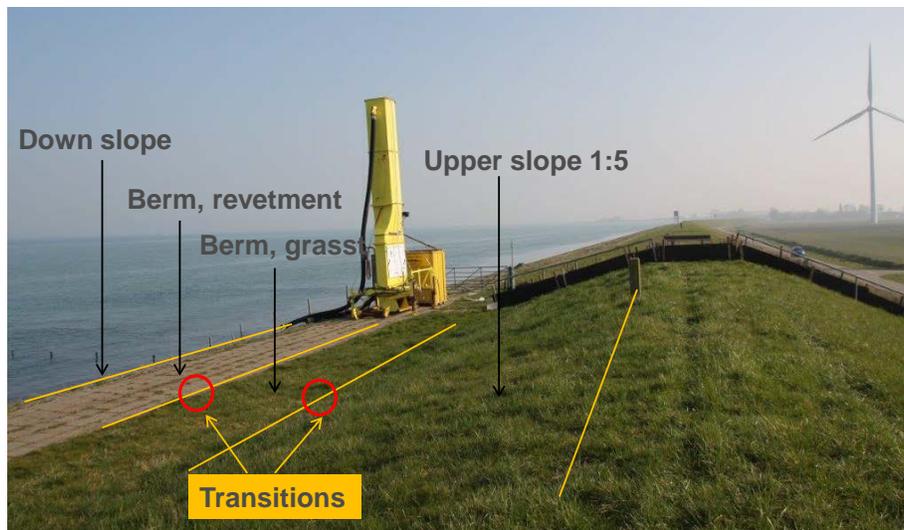
Set-up of the tests. With wave run up, a flow velocity and water layer thickness must be simulated at a certain spot on the seaward slope and then the wave must run up to a certain wave run-up height (Van der Meer *et al.*, 2012). The wave run-up height for a storm condition usually is represented by the height which is reached by 2% of the incoming waves, $R_{u2\%}$. Then a Rayleigh distribution is assumed for the run-up levels. The tests were aimed at eroding a grass cover which started above a block or asphalt revetment, high on the seaward slope of the dike, see Figure 6.

Special point of interests were the transition from the asphalt or block revetment to the grass and from the grassed berm to the 1:5 upper slope, see Figure 6. During the tests pre-defined run-up distributions were simulated according to a Rayleigh distribution, see also Van der Meer *et al.* (2012). The assumed wave height was $H_s = 2$ m and the peak period $T_p = 5.7$ s, giving a wave steepness of 0.04. The storm duration was 6 hours. After each sub-test the imaginary water level was increased by 1 m. The first sub-test started with a water level 3 m below the almost horizontal berm ($x=3$ m) and the last sub-test had a water level at the berm ($x=0$ m). The wave run up simulator remained at the same level throughout each test.

Figure 6. Test setup for the dike *in situ* with horizontal transition and a transition to the upper slope.

The wave run-up tests have been executed successfully. For each test section all relevant strength parameters such as root system of the grass, soil characteristics and thickness of the cover layer were investigated. The tests have been performed on a sea dike in the southwest part of the Netherlands. Five tests have been performed, three on a section as shown in Figure 6, one with handmade damage and one on a staircase.

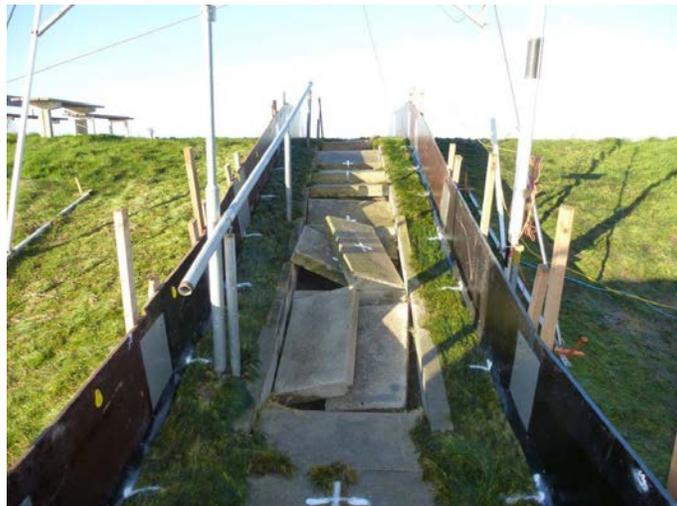
From wave overtopping tests it is known that objects at the landward part of dikes are weak spots if waves overtop the dike. But is this the same for objects on the seaward side of the dikes, which are not subjected to waves overtopping, but to waves rushing up the dike? At the test site stairs were present. These stairs, an object or obstacle in a flood defence, have been tested on resistance against wave run-up and the result is shown in Figure 7.

Figure 7. Testing a staircase with wave run-up simulation.

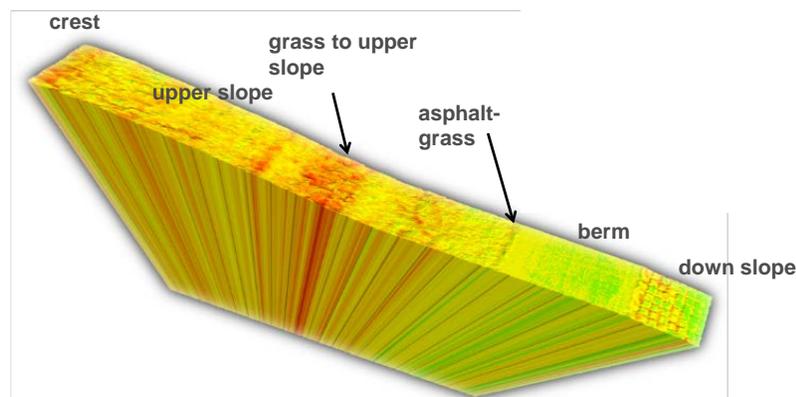
Figure 8. Laser scan of the tested slope of 2 m wide, after test 1. Erosion more than 5 cm is orange to red, no erosion is yellow.

A good way to describe the damage to the transitions in the first three tests is to give the measurements of the erosion by laser. Figure 8 gives the measured erosion after test 1. Erosion more than 5 cm deep has an orange to red colour, where yellow gives no erosion. Figure 8 shows that there is no erosion at the transition from asphalt to the grass on the berm. Apparently there was not really a difference in roughness between asphalt and the grass. Limited damage, but clearly visible in Figure 8, occurred at the start of the upper slope. This damage/erosion was larger than at the remaining higher part of the upper slope. Similar results were found for the other two tests.

Cumulative overload by the new tests with the Wave Run-up Simulator. The method of cumulative overload was developed for wave overtopping. The front velocity of the overtopping wave accelerates down the slope and the cumulative overload is then dependent on the location of damage, as well as the steepness of the landward slope. The front velocity for an up-rushing wave does not accelerate. Over about 75% of the run-up height, the front velocity remains almost at its maximum value. Over the last 25% it drops down to zero. The cumulative damage for run-up depends also on the location on the slope. Very often the location of a transition is the most important one. For the present tests this is the transition from asphalt or revetment to grass and from berm to upper slope. From the test results it has become clear that the transition to the upper slope was critical. At this transition the measured erosion was at its maximum, see Figure 8, although there was still not failure of the grass cover.

As there was no extra erosion at the transition from asphalt/revetment to grass at the berm, it can be concluded that α_1 and α_2 are not substantial different from 1. There was, however, a concentration of erosion at the transition to the upper slope, see Figure 8, and therefore it is logical that α_1 will be a little larger than 1. Table 2 gives the cumulative overload of the total test for critical velocities of 7 m/s, 8 m/s and 9 m/s and for various α_1 -values. As the grass quality looked similar at berm and slope α_2 was kept at a value of 1.0.

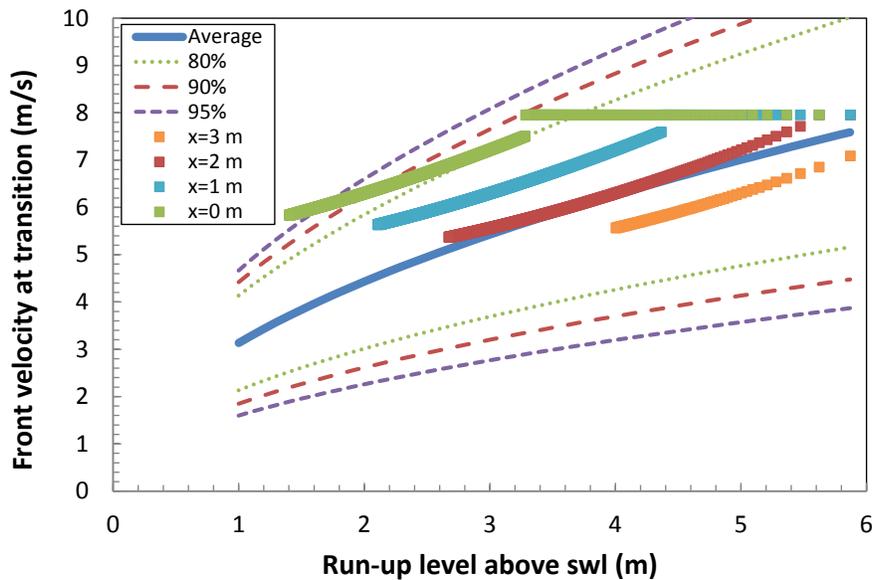
The relationship between run-up level and front velocity of the up-rushing wave was established through the hydraulic measurements described above. With the pre-defined wave run-up distributions it is then possible to develop the distributions of front velocities at the transition from berm to upper slope, see Figure 9.

Figure 9. Distribution of front velocities as simulated at the transition from berm to upper slope, compared to the theoretical distribution (x is the vertical distance from simulated water level to the transition).

The theoretical basis of Figure 9 is the expected front velocity, derived from analysis of wave run-up measurements (Van der Meer *et al.*, 2012). There is a large scatter between the reached wave run-up level and the maximum front velocity. The graph gives the average line, but also the 80%, 90% and 95% exceedance lines.

The wave run-up simulator produces the same front velocity, or the same run-up level, for the same filling level. Figure 9 shows that the front velocities that were simulated were always quite high, roughly larger than 5 m/s, which is already the case for filling levels larger than 1 m. The maximum front velocity was 7.95 m/s, just below 8 m/s.

Subtest $x=3$ m, where the simulated water level is 3 m vertical beneath the point of interest, is a little lower than the average curve in Figure 9, where subtest $x=2$ m is almost equal to the average. The more severe subtests with $x=1$ m and 0 m gave front velocities that were higher than the expected average. In that sense it can be concluded that the simulated conditions for the last two subtests were more severe than can be expected in reality.
